GEOTECHNICAL INVESTIGATION REPORT

PROPOSED NEW DEVELOPMENT

32 GOLF AVENUE, MONA VALE, NSW

Project No.: 2024-004.1

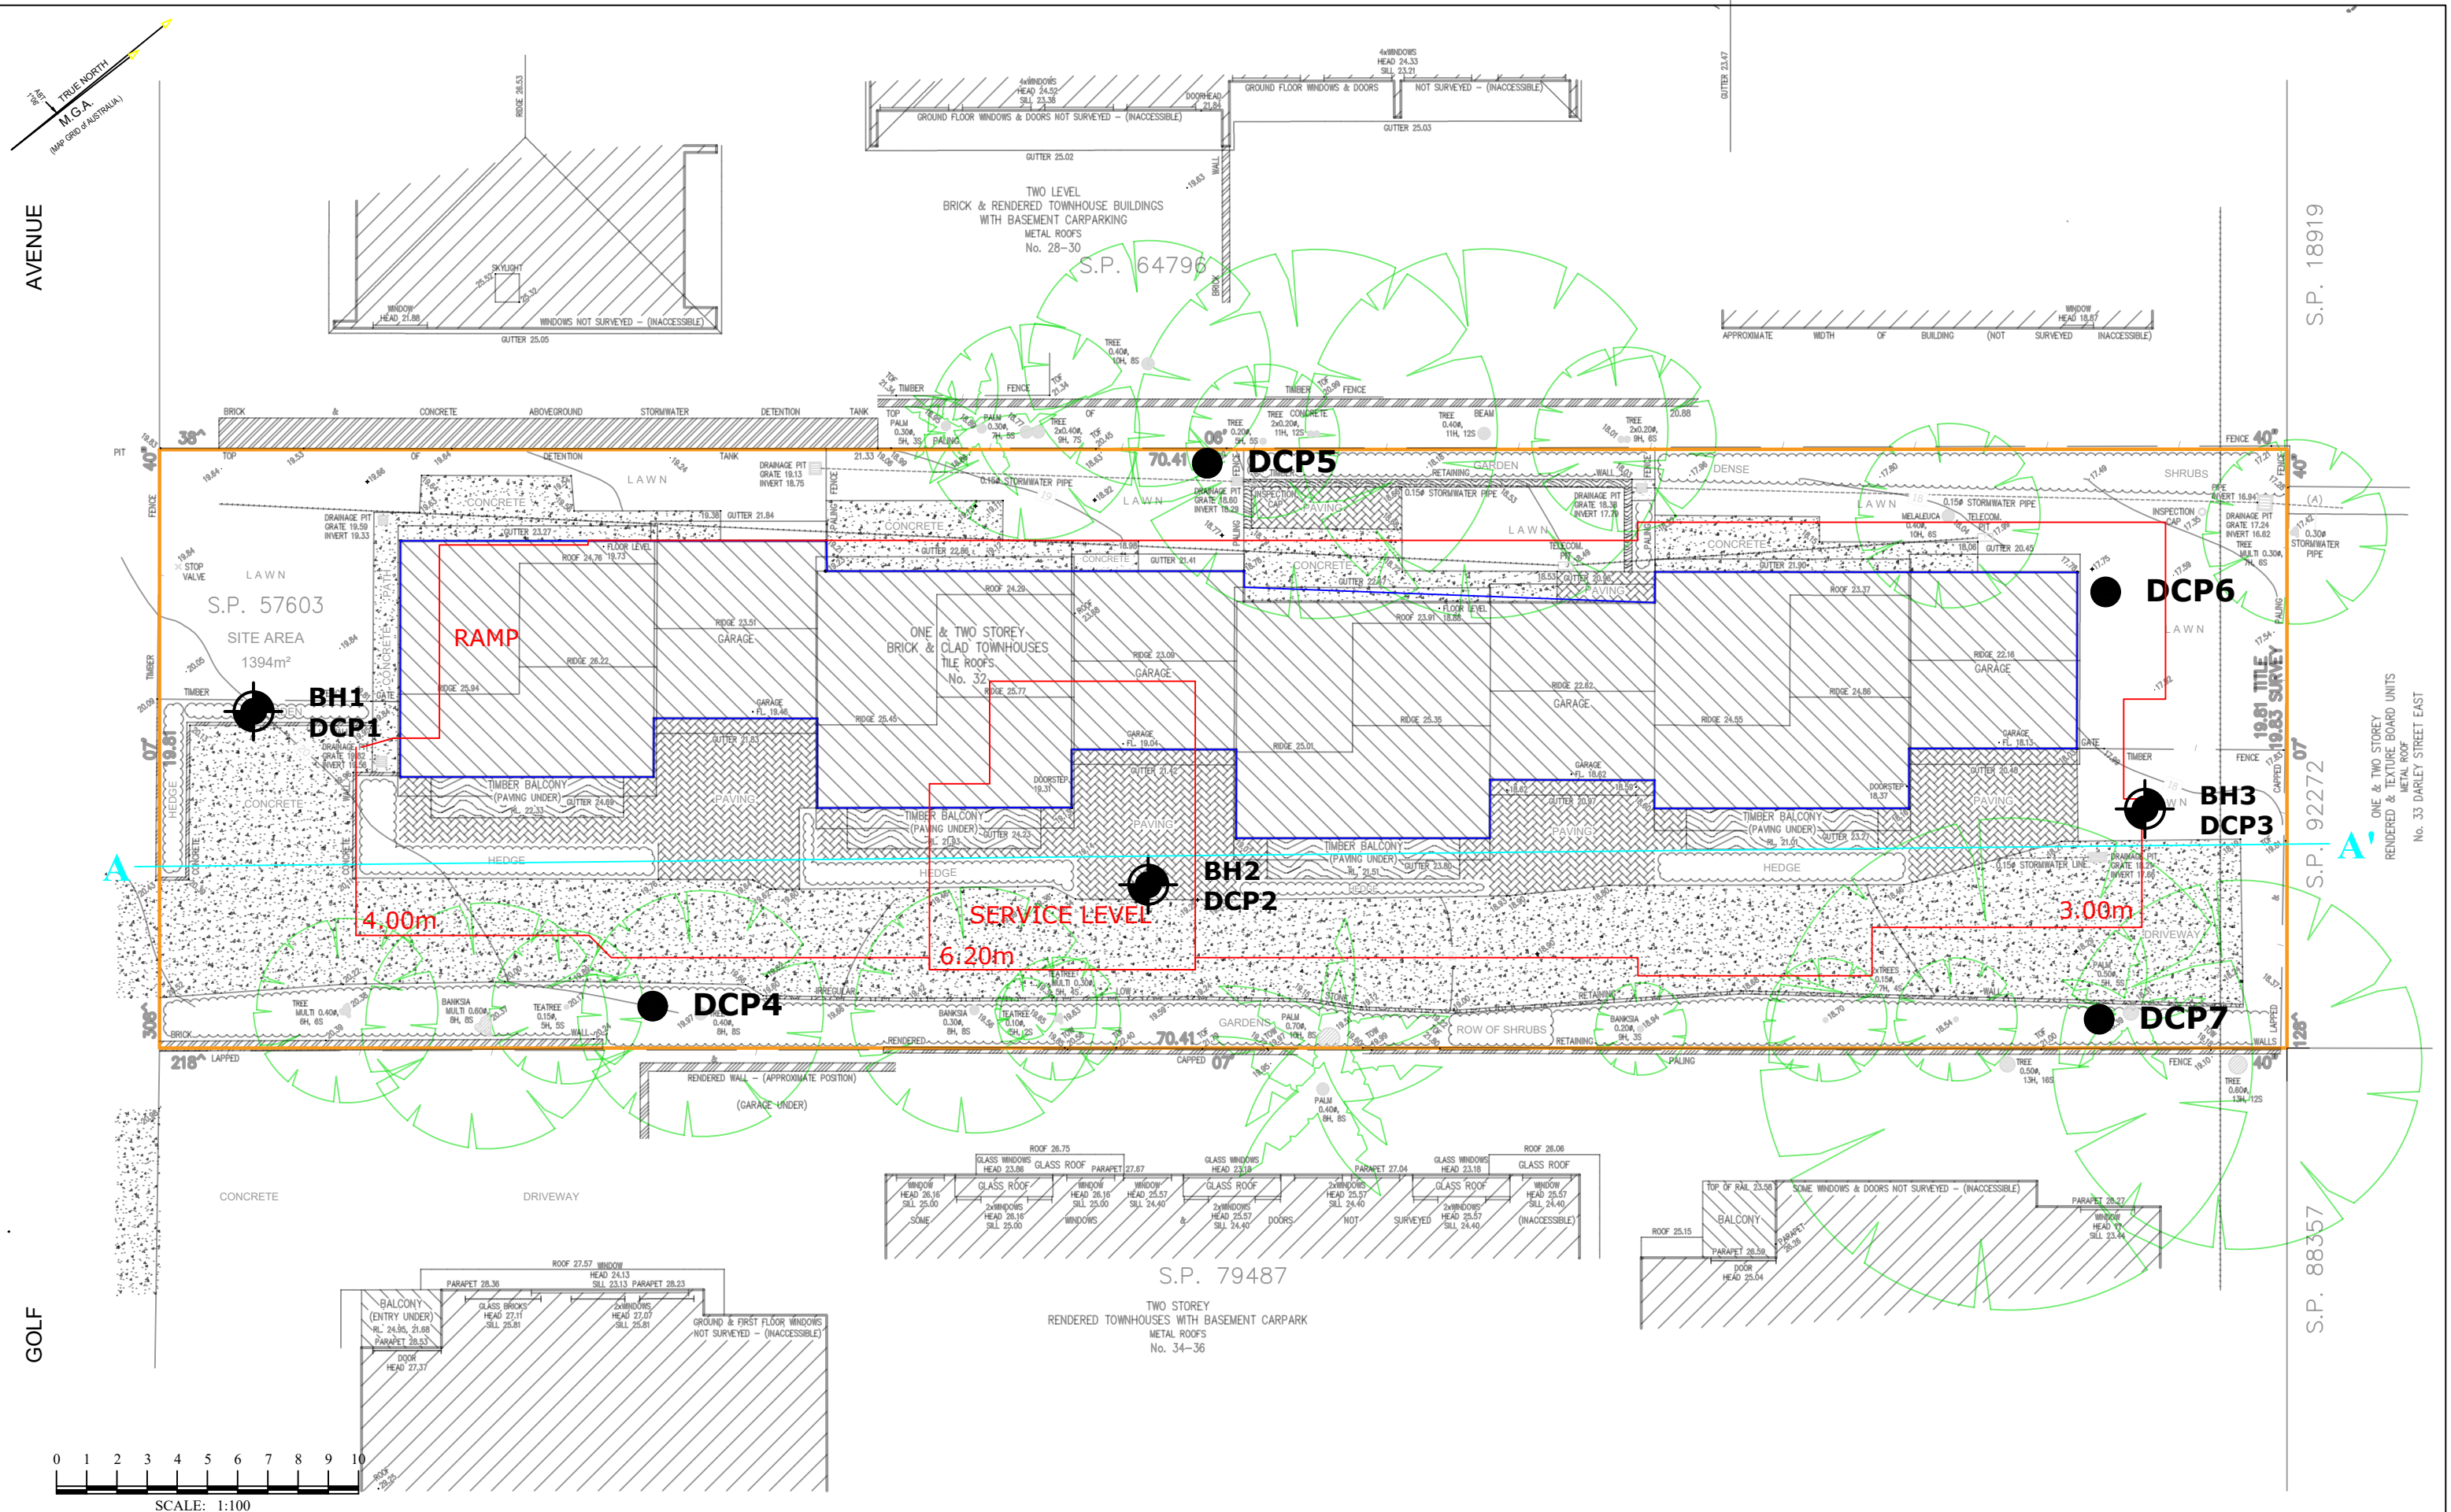
SITE PLAN & TEST LOCATIONS FIGURE 1.

Explanatory notes are included in Appendix: 1. Mapping information and test locations are shown on Figure: 1, along with detailed borehole log and DCP sheets in Appendix: 2, a geological model/section is provided as Figure: 2, Appendix: 2.
