# ARBORICULTURAL IMPACT ASSESSMENT

27 Alan Avenue, Seaforth.

Prepared for: Nick Bell Architects

Date: October 18, 2019.

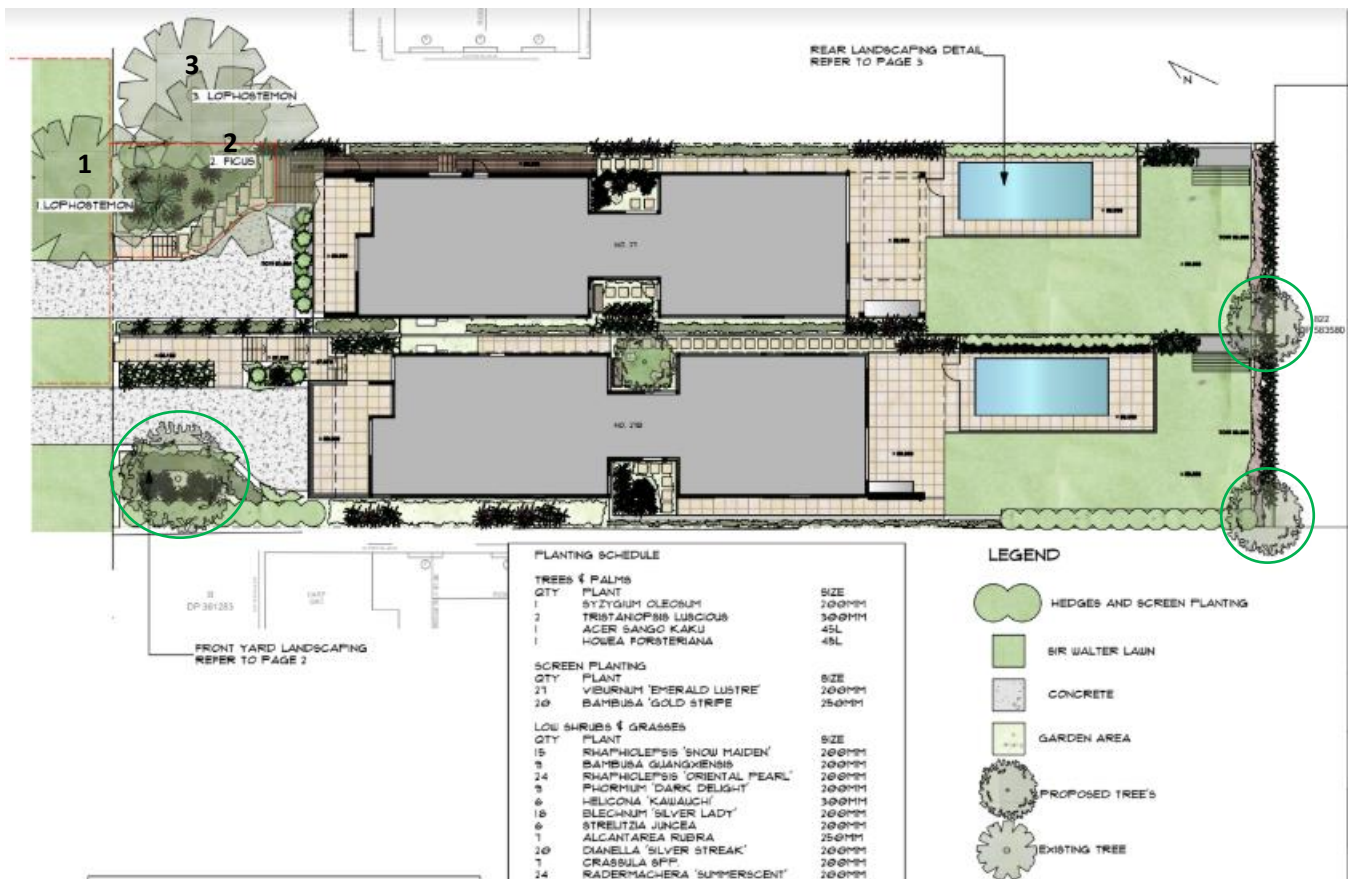
Figure 10-Proposed development showing some of the trees to be retained (numbered) and proposed plantings (green circles).

The proposed development at 27 Alan Avenue will require the removal of two (2) trees of low and very low retention value (trees 4 & 5).

Tree four (4) is a *Melaleuca armillaris*- Bracelet Honey Myrtle. The tree is providing limited amenity value and is of low retention value. The tree will be heavily impacted by grade level changes and swimming pool construction and will require removal.

Tree five (5) is a mature *Eucalyptus nicholii*- Narrow-leaved Black Peppermint. The tree is structurally defective and providing limited amenity value and is of very low retention value due to being an exempt species. The tree will be heavily impacted by grade level changes and swimming pool construction and will require removal.

The removal of tree four (4) will result in the need for at least one replacement planting. Appendix 4 shows the preferred species list for replanting and at least one of the three (3) proposed plantings will need to be a species from this list.
