# BUILDING CODE OF AUSTRALIA SECTION C, D & E COMPLIANCE AUDIT REPORT

Residential Flat Building

97 Queenscliff Road, Queenscliff

REPORT NO. ► 14094 Rev.00

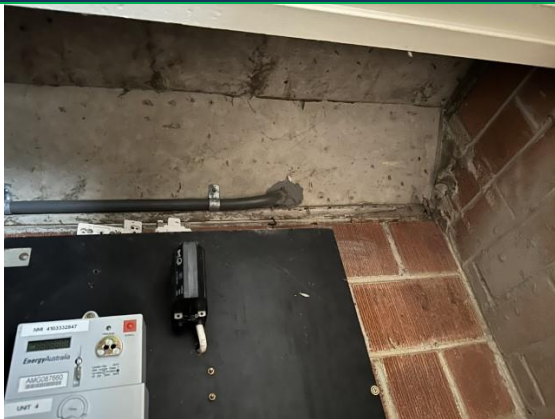
47.	Ground Level Soffit

<p>BCA clause C4D15.</p> <p>Numerous service penetrations between Ground and level 1 are not fire sealed.</p>	<p>All the service penetrations between ground floor and level 1 should be fire sealed in accordance with BCA clause C4D15.</p>

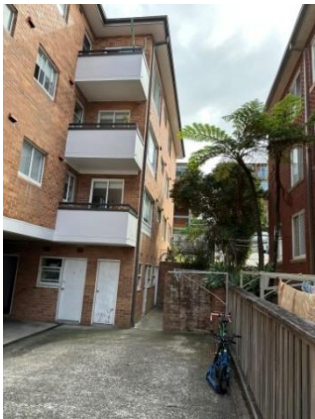
<p>BCA clauses C4D3 and C4D5.</p> <p>Openings in the external wall on the west side of the building are potentially less than 3m from the side boundary and are not fire protected in accordance with BCA clause C4D5.</p>	<p>A survey should be undertaken to confirm the distance the external wall is located from the boundary.</p> <p>If the wall is within 3m of the boundary any openings in the wall are required to be fire rated in accordance with BCA clause C4D5 or addressed via a performance solution from a fire engineer.</p>

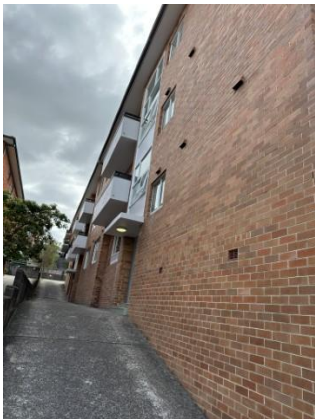
54.	External

<p>BCA clauses C4D3 and C4D5.</p> <p>Openings in the external wall on the east side of the building are potentially less than 3m from the side boundary and are not fire protected in accordance with BCA clause C4D5.</p>	<p>A survey should be undertaken to confirm the distance the external wall is located from the boundary.</p> <p>If the wall is within 3m of the boundary any openings in the wall are required to be fire rated in accordance with BCA clause C4D5 or addressed via a performance solution from a fire engineer.</p>

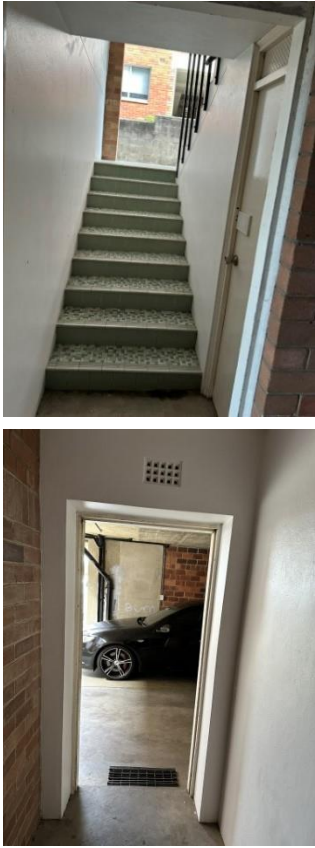
<p>BCA clause E4D6</p> <p>There was no directional exit sign installed at ground floor.</p>	<p>An exit sign should be installed at the ground floor in accordance with BCA clause E4D6 and AS/NZS 2293.1 – 2018.</p>

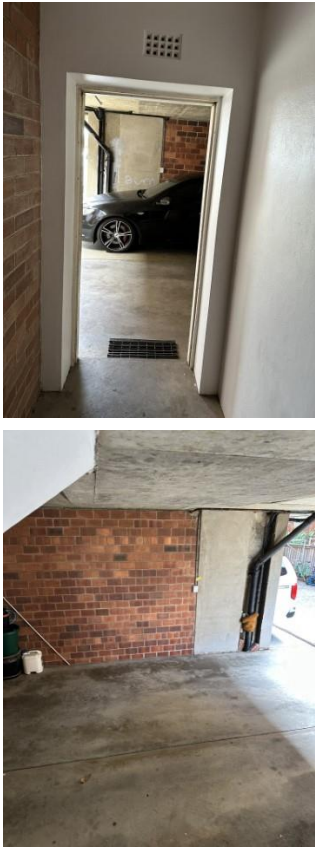
<p>BCA clause S2OC7</p> <p>A Building Occupant Warning System is not provided with the ground floor.</p>	<p>A Building Occupant Warning System should be provided to this level in accordance with BCA clause S2OC7.</p>

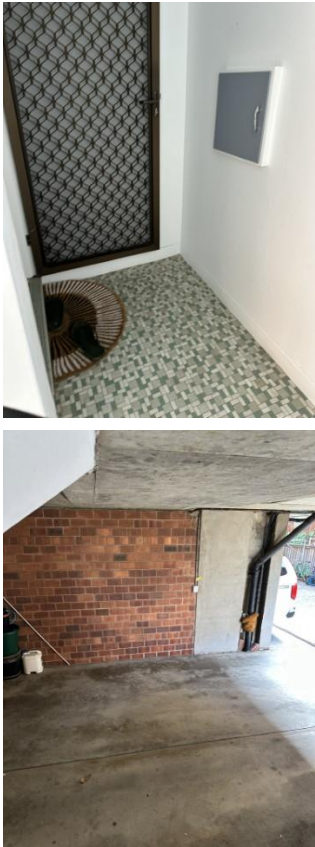
<p>BCA clause E1D14 No portable fire extinguishers were installed throughout the building.</p> <p>BCA clause E1D3 In addition there were no fire hose reels within the ground floor carpark area.</p> <p>This level may be less than 500m<sup>2</sup> in floor area, if so fire hose reels would not be required (where compliant street hydrant coverage is achieved see comments further above about hydrants above).</p>	<p>Confirmation of the floor area of the ground level is required in terms of over or under 500m<sup>2</sup></p> <p>Install fire extinguishers and fire hose reels as required in accordance with clauses E1D3 and E1D14 of the BCA once the floor area of the carpark and the hydrant requirements are confirmed.</p>
