GEOTECHNICAL INVESTIGATION:

New Carport, Storeroom and Lift at **103 Narrabeen Park Parade, Mona Vale**

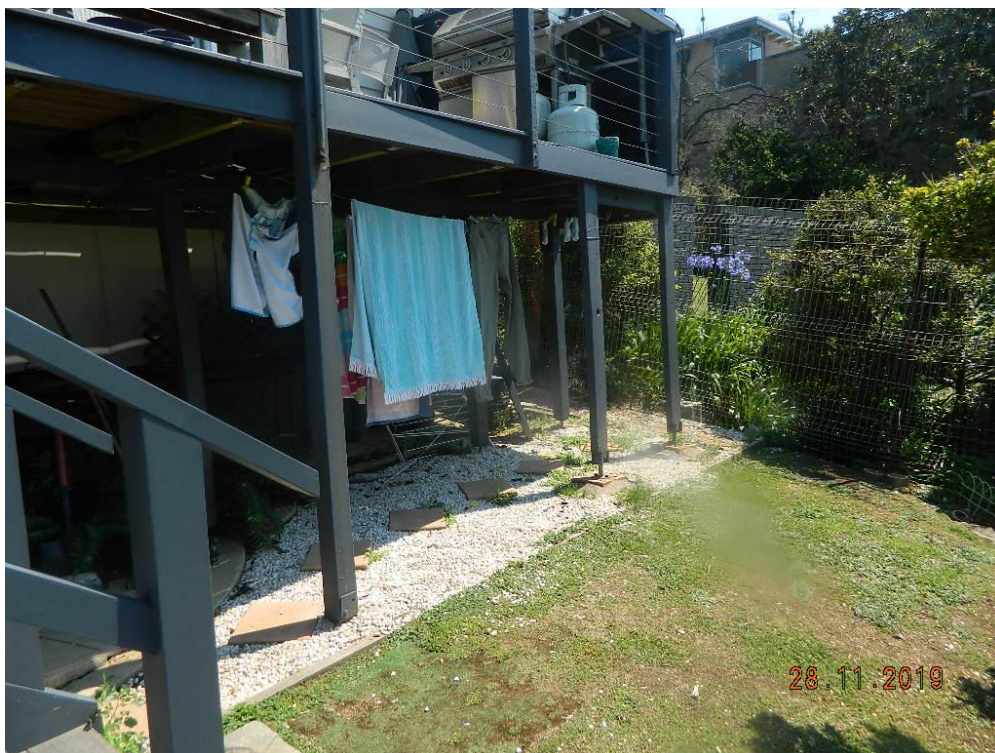
Photo 14

garden is supported by a stable stack rock retaining wall ~1.0m high (photo 8). The cut below the lawn is supported by a stable sandstone retaining wall ~1.0m high (photo 9). The two storey timber and weatherboard clad house is supported on brick walls, brick piers and concrete piers (photos 10 to 14). The supporting walls and piers show no significant signs of movement. A stable timber retaining wall supports a cut batter located underneath the downhill side of the house (photo 13). A suspended timber deck supported on timber posts extends off the downhill side of the house. (photo 15). A fill that provides a level platform for a stone pavement is supported by a stable timber retaining wall (photos 12, 16 & 17). A moderately sloping lawn descends downhill to the SE boundary of the property (photo 18). Below the boundary the surface is covered in coastal shrub and continues to Warriewood Beach (photos 19 & 20).
