87 Alexandra Crescent, Bayview

Comments on Updates to Plans

GEOTECHNICAL INVESTIGATION:

Alterations and Additions at **87 Alexandra Crescent, Bayview.**

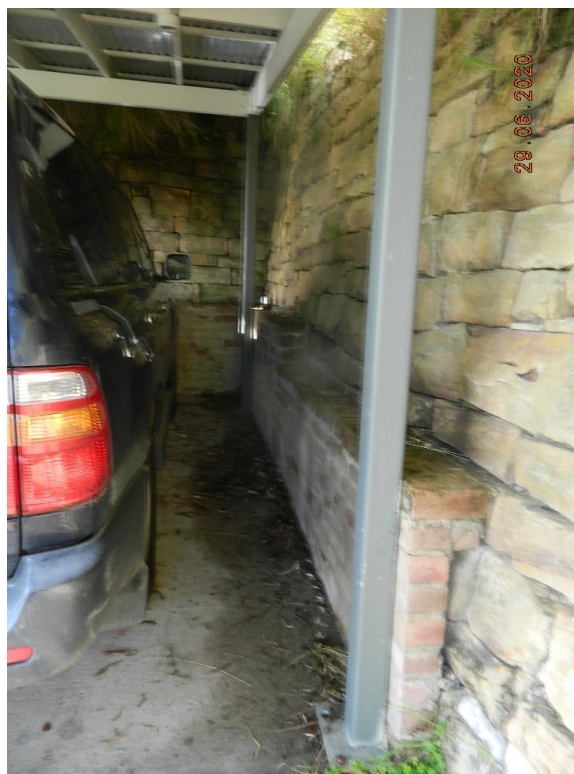
Photo 2

2.3 At the road frontage a concrete driveway runs to a carport cut into the slope (Photo 1). The cut is supported by sandstone block, brick and concrete block retaining walls up to ~3.4m high (Photos 1 to 3). The highest portion of the sandstone block wall is supported by a brick wall in front of the base of the retaining wall (Photo 2). The retaining walls are considered to be stable. Between the carport and the house is a steep and thickly vegetated slope (Photo 1). The part three storey rendered brick and weatherboard clad house is supported by brick walls and brick piers Photos (1 & 4). The supporting walls and piers stand vertical and show no significant signs of movement (Photo 5). Uphill of the house a cut in the slope provides a level platform for the house. The cut is supported by concrete block and sandstone flagging retaining walls up to ~2.7m high. (Photos 6 & 7). The W portion of the concrete block retaining wall is tilting at up to ~4° from vertical. See 'Section 16 Ongoing Maintenance'. A Medium Strength Sandstone bedrock cliff face up to ~7m outcrops above the cut for the house (Photo 8). A portion of the cliff face is undercut by up to ~4.4m (Photo 9). The undercut is considered stable. No geotechnical hazards were observed on the neighbouring properties that could impact on the subject property as seen from the street and subject property.

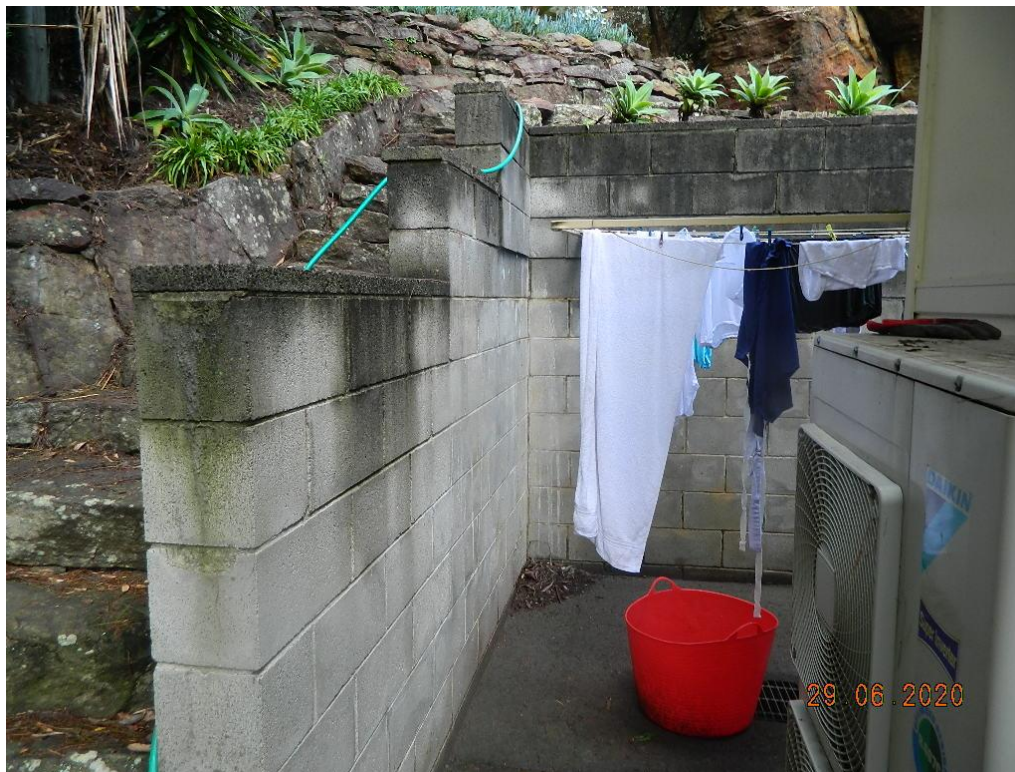
Photo 6

The concrete block retaining wall (Photo 6) is to be monitored by the owners on an annual basis or after heavy prolonged rainfall events, whichever occurs first. A photographic record of these inspections is to be kept. Should further movement occur the wall is to be remediated so it meets current engineering standards. We can carry out these inspections upon request.

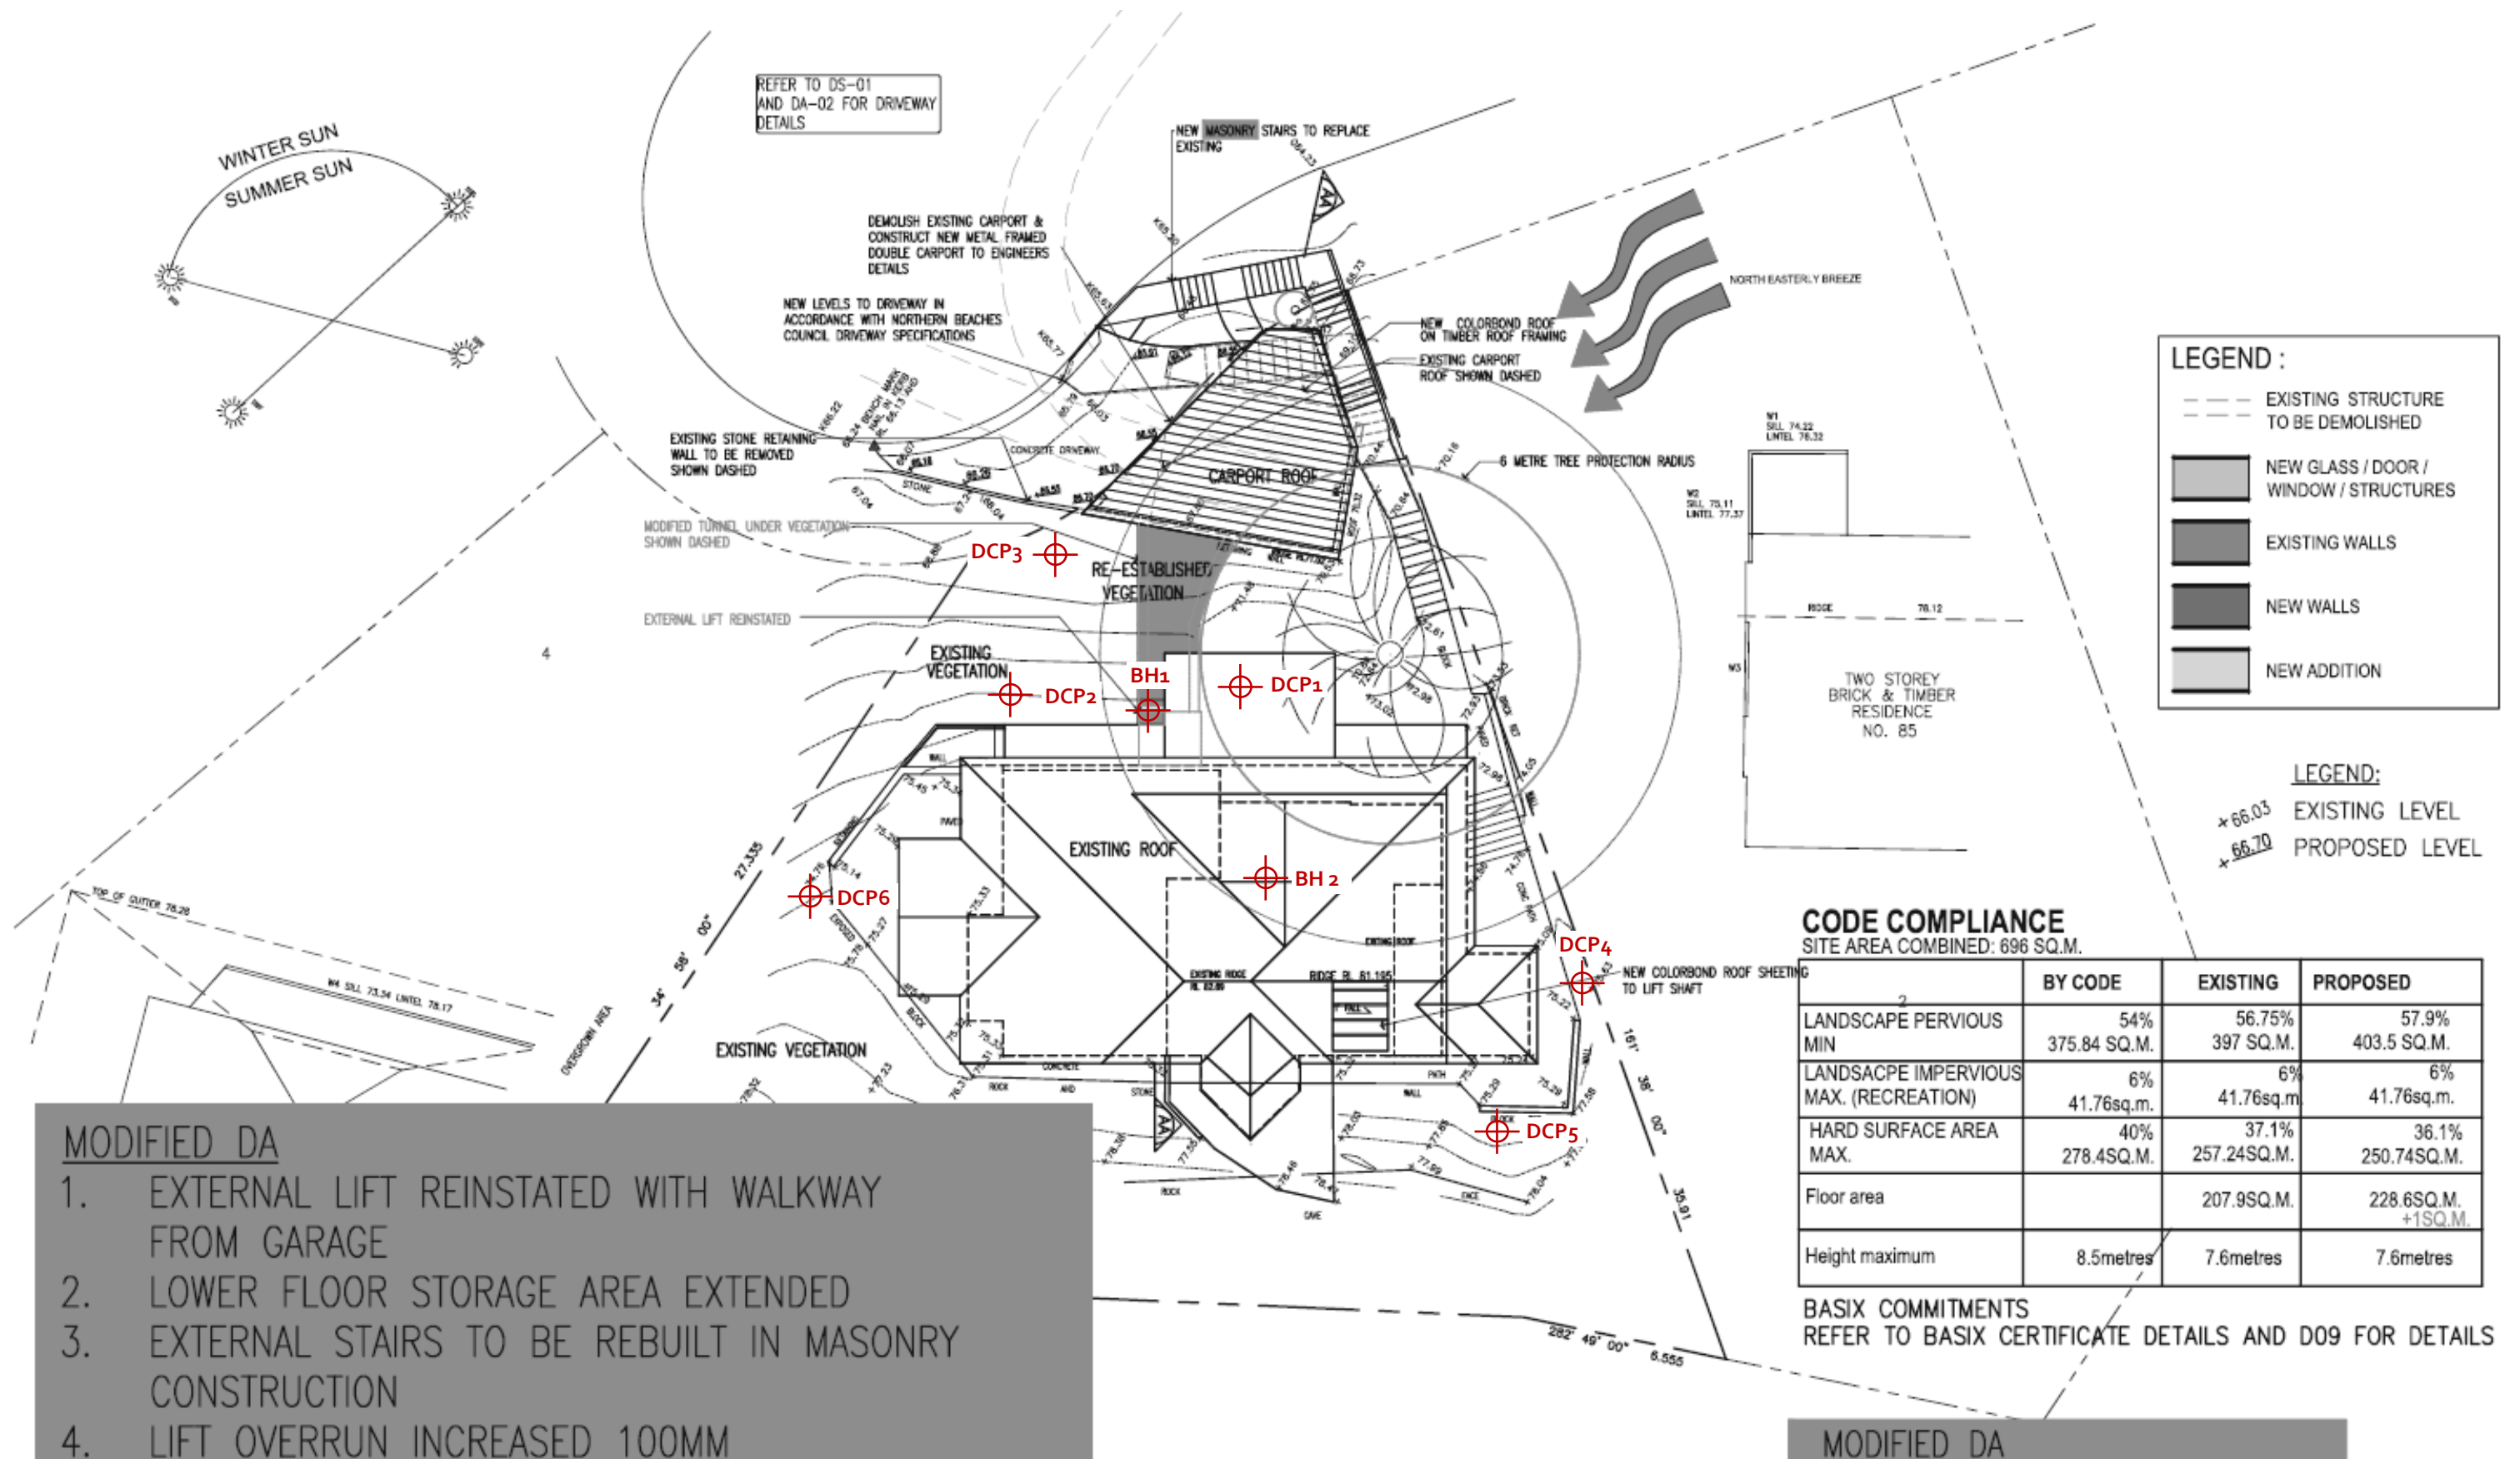
SITE PLAN – showing test locations

DCP2 – End of Test @ 2.4m, DCP still very slowly going down, dark brown rock fragments on moist tip.

DCP3 – End of Test @ 1.5m, DCP still very slowly going down, dark brown sandy soil on moist tip.

DCP5 – Refusal @ 1.0m, DCP bouncing, orange impact dust on moist tip.
