VT 25577A 16th July, 2008 Page 1

62 HERBERT AVENUE, NEWPORT Order No NOT0092/08 and FINALISATION OF APPROVAL P0523/97

RISK ANALYSIS & MANAGEMENT FOR BUILDING CERTIFICATE AT 62 HERBERT AVENUE, NEWPORT

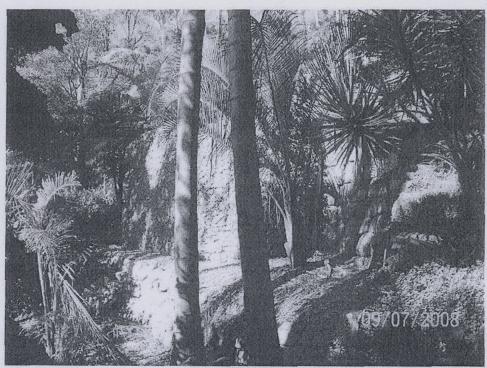
Photo 2

- 2 1 The site was inspected on the 9th July 2008
- The property is on the low side of the road and has a northerly aspect (Photo 1) The road is supported by a sandstone block retaining wall in good condition (Photo 2). A second block wall is located immediately down slope and the path to the house runs along the trop of this wall (Photo 3). The wall has had some remedial work carried out in the recent past and Gabion Baskets have been installed in front of the wall to support it (Photo 4). The boundary of the road reserve is just below the Gabion Baskets. From the toe of this wall the surface slopes down steeply to the house at angles of some 20 degrees where a low cut is supported by a stable stack rock wall (Photo 5). The grade reduces at the house footprint and the surface continues to slope down to the rear boundary at angle of some 10 degrees. Some landscaping has been carried out below the house (Photo 6) and a Gabion Basket supports a fill just above the lower boundary (Photo 7 & 8).
