## **GEOTECHNICAL INVESTIGATION:**

Subdivision and New Houses at **12-14 Gladys Avenue, Frenchs Forest**

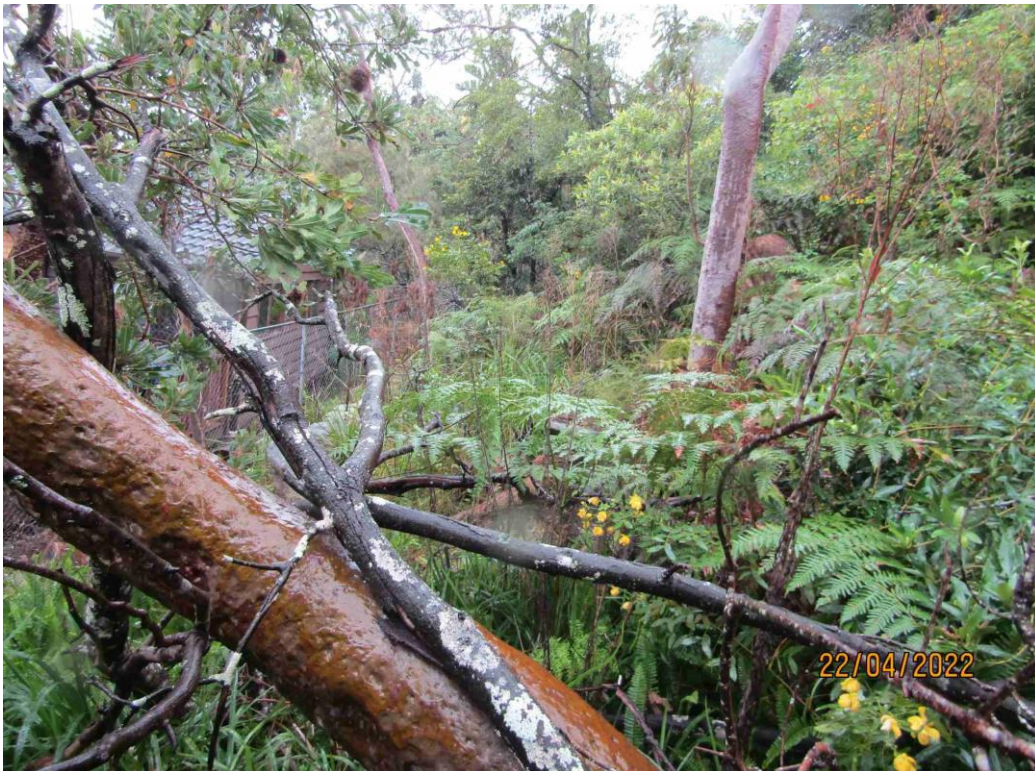
Photo 6

is estimated to be undercut by up to ~1.5m (Photo 5). The visible undercut has a relatively thick cantilever arm in relation to its overhang length and is currently considered to be stable. The slope below the rock face is densely vegetated (Photo 6). Sandstone bedrock outcrops in places on the slope. Sandstone joint blocks are embedded in stable positions in the slope.
