# **Arboricultural Impact Assessment Report**

Site Address: Lot 8, 18 Alexander Avenue, Collaroy NSW

**Phone:** 0426 836 701 **Date Prepared:** 9<sup>th</sup> March 2020

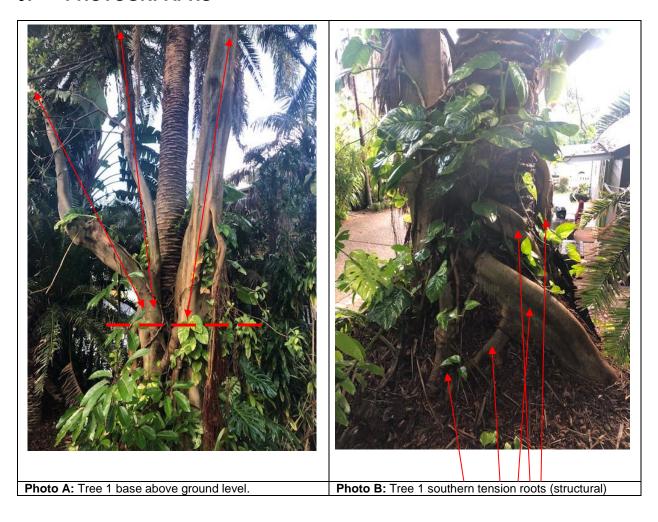
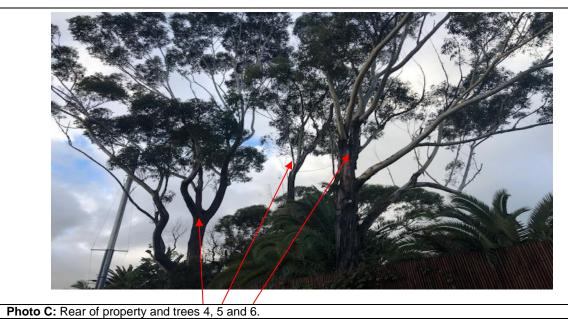
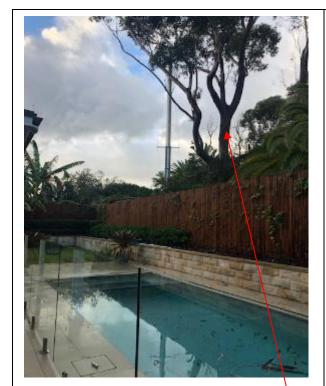
#### 9. **PHOTOGRPAPHS**

Tree ID	Species	Retention value	TPZ radius (m)	SRZ radius (m)	TPZ encroachment	Discussion/ Conclusion	Recommendation
1	Ficus rubiginosa (Port Jackson Fig) And Phoenix canariensis (Phoenix Palm)	A2	5	2	Major	Tree 1 has self-seeded onto the trunk of a Phoenix Palm ( <i>Phoenix canariensis</i> ) at approximately 1.5 meters from the ground. The Ficus has subsequently developed into a 'strangler Fig' form whereby it extends aerial roots down a structure, in this case the Palm tree, and into the soil to form structural woody prop roots above ground.  The base of the Ficus is situated 1.5 meters above the ground level and wraps around the trunk of the palm giving it a narrow and curved form. The typical measurements required to calculate TPZ areas taken at 1.4m on the trunk and above the root flare at base were not achievable due to the reasons noted above.  This provides a certain degree of ambiguity with calculations used to obtain the Tree Protection Zone and Structural Root Zone radius in accordance with AS4970 Protection of Trees on Development Sites (2009).  The TPZ and SRZ measurements stated for tree 1 used to discuss the potential development impacts have been based on the minimum TPZ area of the Palm tree (one meter outside of the crown radius) and an allowance of a 2 meter radius SRZ for the Ficus, noting the minimum SRZ in accordance with AS4970-2009 is 1.5 meters radius.  The proposed residences and walkway will be raised above grade on the first floor providing no encroachment into the TPZ area with the exception of a two meter section of wall, most of which is already occupied by the existing structure proposed for demolition. Canopy pruning will be required on the eastern side of the Ficus to allow for the suspended walkway clearance. One primary limb	Retain and protect

Tree ID	Species	Retention value	TPZ radius (m)	SRZ radius (m)	TPZ encroachment	Discussion/ Conclusion	Recommendation
						measuring approximately 300 millimeters in diameter will require removal. This is not considered to detract from the trees existing amenity value or adversely impact the trees health.  The proposed driveway and car parking space (7) will encroach into the TPZ area and the notional SRZ area by up to 37.3%. This is considered to be a major encroachment and the severance of structural roots may lead to the destabilization of the tree. The driveway has been designed to be constructed above the existing soil grade and involve minimal excavations for piers. It is possible to utilize permeable or semi permeable surfaces to allow the filtration of rain runoff to penetrate to the roots below. Given the ground floor parking area is open between the raised walkway and the tree it is anticipated this will be effective in providing some irrigation. In addition, downpipes from guttering can be redirected toward the base of the tree providing further irrigation.  The proposed small car space (7) will not increase the level of encroachment proposed by the driveway as it is included within the driveway slab. On the provision there is no piers located within the notional 2 meter SRZ of the Ficus the impact may be managed at a sustainable level.  The combined encroachment from Lot 8 and associated pruning works is likely to have a low to moderate combined impact on the health of the trees in the short term only. This may be mitigated by providing appropriate care during and post construction.

Tree ID	Species	Retention value	TPZ radius (m)	SRZ radius (m)	TPZ encroachment	Discussion/ Conclusion	Recommendation
						No structural roots to the south of the tree have been proposed to be disturbed, the Project Arborist is to assess any additional works proposed within 2 meters of the Ficus tree.  The development currently under assessment for lot 9 will also impact the subject trees. Lot 9 has been designed so no excavations will be carried out within the TPZ of retained trees and will also be of sustainable impact to the tree.	
2	Phoenix canariensis (Phoenix Palm)	Z3	4	-	Major	The proposed driveway will encroach into the TPZ area by up to 50%. As discussed with tree number 1 the surface is proposed to be raised above the existing grade and require minimal excavations. Tree 2 is an early mature Palm tree that is considered to be capable of acclimatizing to development impacts as it reaches maturity, providing the development is constructed using tree sensitive methods. The recommendations to mitigate development impact for tree 1 will also mitigate the impacts proposed on tree 2. Unlike tree 1, the trunk of tree 2 is closer to the proposed slab. It will be recommended that a 300mm grate is incorporated into the slab to allow a greater setback to be provided for the trunk as the tree matures.	Retain and Protect

- 10.4 The proposed driveway is recommended to be constructed above the existing grade on piers. No piers are to be situated within two metres radius of the centre of the tree (T1) to avoid the disturbance of structural roots.

- 10.5 The driveway is recommended to be of a porus or semi porous nature to allow for the filtration of water to roots below. Downpipes are recommended to be aligned to deliver water to the base of the tree.

- 10.10 Soil conditioner and Fertiliser is to be applied to all trees and Palms, particularly trees 1 and 2 one month prior to any works carried out on site. They are to be provided the same management throughout construction by the Project Arborist. Upon completion of the development, the Project Arborist is to prepare a 12 month management plan to continue managing trees 1 and 2 to assist with their recovery.
