**Proposed Mixed-use Development
4 Delmar Parade & 812 Pittwater Road, Dee Why
NSW**

Geotechnical Investigation

Our ref: 6561-G1
25 November 2021

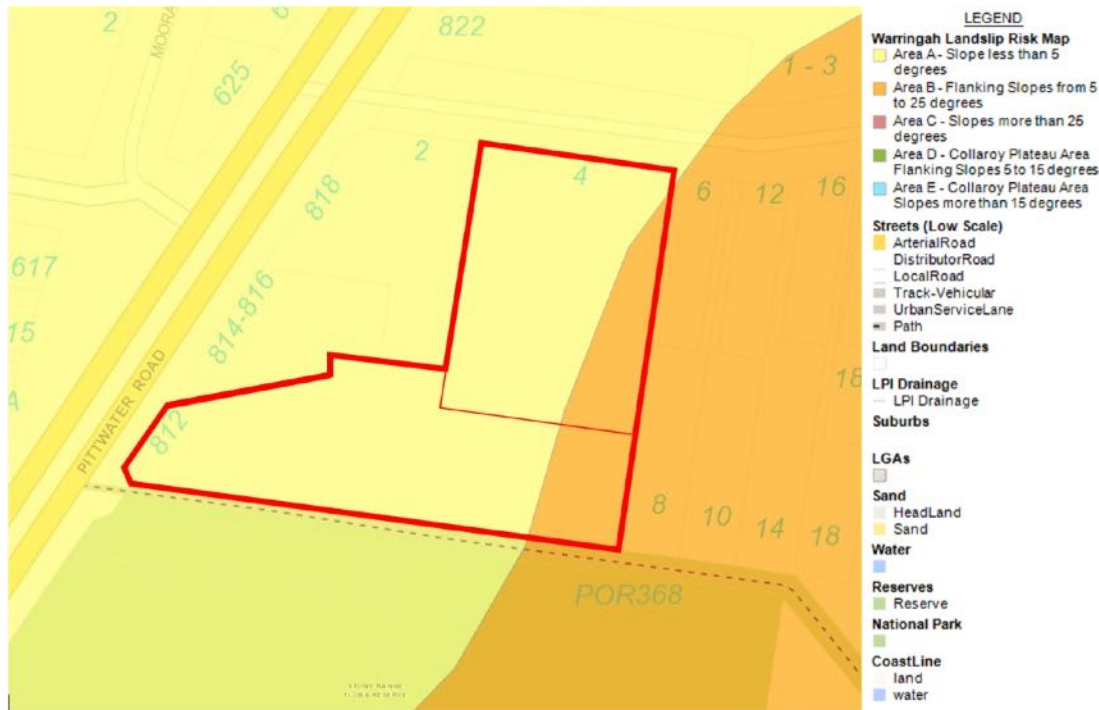
Plate 1 – Land Instability Risk Mapping (Source: Warringah Landslip Risk Map)

The site is located partially within “Area A” – Slope less than 5 degrees and partially within “Area B” – Flanking Slopes from 5 to 25 degrees on the Warringah DCP Landslip Risk Map, as shown in **Plate 1**.
