1 Tabalum Road, Balgowlah Heights

Geotechnical Comments for New DA.

GEOTECHNICAL INVESTIGATION:

New House and Pool at 1 Tabalum Road, Balgowlah Heights

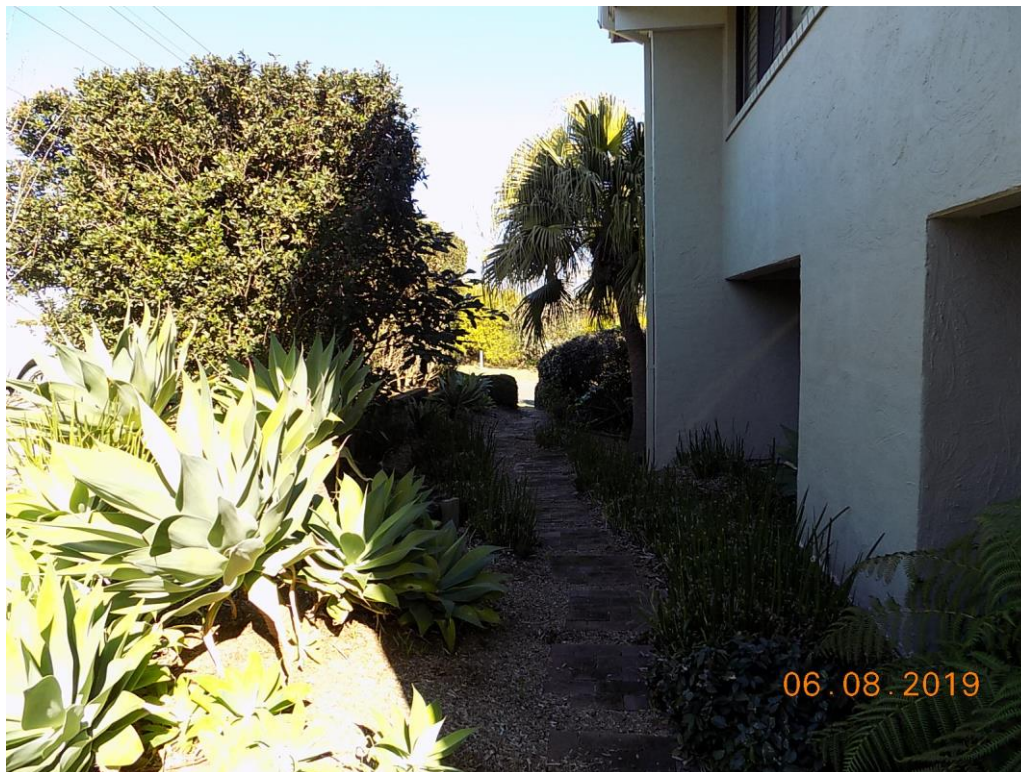
Photo 2

- 2.3** At the road frontage to Tabalum Road, a concrete driveway runs to a carport attached to the uphill side of the house (Photo 1). Competent Medium Strength Sandstone bedrock was observed to be outcropping on both sides of this driveway (Photo 2). Between the road frontage and the house is a gently sloping garden area (Photo 3). At the road frontage to Cutler Road, a concrete driveway runs to a garage on the lower ground floor of the house (Photo 4). The cut for the driveway has been partially taken through outcropping sandstone (Photo 5). The remainder of the cut is supported by a timber retaining wall. The part three-storey rendered brick house was
