Report Title: Geotechnical Report 187 Riverview Road, Avalon Beach

Report Date: 7/9/23

## **GEOTECHNICAL INVESTIGATION:**

New House and Pool at **187 Riverview Road, Avalon**

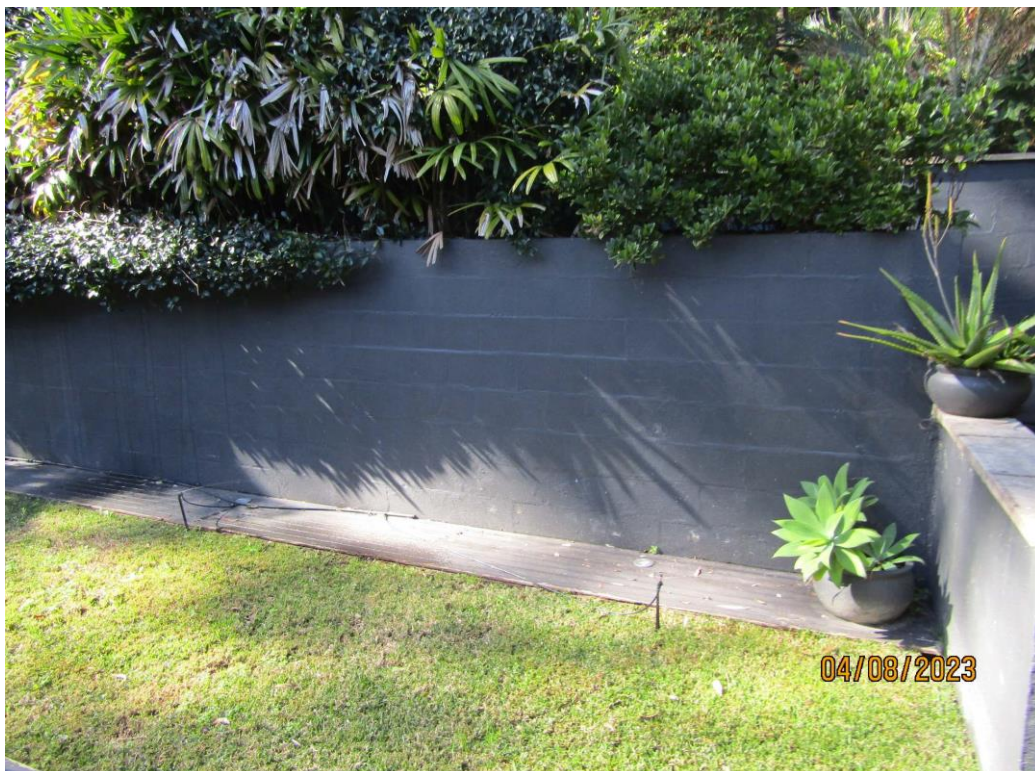
Photo 1

**2.3** At the road frontage, a concrete driveway runs down the slope to a rendered masonry garage that shows no significant signs of movement (Photo 1). Rendered masonry and concrete block retaining walls up to  $\sim 1.8\text{m}$  high beside and below the driveway support cuts and fills for lawn and garden areas (Photos 1 & 2). The upper retaining wall displays a vertical crack, but will be demolished as part of the proposed works. The two storey rendered brick house is supported on brick walls (Photos 3 & 4). The external supporting walls show no significant signs of movement.

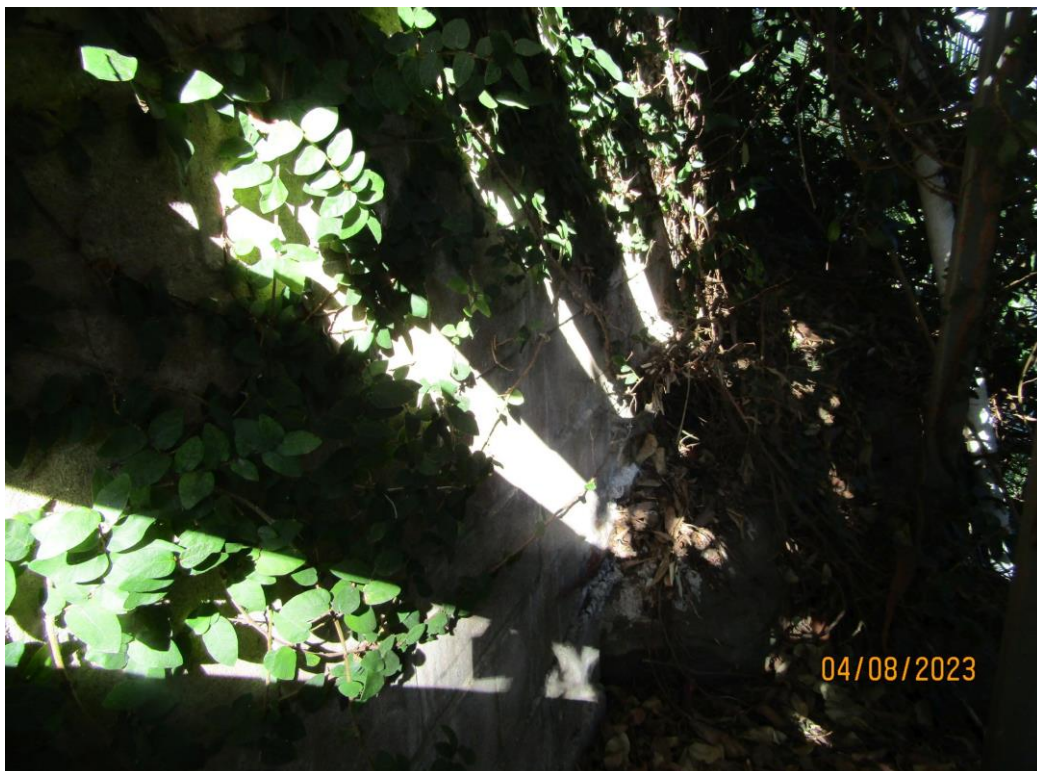
Photo 5

A timber deck and balcony extend off the downhill side of the house. An inclined lift runs from the upper floor of the house to the waterfront. Masonry retaining walls up to  $\sim 2.0\text{m}$  high support filled garden areas on the downhill side of the house (Photos 5 & 6). The retaining walls were partially obscured by vegetation, but from what could be seen of the walls they appear to be stable. The lower wall is supported directly on a Medium Strength Sandstone rock face that is estimated to be up to  $\sim 6.0\text{m}$  high (Photo 7). The rock face displays some jointing (Photo 8), but appears to be currently stable. Another sandstone rock face that is estimated to be up to  $\sim 4.5\text{m}$  high is located downhill of the upper rock face (Photo 9). The rock is undercut slightly at the base (Photo 10), but given the relatively thick cantilever arm in relation to its overhang length the rock is considered to be stable. Large detached sandstone joint blocks are located in stable positions on the slope below the rock faces near the waterfront (Photo 11). Construction works are ongoing at the waterfront. The works have slightly undercut a brick and mortared stone retaining wall  $\sim 2.0\text{m}$  high (Photo 12). The owner of the property has informed us that this wall will be remediated as part of the ongoing boatshed construction works.

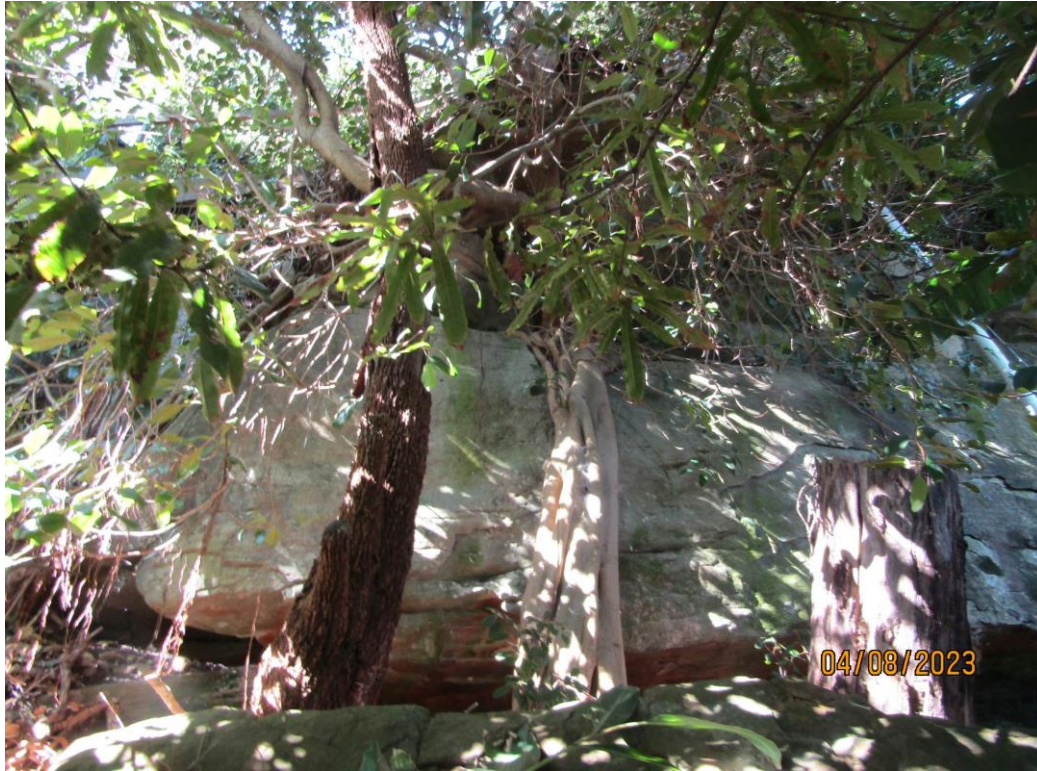
Photo 8

Excavations through Medium Strength Rock or better should be carried out to minimise the potential to cause vibration damage to the S and N neighbouring properties and jointed sandstone rock face (Photos 7 & 8). Allowing for backwall drainage, the excavation is set back ~3.0m from the S neighbouring house, ~1.0m from the S neighbouring garage, ~1.7m from the N neighbouring house (currently under construction), ~1.2m from the N neighbouring garage (currently under construction) and is estimated to be set back ~3.0m from a joint in the sandstone rock face (Photo 8).
