67 Marine Parade, Avalon

Comments on Updates to Plans

GEOTECHNICAL INVESTIGATION:

Alterations and Additions at 67 Marine Parade, Avalon

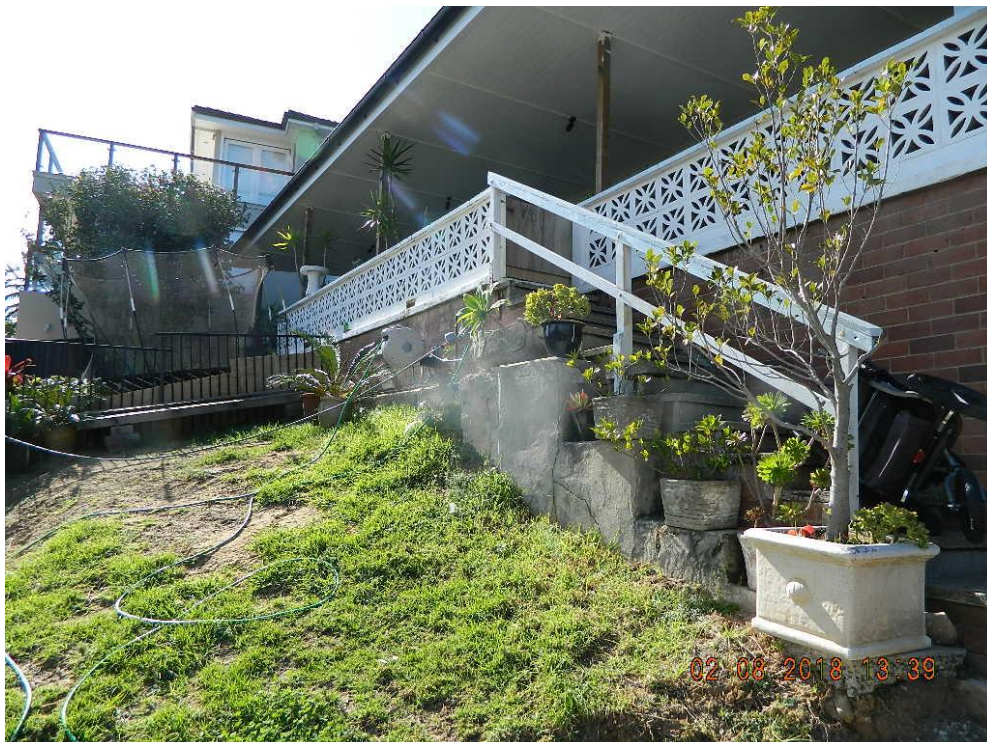
Photo 7

Sandstone bedrock outcrops at the sea cliff face to the E of the property and is visible outcropping down the slope to the house (Photo 7). This is an unusually thick sandstone bed
