## **20 Sunrise Road, Palm Beach**

### Comments on Updates to Plans

## **GEOTECHNICAL INVESTIGATION:**

New Secondary Dwelling and Inclined Lift at **20 Sunrise Road, Palm Beach**

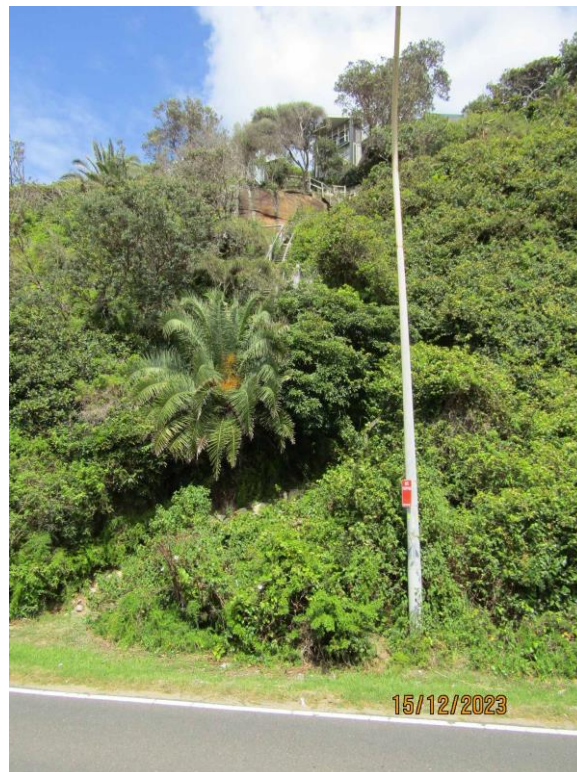
Photo 6

stand vertical. Some of the supporting walls were observed to be supported directly off competent Medium Strength Sandstone bedrock (Photo 3). A mostly suspended pool has been constructed off the downhill side of the house (Photo 4). The concrete shell of the pool displays no signs of movement related to slope instability and is considered stable. A steep slope falls from the base of the pool to the top of a ~6.0m high sandstone cliff (Photo 5). The cliff consists of massive Medium Strength Sandstone and displays no significant geological defects. Thus, it is considered stable. A very steep and very densely-vegetated slope falls from the base of the cliff to the road frontage with Ocean Road (Photo 6). Some stable bands of sandstone were observed to be outcropping through this slope (Photo 7).
