Report Title: Geotechnical Report 114 Whale Beach Road, Whale Beach
Report Date: 14/9/20

GEOTECHNICAL INVESTIGATION:

Alterations and Additions at 114 Whale Beach Road, Whale Beach

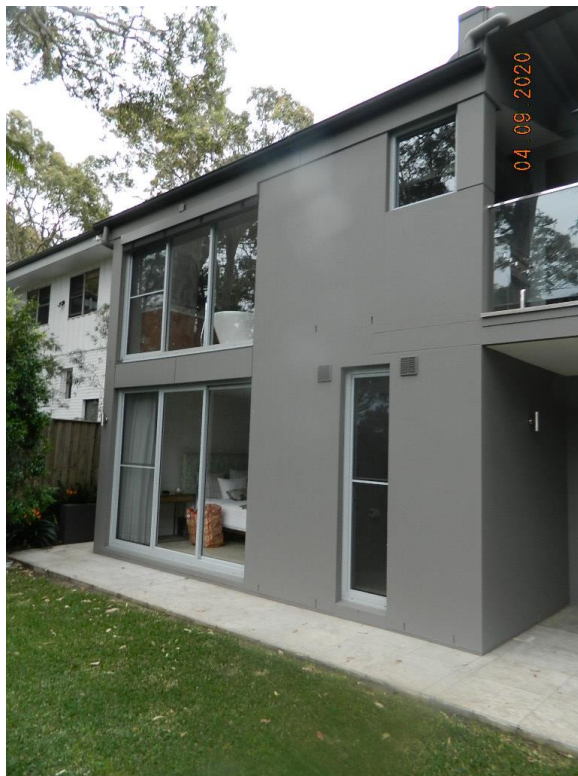
Photo 6

The driveway runs to a paved parking area and garage (Photo 4). The cut for the parking area is supported by a rendered retaining wall up to ~3m high in good condition (Photo 5). Next to the parking area is an above ground pool and terrace/lawn area in good condition (Photo 6). The garage is located below the terrace. The part three storey house is supported by rendered walls and stone dressed concrete walls (Photos 4 & 7). The external supporting walls show no significant signs of movement. Fill provides level lawn and garden areas on the SW side of the property (Photos 8 to 10). The fill is supported by low timber retaining walls and a stable ~1.6m high concrete block retaining wall. Overall the slope across the property is considered stable. The adjoining neighbouring properties pose no risk of instability to the subject property as seen from the street and subject property.
