Report Title: Geotechnical Report 87 Alexandra Crescent, Bayview

Report Date: 15/12/22

## **GEOTECHNICAL INVESTIGATION:**

Alterations and Additions at **87 Alexandra Crescent, Bayview.**

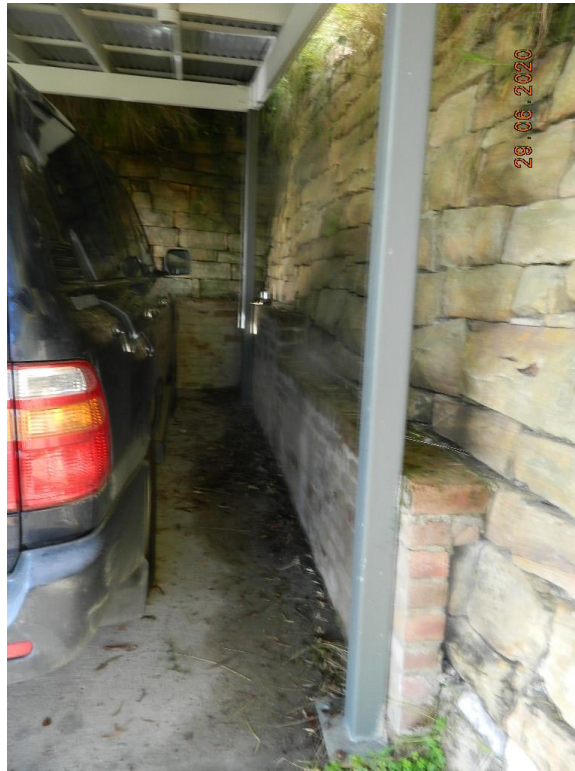
Photo 2

**2.3** At the road frontage a concrete driveway runs to a carport cut into the slope (Photo 1). The cut is supported by sandstone block, brick and concrete block retaining walls up to ~3.4m high (Photos 1 to 3). The highest portion of the sandstone block wall is supported by a brick wall in front of the base of the retaining wall (Photo 2). The retaining walls are considered to be stable. Between the carport and the house is a steep and thickly vegetated slope (Photo 1). The part three storey rendered brick and weatherboard clad house is supported by brick walls and brick piers Photos (1 & 4). The supporting walls and piers stand vertical and show no significant signs of movement (Photo 5). Uphill of the house a cut in the slope provides a level platform for the house. The cut is supported by concrete block and sandstone flagging retaining walls up to ~2.7m high. (Photos 6 & 7). The W portion of the concrete block retaining wall is tilting at up to ~4° from vertical. See 'Section 16 Ongoing Maintenance'. A Medium Strength Sandstone bedrock cliff face up to ~7m outcrops above the cut for the house (Photo 8). A portion of the cliff face is undercut by up to ~4.4m (Photo 9). The undercut is considered stable. No geotechnical hazards were observed on the neighbouring properties that could impact on the subject property as seen from the street and subject property.
