REPORT ON GEOTECHNICAL SITE INVESTIGATION

PROPOSED ALTERATIONS AND ADDITIONS

2 DIXON AVENUE, FRENCHS FOREST

Project No.: 2021-002

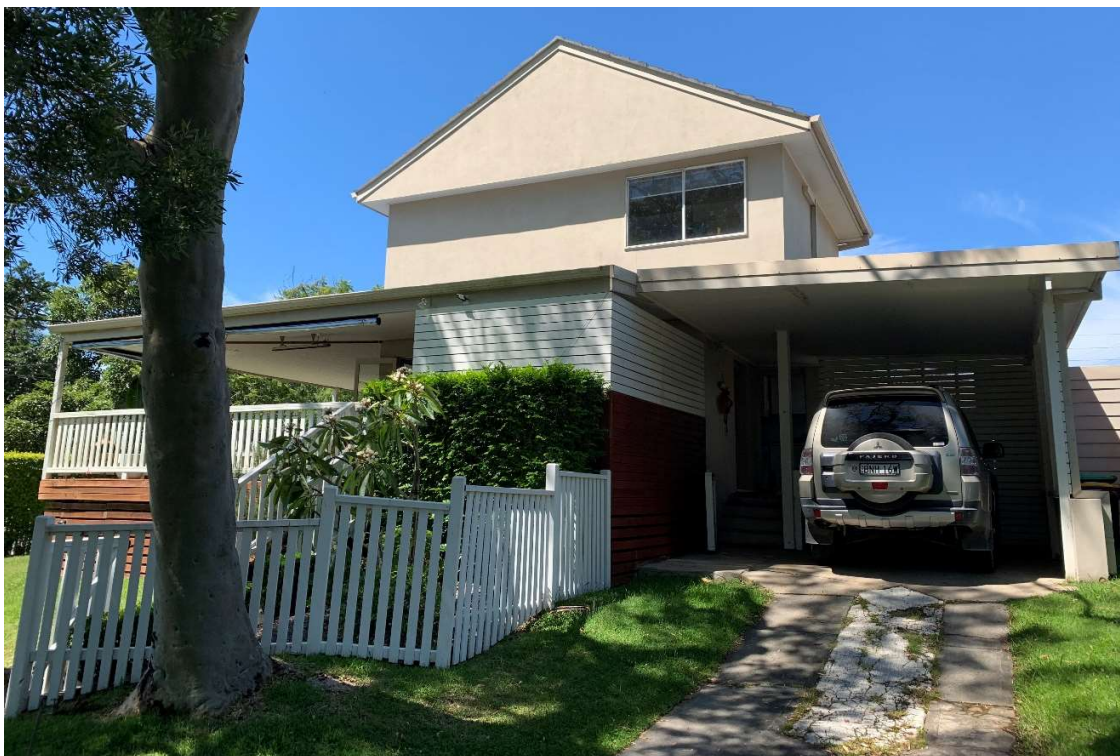
Photograph 2. View of the front of the house, facing south

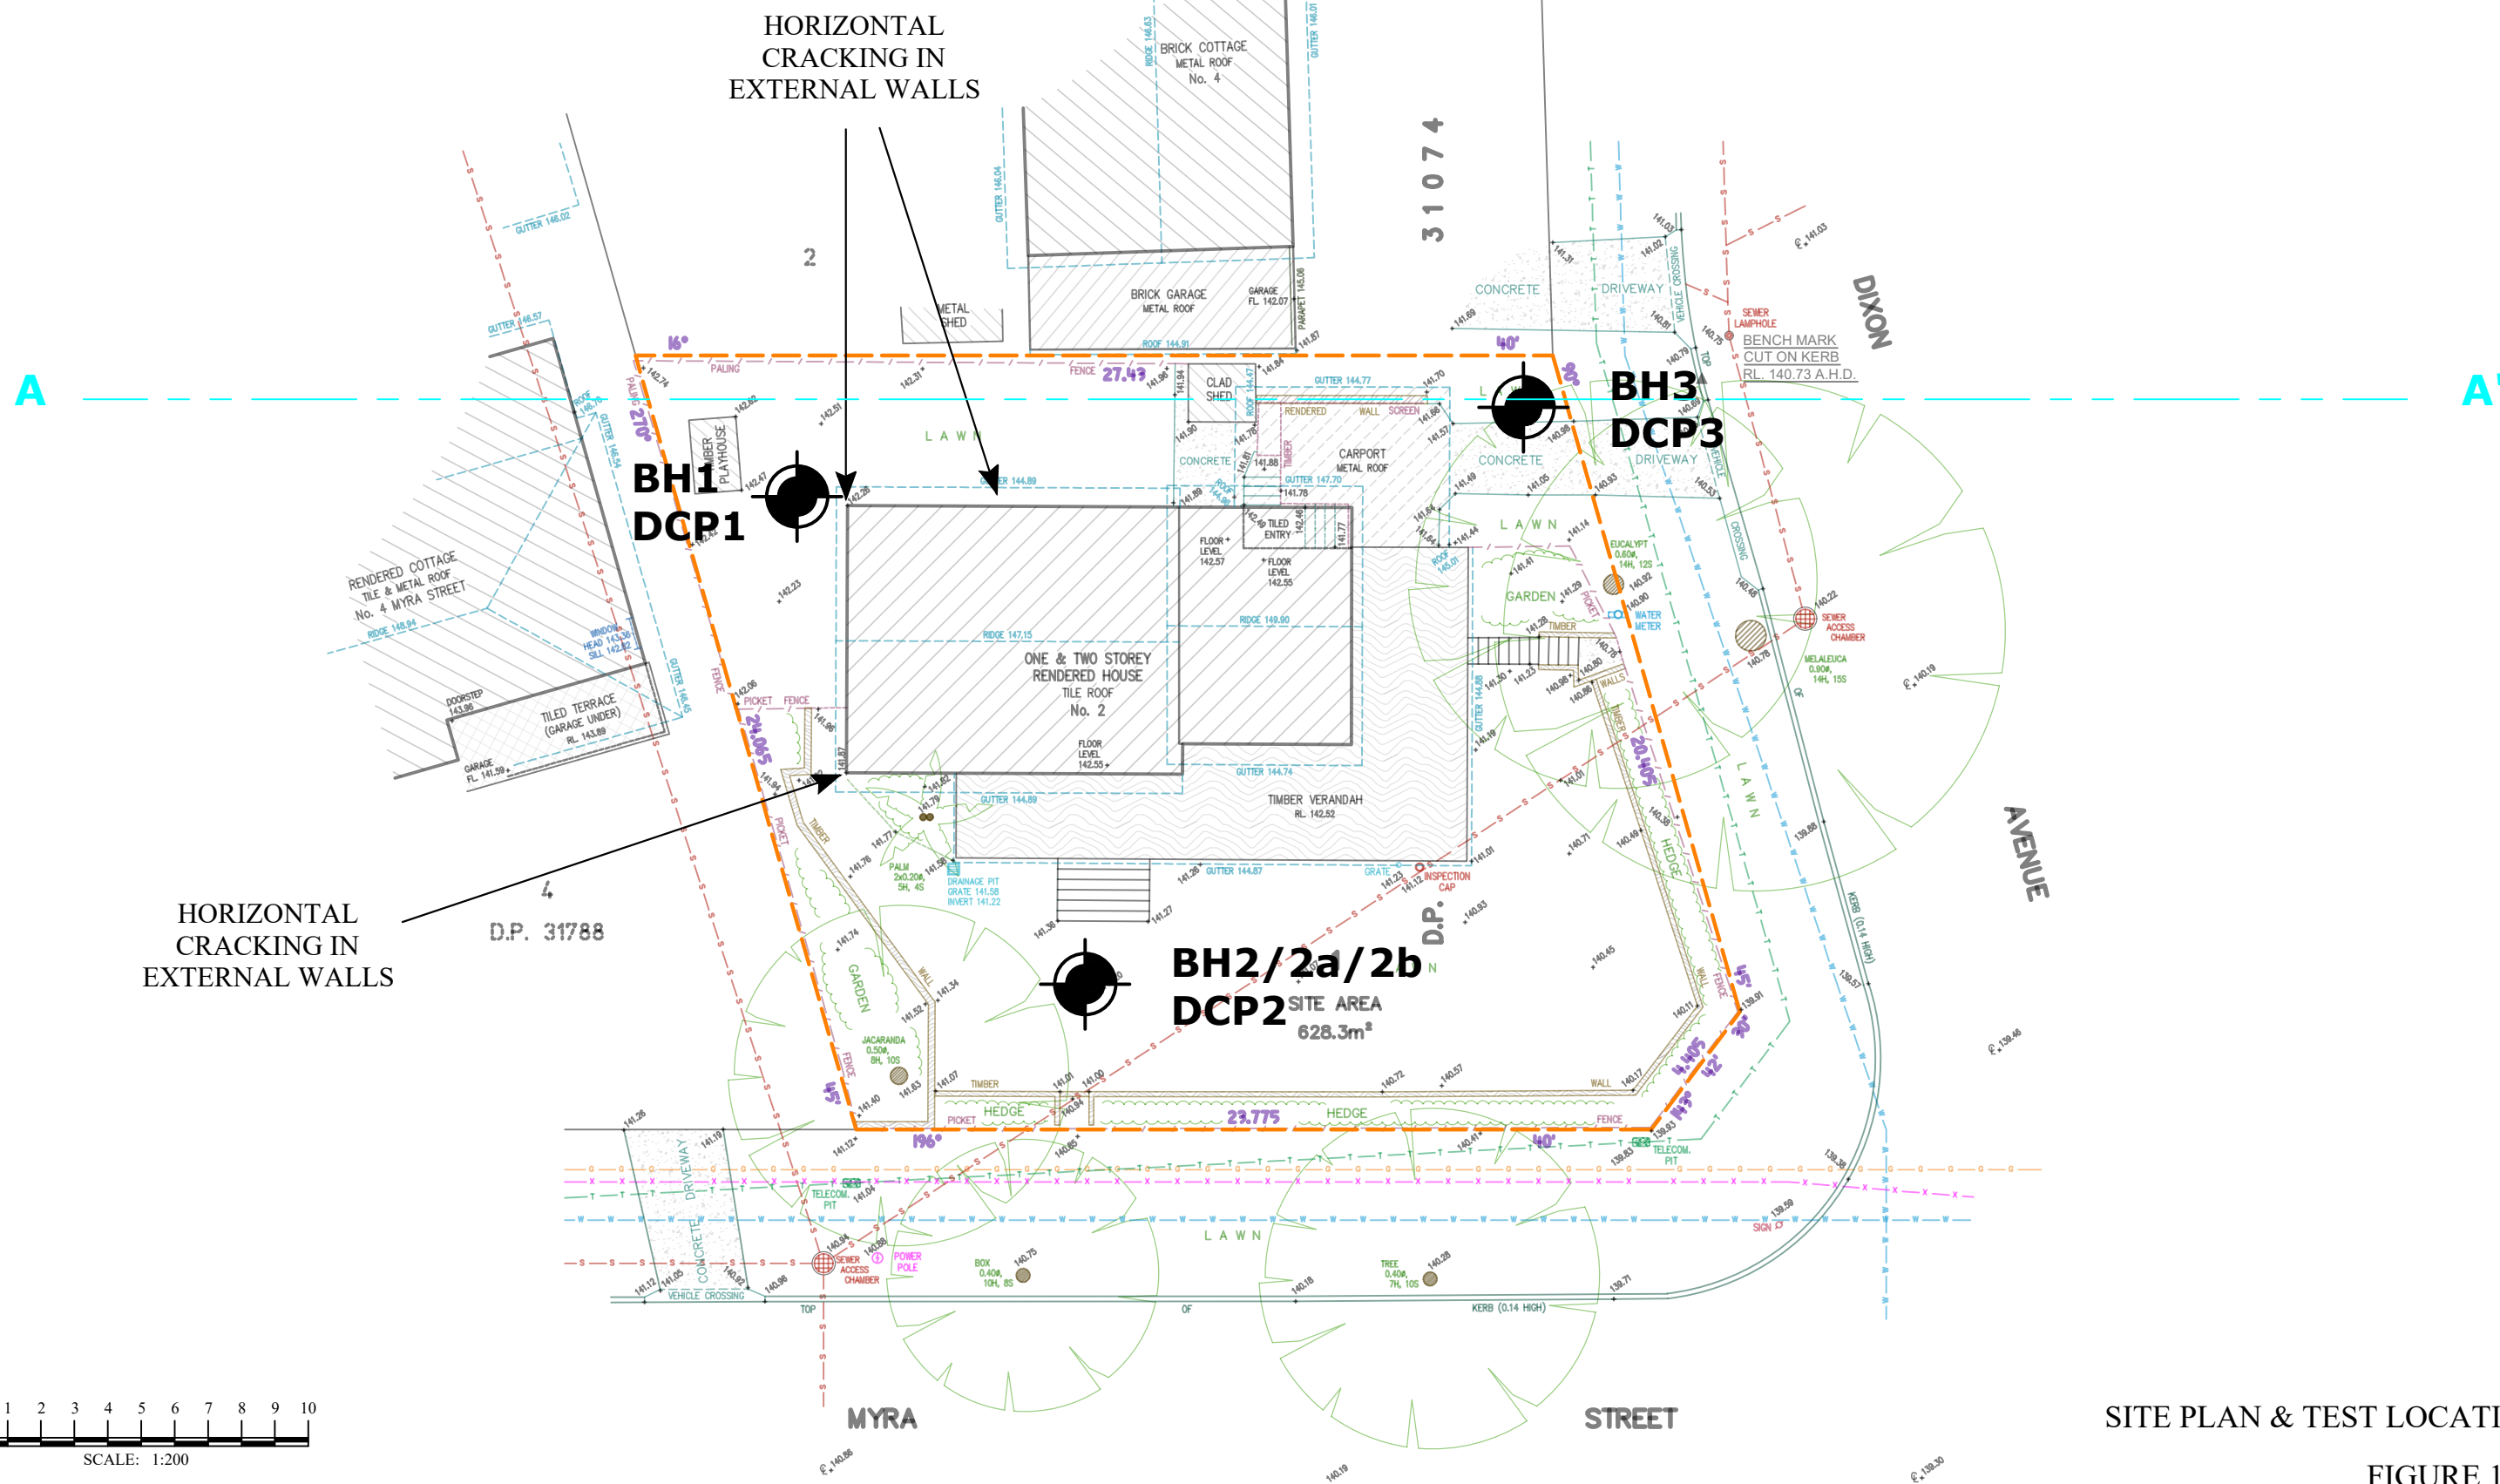
SITE PLAN & TEST LOCATIONS
FIGURE 1.

Explanatory notes are included in Appendix: 1. Mapping information and test locations are shown on Figure: 1, along with detailed borehole log and DCP sheets in Appendix: 2, a geological models/section is provided as Figure: 2, Appendix: 2.
