Mr Christian Stevens (c/o A Grade Pools),
19A Philip Road,
Mona Vale
NSW 2103

Preliminary Geotechnical Assessment – Swimming Pool 19A Philip Road, Mona Vale, NSW 2103

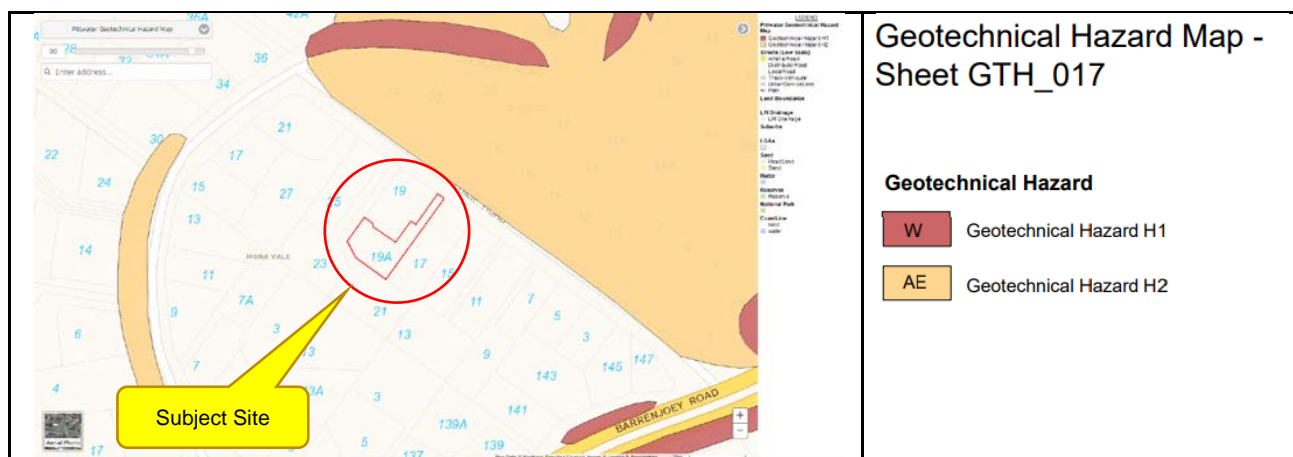
Figure 1 –Geotechnical Hazard Classification
(Source: Northern Beaches Council / GeoReports)

GRMP Criteria (Not Requiring Detailed Report)	Applicability / Comment
The proposed works involve a minor development, minor alterations and/or development separate from a Geotechnical Hazard*	✓ Minor works; See below for geotechnical hazard assessment
The proposed works are separate from the primary development*	✓ Swimming pool is separate from the primary development
The property is located in Geotechnical Hazard Zone 3	✓ The Site is H3 (outside H1 and H2) - See Figure 1

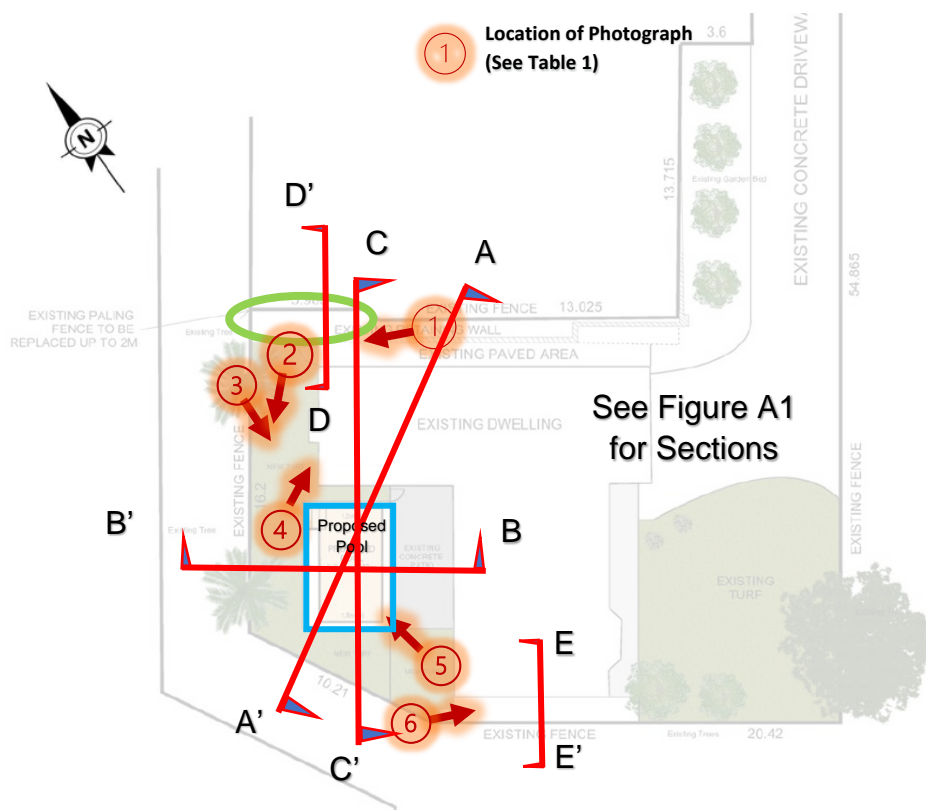
Figure 5: Key plan showing numbered photographs (Table 1) and Sections (Figure A1, attached)

- A plan showing the site topography is presented in Figure 4, below and indicates that the elevation falls about RL 40m to RL 38m AHD across the central portion of the block (approximately 10% or 6° average slope angle).
- A marked-up plan showing key features is presented as Figure 5, below, and includes locations of numbered photographs which are shown in Table 1. Sections through the site showing excavation extents in relation to site features are shown in Figure 6 (plan) and Figure A1 (attached, sections).

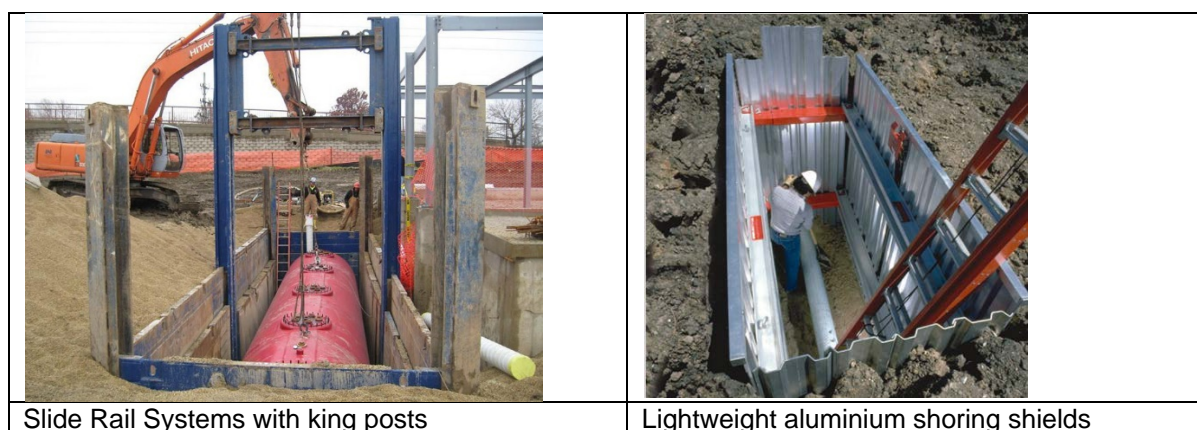
Figure 6: Shoring Systems

Due to the presence of adjacent slab, and nearby house and pergola footings, pro-active and pre-emptive excavation support measures must be implemented during excavation to provide relatively stiff excavation support to limit movements at adjacent structures. Examples of suitable shoring systems are shown below in Figure 6 (Refer <https://www.coates.com.au/> for further information).

Ground movements surrounding excavations are likely, and unless adequately controlled may adversely impact nearby slabs and structures which rely on ground for support. For excavations within a 1H:1V envelope extending below the underside of slabs and footings, we recommend use of pre-support systems installed ahead of excavations which provide continuous face support and can provide positive strutting pressure (such as hydraulic bracing).
