## **Geotechnical Assessment**

**Project:** Alterations & Additions  
72 Herbert Avenue, Newport NSW

**REF: AG 21129**  
17 May 2021

For **Alterations & Additions** at  
**72 Herbert Avenue, Newport NSW**

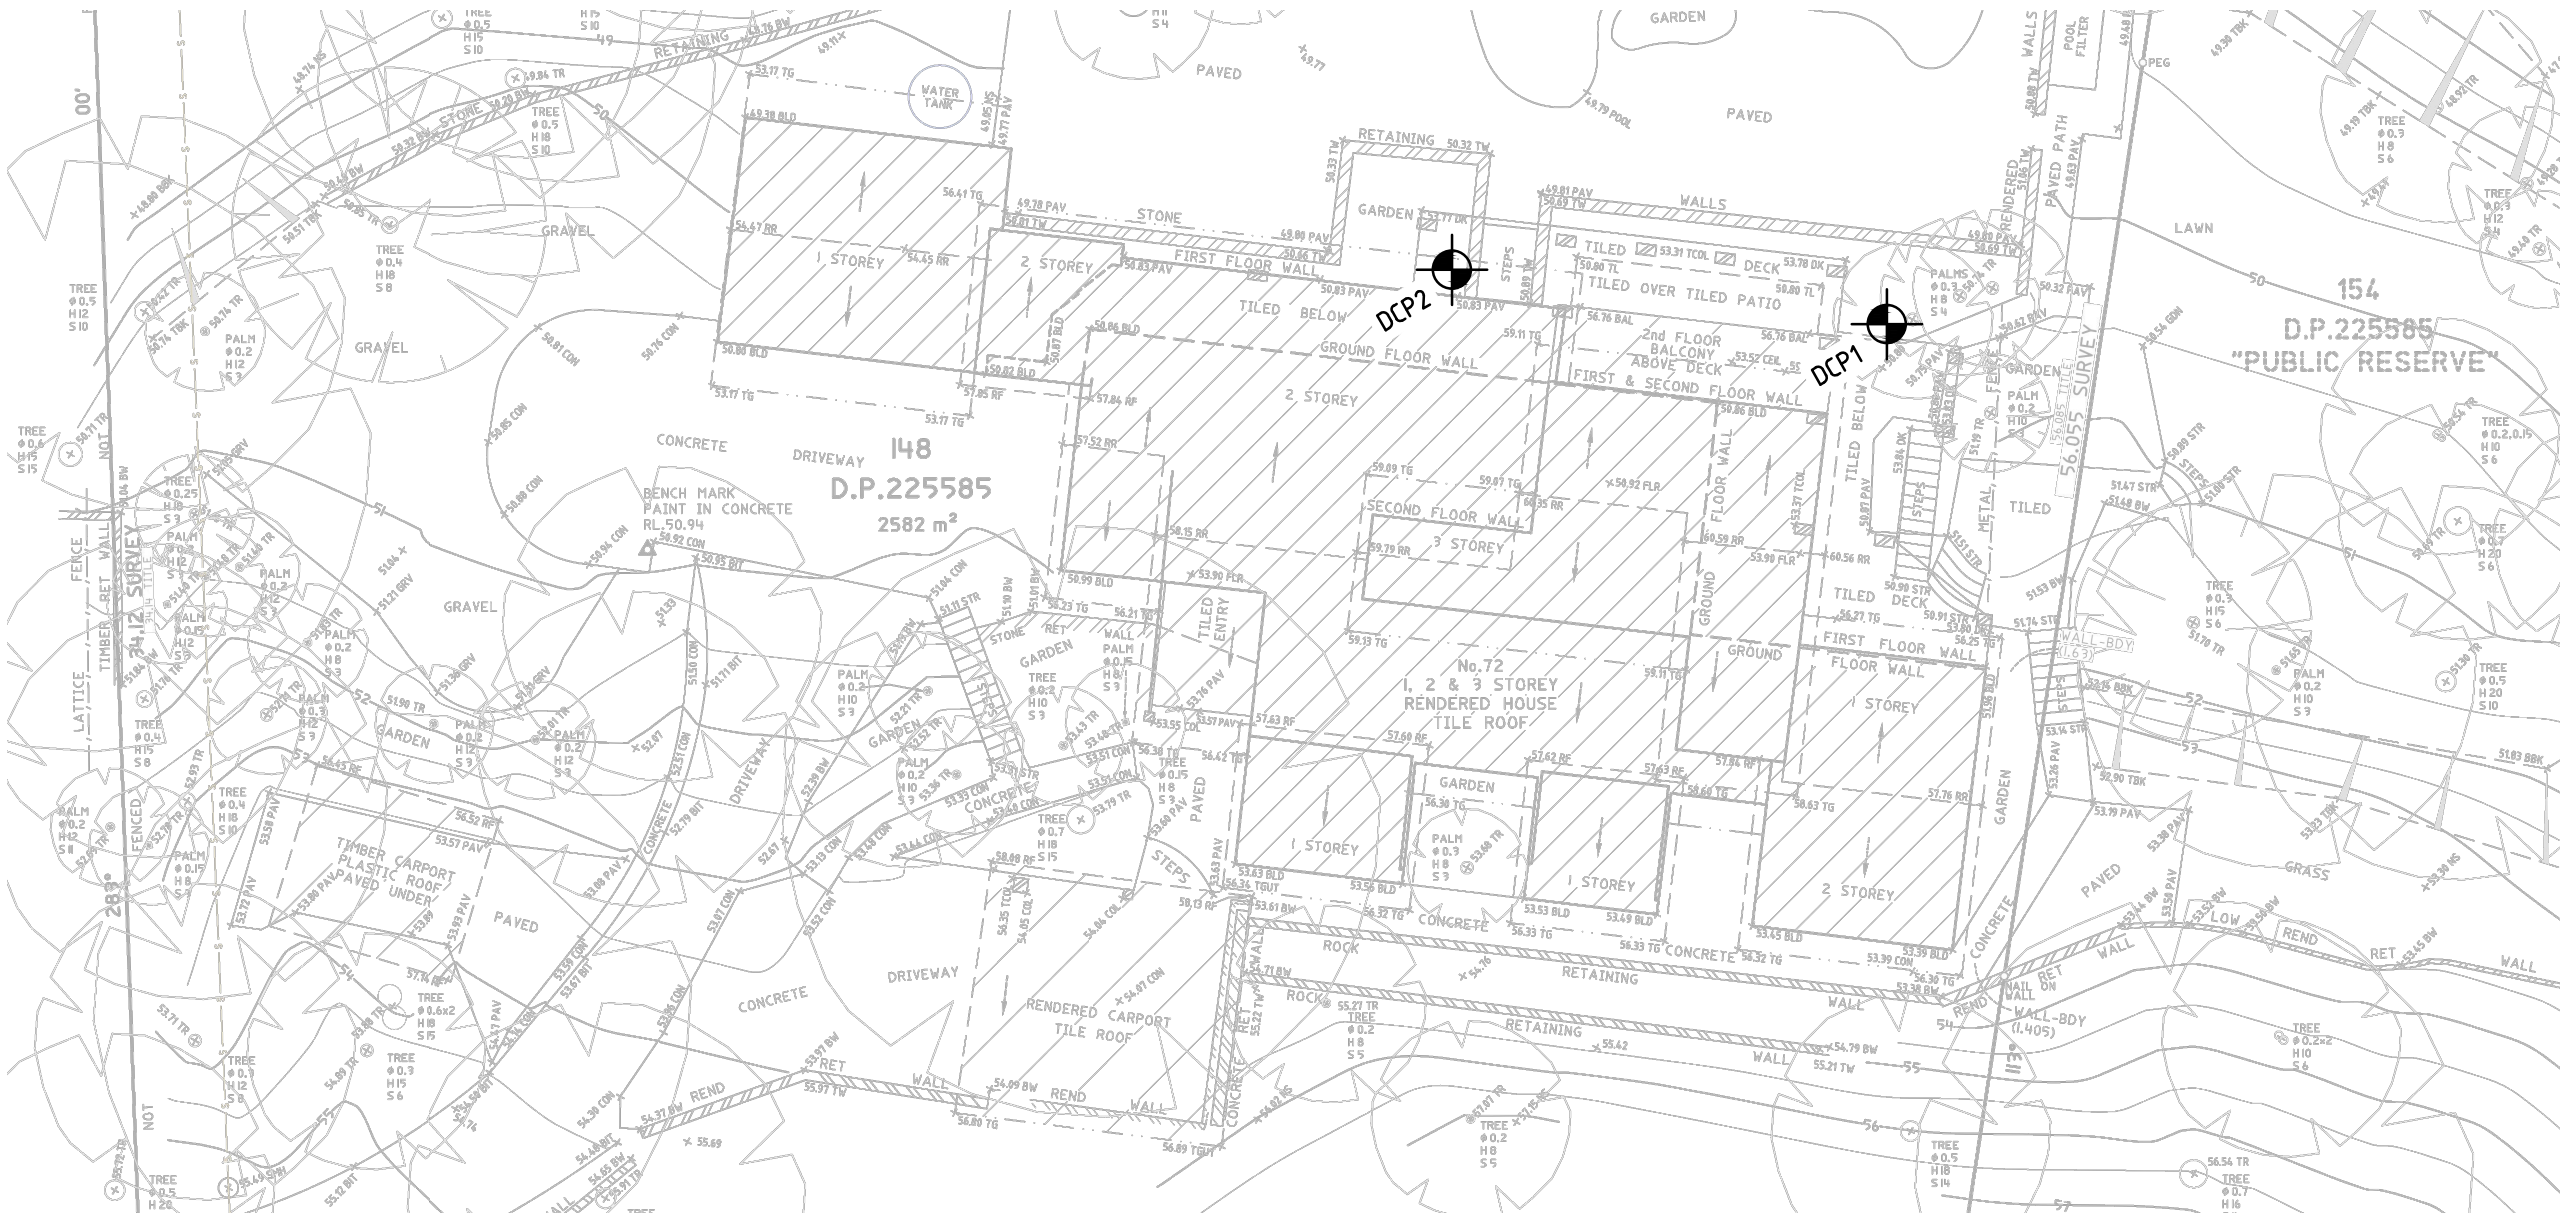
DATE:	16/05/2021
SCALE:	AS SHOWN @ A3
DRAWING TITLE:	<b>SITE PLAN</b>
DRAWING NO:	<b>AG21129- S1</b>

**SITE PLAN/GROUND TEST LOCATIONS**  
SCALE NTS
