J2644. 7<sup>th</sup> April, 2020. Page 1.

## **GEOTECHNICAL INVESTIGATION:**

New Garage and Pool at 11 Bungaloe Avenue, Balgowlah Heights

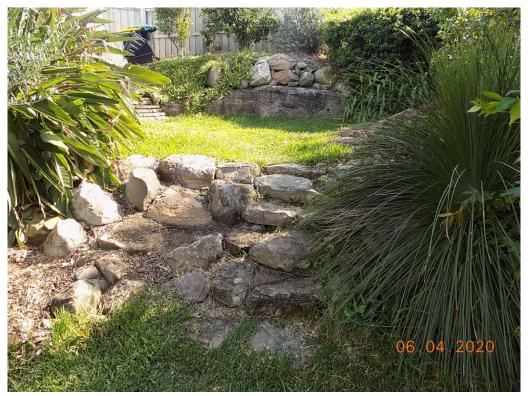
Photo 7

retaining walls (Photo 3). Some of these walls were observed to be supported directly onto outcropping competent Medium Strength Sandstone. The part three-storey rendered masonry house is supported on masonry walls (Photo 4). No significant signs of movement were observed in the supporting walls. An excavation has been made in the slope to create a level platform for the ground floor of the house. The cut is supported by a stable stack rock retaining wall and battered slope that will be removed as part of the proposed works (Photo 5). The slope between the uphill side of the house and the road frontage to Woodland Street is also terraced with a series of low stable stack rock retaining walls that will be removed as part of the proposed works (Photos 6 & 7). Medium Strength Sandstone outcrops through the uphill side of this slope. At the road frontage to Woodland Street, a concrete driveway runs to a brick garage in the SW corner of the property that will be demolished as part of the proposed works (Photo 8).
