GEOTECHNICAL INVESTIGATION:

New Pool and Cabana at **99 Riverview Road, Avalon Beach**

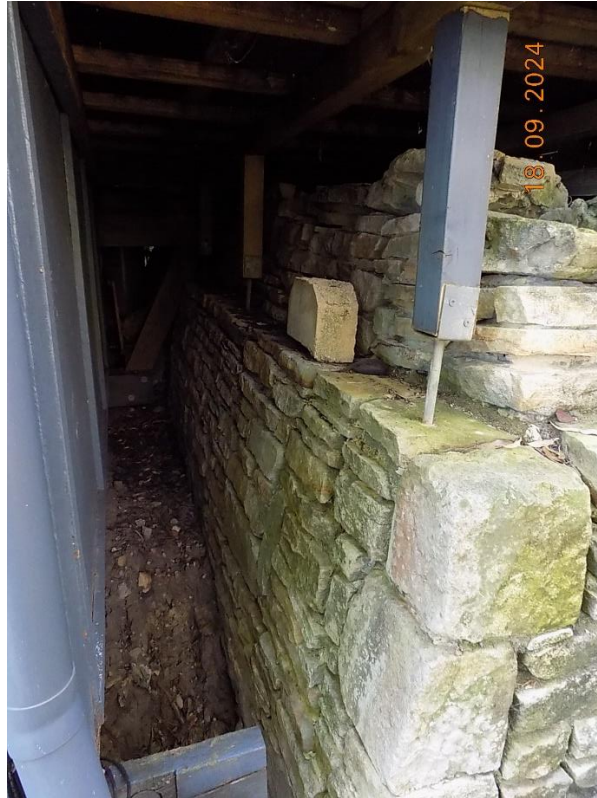
Photo 4

Strength Sandstone outcrops immediately above the subject house (Photo 3). The observable portions of the rock face were seen to be free from significant geological defects that could affect its stability. Fill for landscaping in this location is supported by a stable low mortared sandstone retaining wall which is partially supported on the outcropping rock (Photo 3). The part three-story fibre board and timber clad house is supported on concrete piers and timber posts. One of the concrete piers exhibits slight tilting. This appears to have been how it was initially constructed. As such, all foundations are considered stable. A cut for the lower ground floor of the house is supported by a stable mortared sandstone retaining wall reaching up to ~1.1m high (Photo 4). An inclined lift extends from the N of the house to the road frontage. Where the lift has been excavated into the slope, the cut is supported by a stable dry stack retaining wall (Photo 5) which is partially supported on outcropping sandstone. Stable low timber retaining walls support fill for landscaping between the downhill side of the house and the lower common boundary (Photo 6).
