Preliminary Geotechnical Assessment

Project: Alterations & Additions
22 Tobruk Avenue, Allambie Heights NSW

Ref: AG 24559
12 December 2024

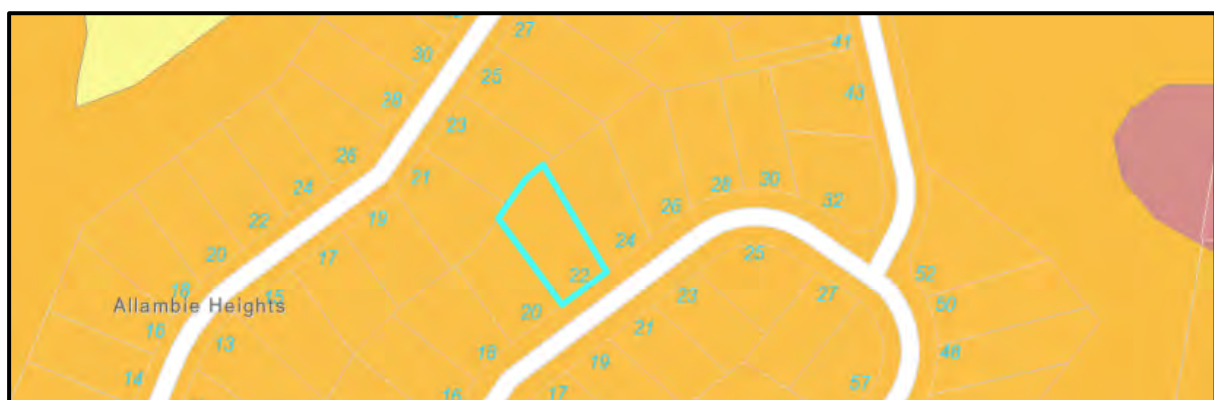
The site is mapped as **Area B** subject to specific landslip risk/geotechnical hazard mapping with reference to the Warringah (WLEP) Landslip Risk Map, Northern Beaches Council (**Image 1**).

Figure 1. Warringah Landslip Risk Map:
22 Tobruk Avenue, Allambie Heights NSW (© NBC Maps)
