# Geotechnical Site Investigation

Lot. 40 / DP15762

136 Narrabeen Park Parade

Mona Vale NSW 2103

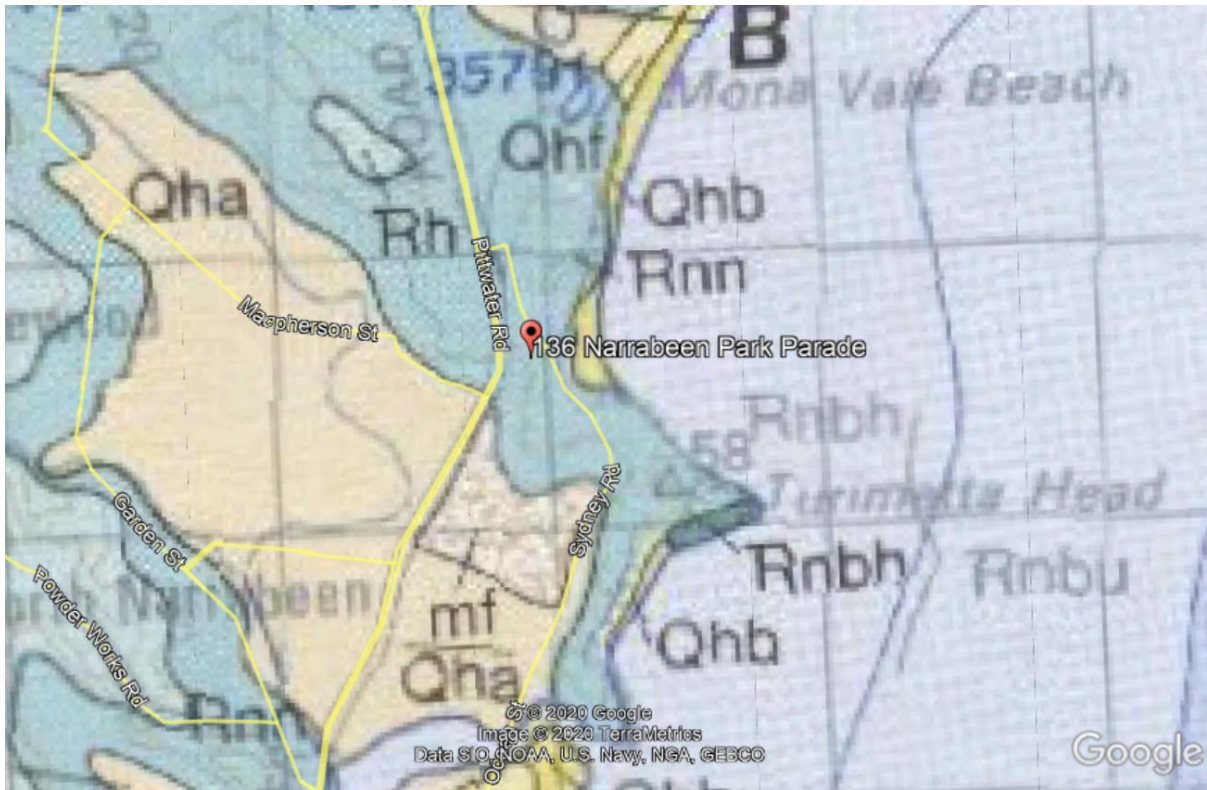
Figure 1: Extract of local geology from 1:100,000 Sydney Map

Investigation of geological maps from the Geological survey of NSW has identified the expected site geology is Triassic aged group Newport Formation and Garie Formation Narrabeen Group (Rn, undifferentiated) which comprises interbedded laminite, shale and quartz to lithic quartz sandstone, minor red claystone north of Hawkesbury River. Clay pellet sandstone (Garie Fm) south of Hawkesbury River. This geology was consistent with the visual identification of material on site. An extract of the local geological map is provided below.
