Report Title: Geotechnical Report 55 Robertson Road, Scotland Island

Report Date: 12/8/20

GEOTECHNICAL INVESTIGATION:

Alterations and Additions at 55 Robertson Road, Scotland Island

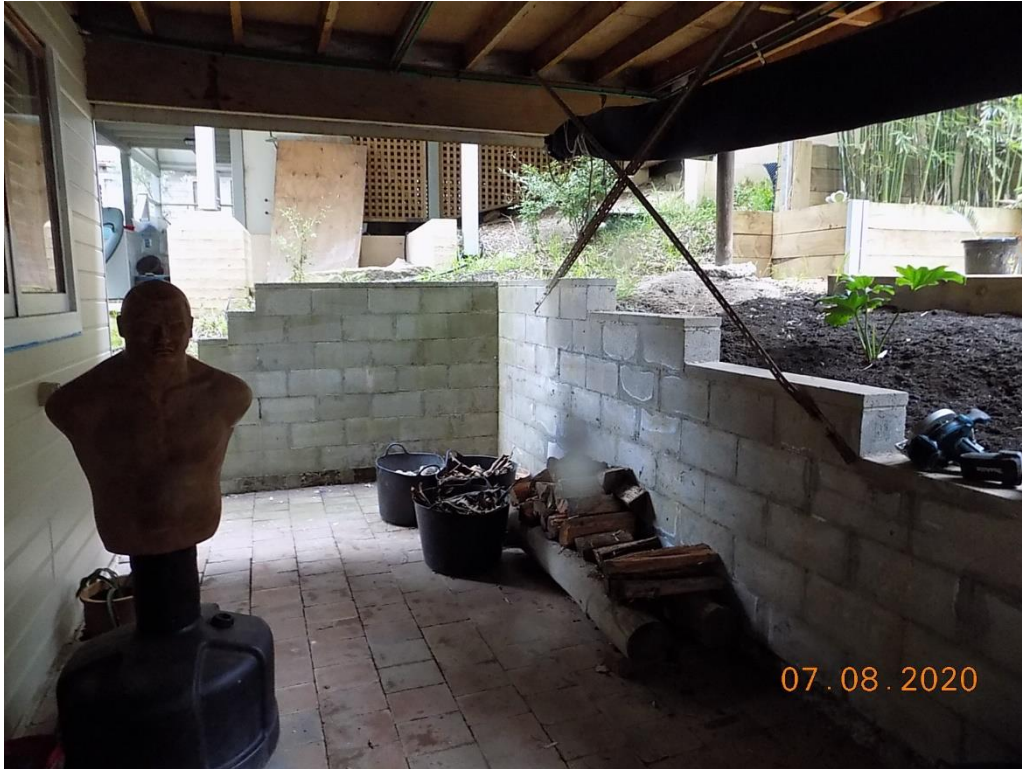
Photo 4

- 2.3** Between the road frontage and the house, the slope has been terraced with a series of stable treated timber retaining walls reaching ~0.6m high (Photos 1, 2, & 3). The part two-storey timber framed and weatherboard clad house is supported on stable timber posts (Photo 4). Excavations have been made in the slope to create level platforms for the ground floor and lower ground floor. The cuts are supported by stable concrete block and treated timber retaining walls reaching ~1.8m high (Photos 5 & 6). A gently sloping lawn has been cut into the slope on the downhill side of the house. The proposed timber deck that is the subject of this report has been
