GEOTECHNICAL INVESTIGATION:

New house and Granny Flat at 28 Stuart Street, Collaroy

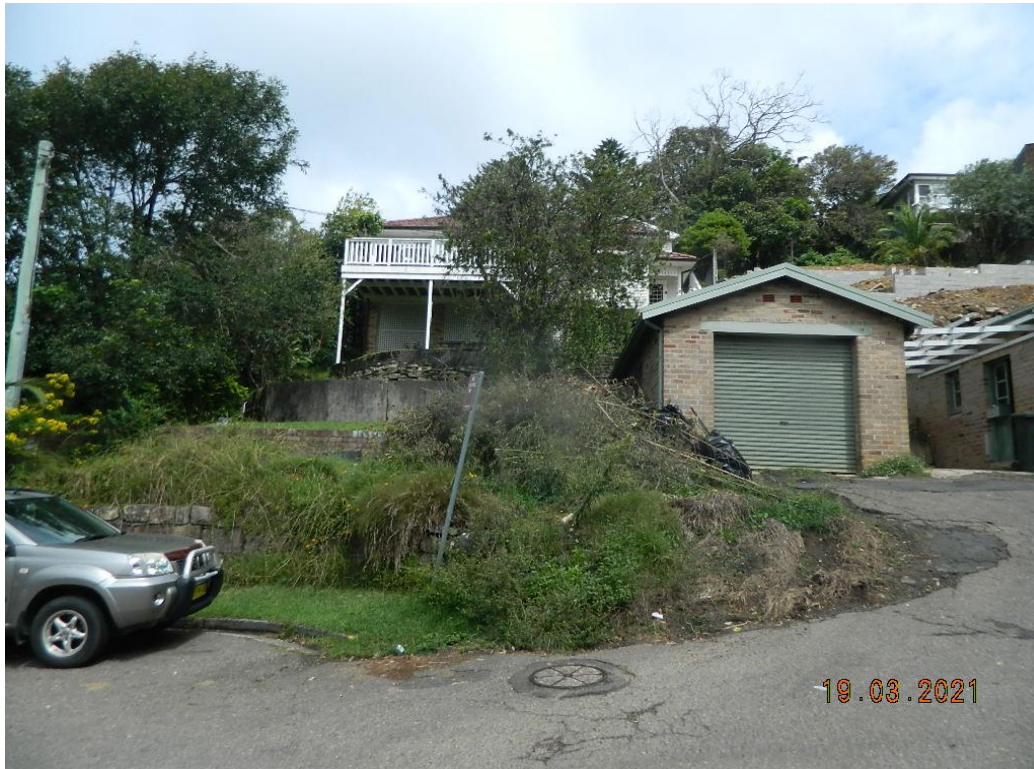
Photo 1

- 2.1** The site was inspected on the 19th March, 2021.
- 2.2** This residential property is on the high side of the road and has a N aspect. The block is located on the steeply graded lower middle reaches of a hillslope. The slope falls across the property at an average angle of ~20°. The slope below the property decreases in grade. The slope above the property continues at similar angles for ~60m and then increases in grade for ~70m before reaching the crest of the slope.
- 2.3** At the road frontage, a bitumen driveway runs to a brick garage (Photo 1). The E brick wall of the garage displays stepped and vertical cracking up to ~28mm thick (Photo 2), but will be demolished as part of the proposed works. Sandstone block,

The house excavation requires the removal of the existing concrete retaining walls on the uphill side of the house (Photos 7, 10, 11) and the brick retaining walls supporting the cut for the existing garage (Photos 1 & 2). The retaining walls are to be demolished from the top down prior to the excavations commencing. The fill, soil and clay behind the walls is to be battered at 1.0 Vertical to 1.7 Horizontal (30°) as the walls are demolished.

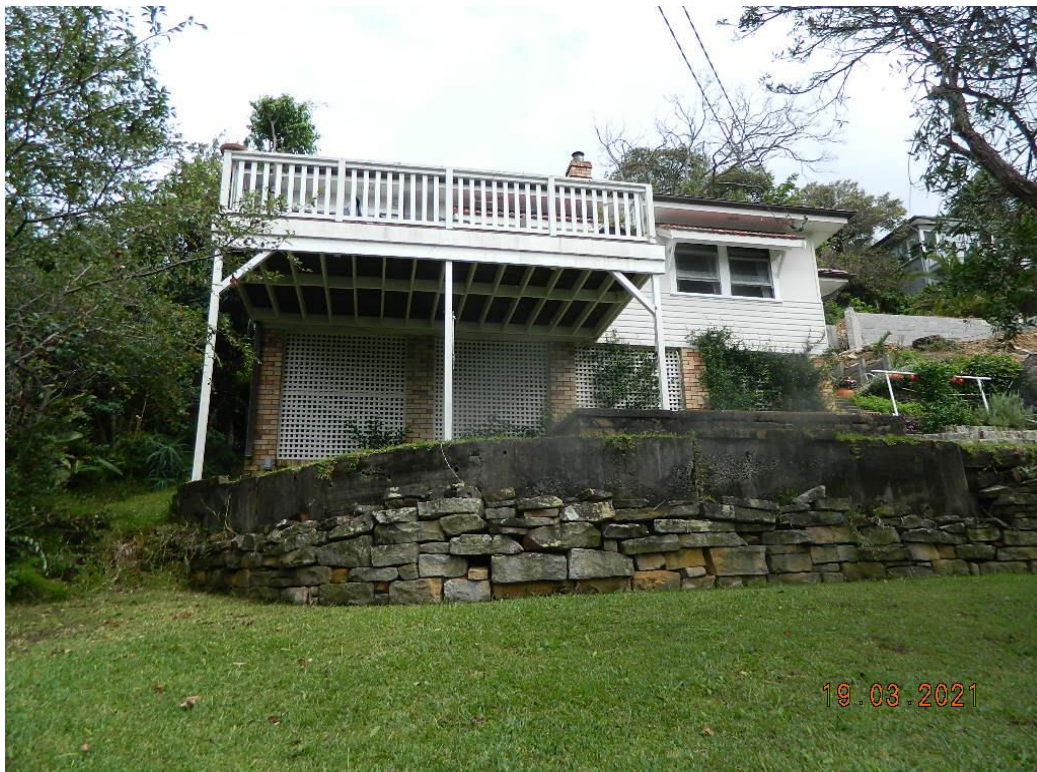
Photo 6

brick and concrete retaining walls up to ~1.4m high support the fill for a terraced lawn area between the road frontage and the house (Photos 3 to 5). The upper and middle concrete retaining walls displays vertical cracks up to ~30mm. It is expected that the walls will be demolished as part of the proposed works. The single storey brick and timber clad house is supported by brick walls, brick piers and steel posts (Photos 6 & 7). The supporting walls, piers and posts stand vertical and show no significant signs of movement (Photos 8 & 9). Brick and rendered brick retaining walls support a low cut for a storage area in the foundation space of the house.

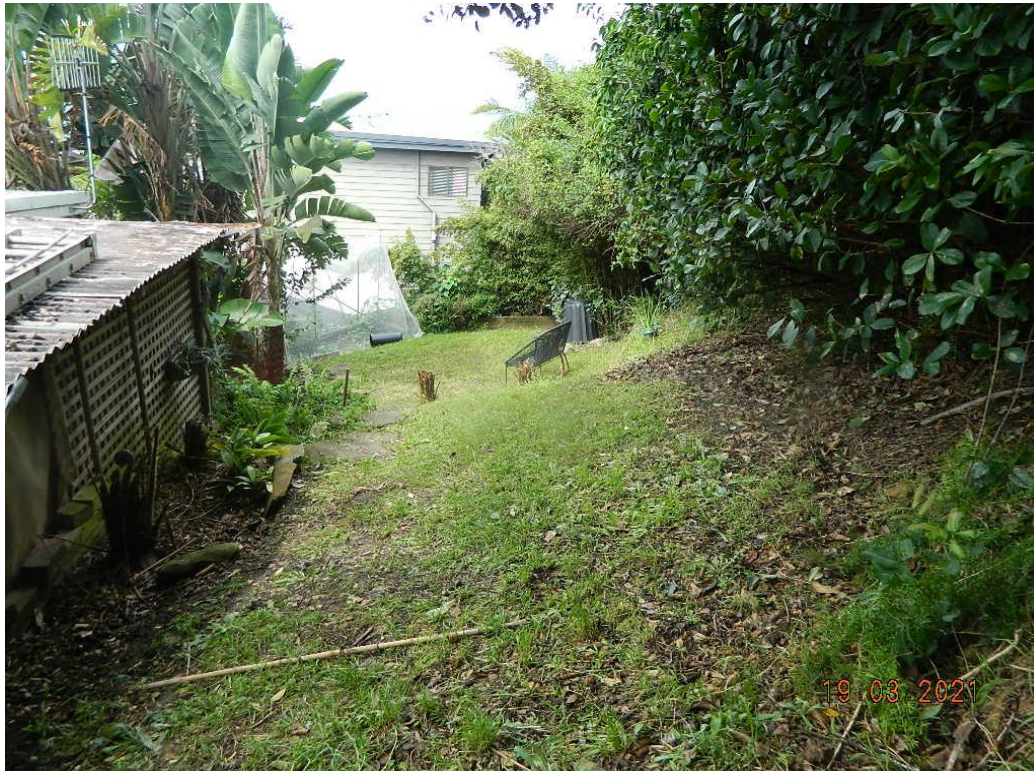
Photo 17

Formed concrete retaining walls up to ~2.2m high support a cut and fill on the uphill side of the house (Photos 7, 10 & 11). Weep holes have been installed in the walls to provide drainage. The southern walls display cracks up to ~30mm thick and a portion of one of the walls has separated ~35mm downslope, but the walls will be demolished as part of the proposed works (Photo 12). A gently sloping lawn and a single storey timber clad studio with storage room below is located on the uphill side of the retaining walls (Photos 13 & 14). The studio is supported by timber posts, concrete walls and brick piers. The supporting concrete walls display some minor cracking but are considered to be stable (Photo 15). Sandstone bedrock is outcropping in the foundation space (Photo 16). A lawn and garden area is located on the uphill side of the studio (Photo 17).
