# Jack Hodgson Consultants Pty Limited

MU 31713.  
24<sup>th</sup> May, 2019.  
Page 1.

## **RISK ANALYSIS & MANAGEMENT FOR PROPOSED ALTERATIONS, ADDITIONS AND DRIVEWAY AT 13 AMIENS ROAD, CLONTARF**

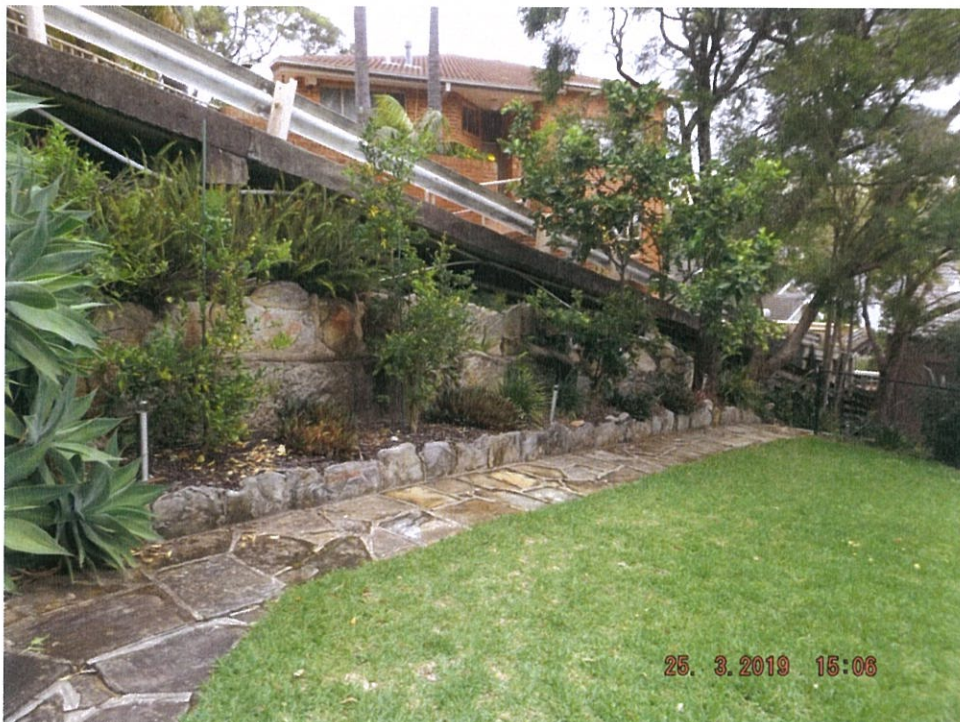
**Photo 3**

Photo 2. At the rear of the garage a gentle sloping lawn areas is accessed by a set stairs of the western side of the garage, Photo 3. This lawn area is created by use of retaining walls along the western and northern edges and the use of fill material placed over the existing bedrock. A storage area is under the existing garage. The sandstone walls of the storage room are also retaining walls. An elevated driveway runs adjacent the southern side boundary on the neighbouring property with low rock retaining wall supporting material along this boundary, Photo 4. A set stairs on the southern side of the property leads down a patio in front of the existing residence siting at the toe of the visible rock shelf, Photo 5. No access to the rear the property is possible on the southern side of the existing residence, Photo 6. A set stairs provides access to the rear of the property on the northern side of the existing residence, Photo 7. An elevated balcony and swimming pool is at the rear of the residence, Photo 8. On the northern underside of the elevated rear patio an old masonry retaining wall is observed to be out of vertical, Photo 9. This retaining wall maybe no longer required but we were unable to determine this at the time of our inspection and further investigation would be required. A set stairs on the southern side of the swimming pool provides access to the rear of the site. The landscaped stairs have been carved out of the exposed sandstone bedrock in some places, Photo 10. Some terraced rock stacked retaining walls provide support along the southern side boundary toward the south western rear corner. These retaining walls were observed stable at the time of inspection, Photo 11. A stable batter was observed underneath of the swimming pool where we also observed the piers that support the swimming pool, Photo 12.
