Geotechnical Assessment

Project: New Dwelling
12 Molong Street, North Curl Curl NSW

Ref: AG 25041
6 February 2025

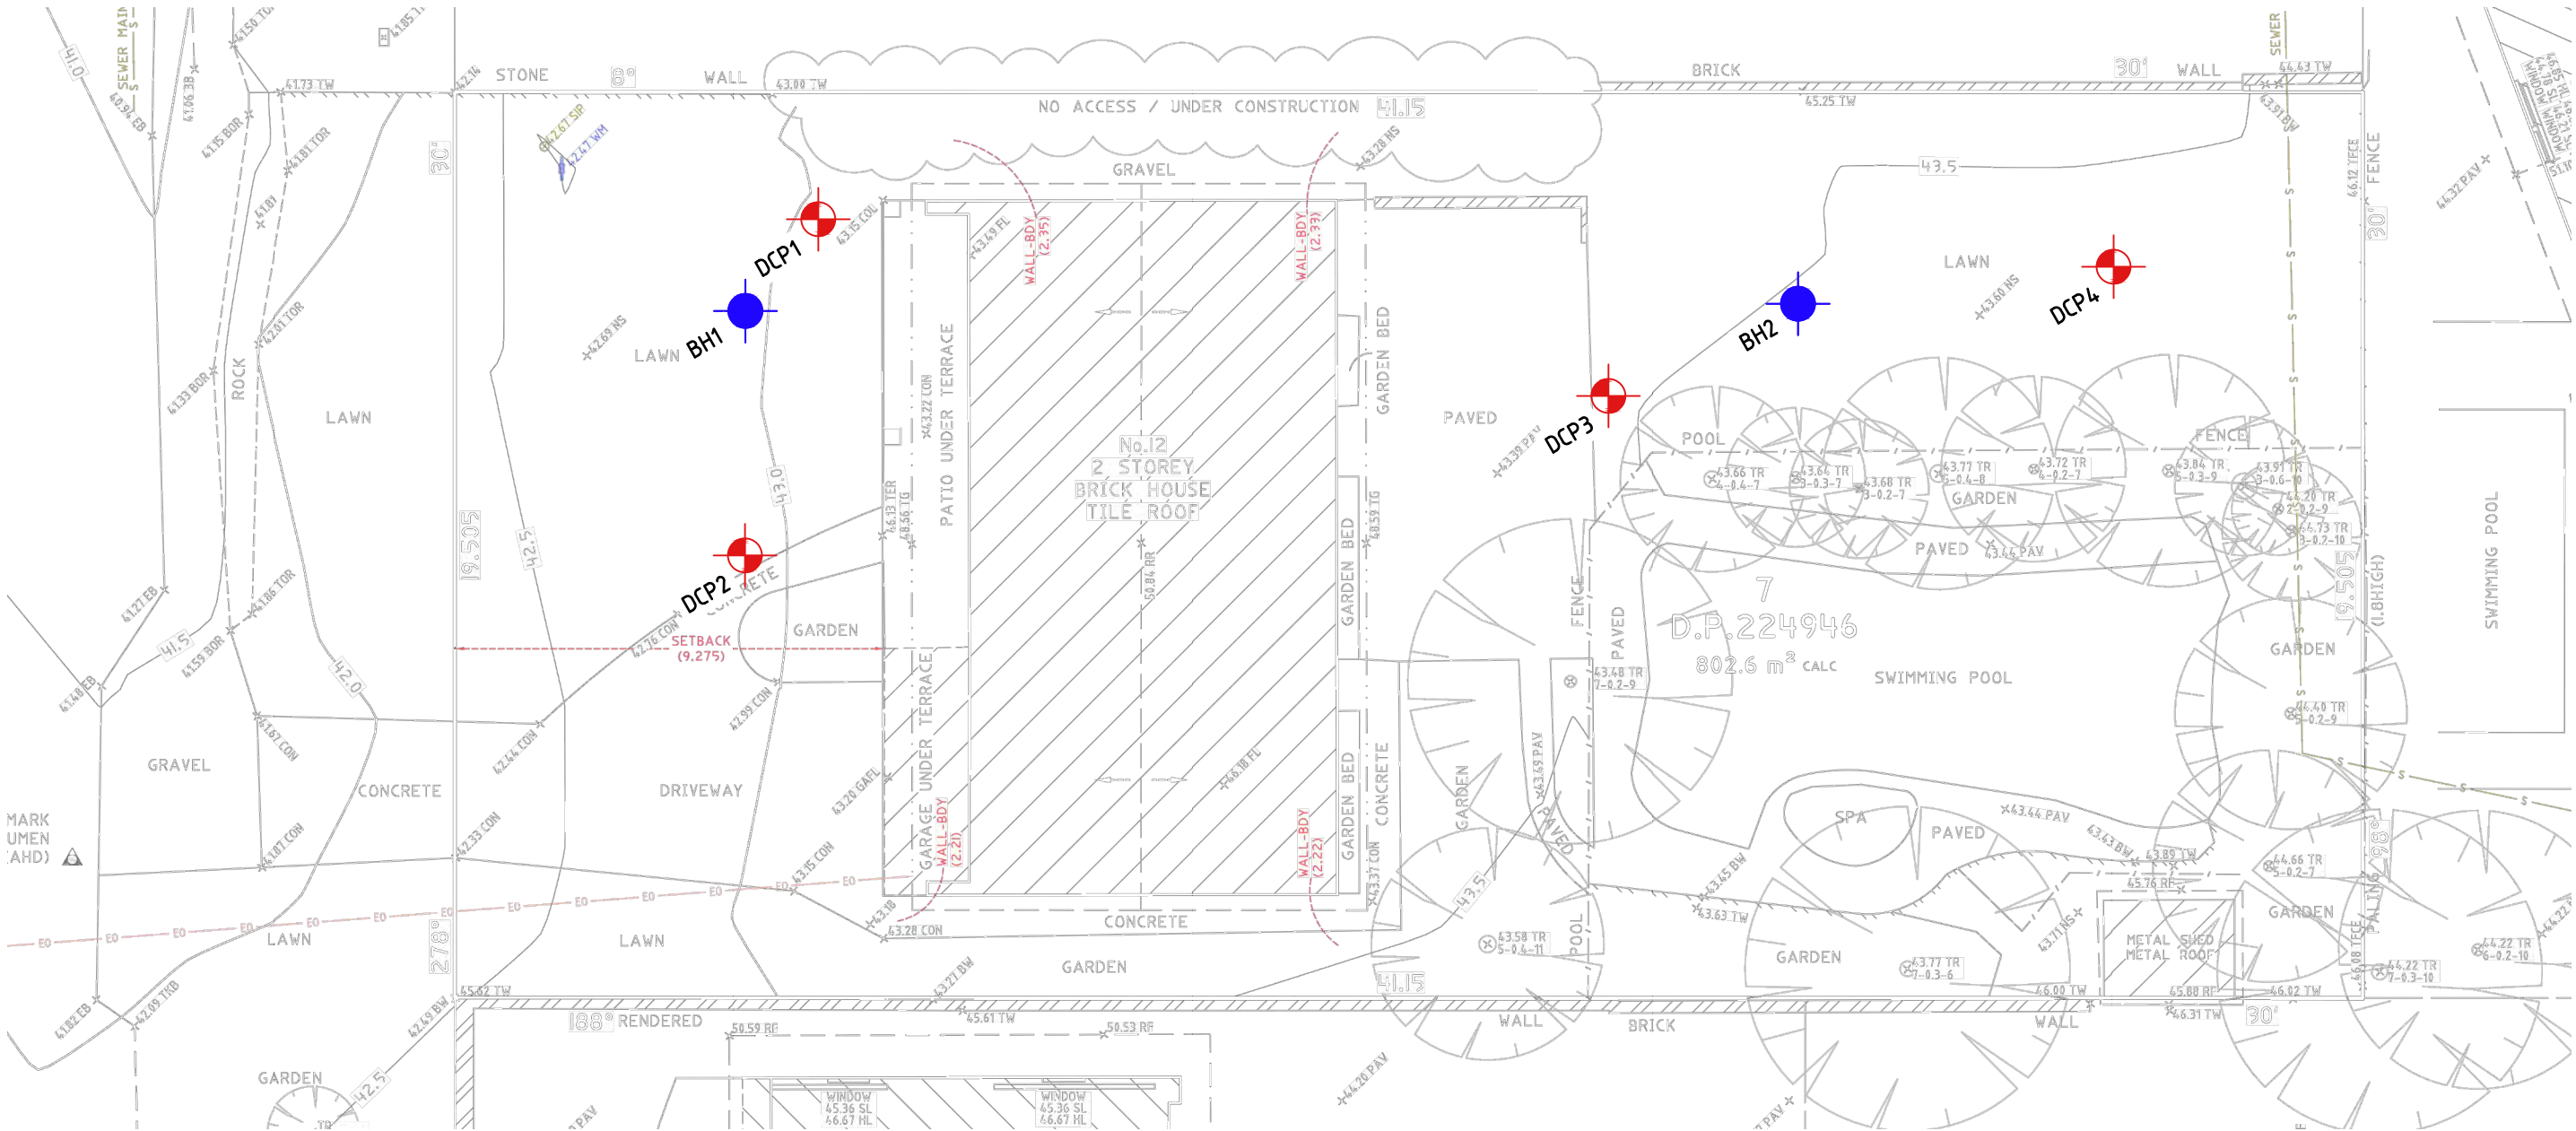
SITE PLAN/GROUND TEST LOCATIONS
SCALE NTS

Test	Summary
DCP 1	Refusal @ 0.3m Bouncing on bedrock. Grey sand on moist tip.
DCP 2	Refusal @ 0.3m Bouncing on bedrock. Grey sand on moist tip.
DCP 3	Refusal @ 0.3m Bouncing on bedrock. Grey sand on moist tip.
DCP 4	Refusal @ 0.9m Bouncing on bedrock. Grey sand on moist tip.
