Report Title: Geotechnical Report 77, 77A, & 81 Myola Road, Newport

GEOTECHNICAL INVESTIGATION:

New Right of Carriageway at 77, 77A, & 81 Myola Road, Newport

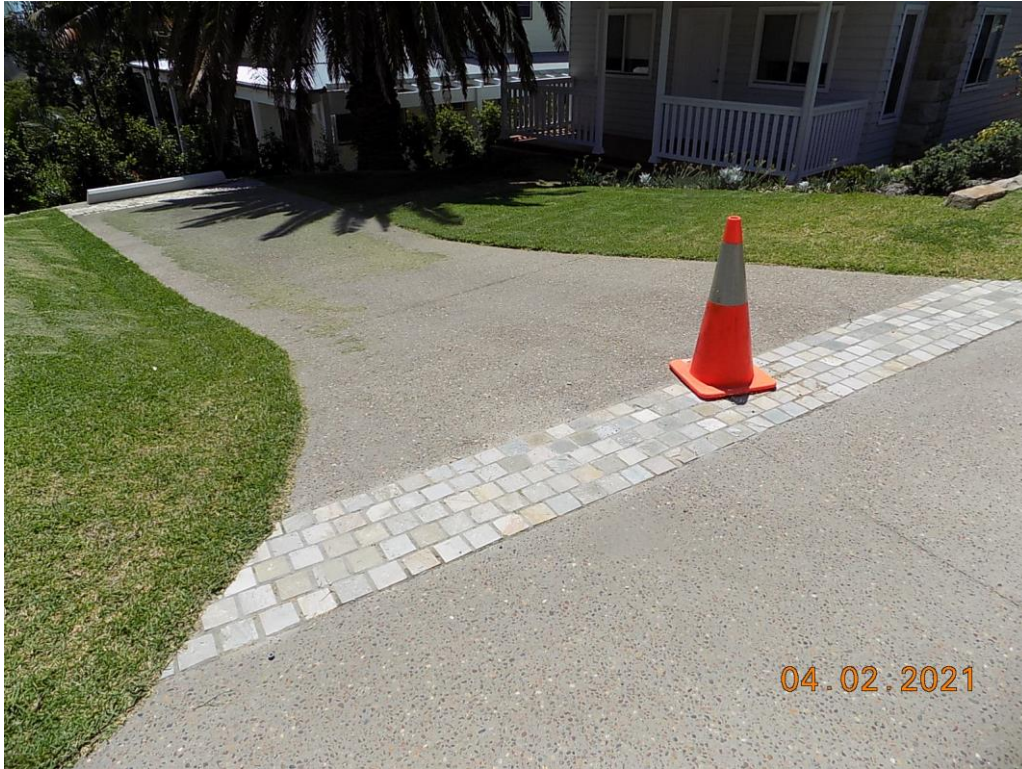
Photo 2

- 2.3 **77 Myola Road** – At the road frontage, a long concrete ROW runs past the S side of the property (Photo 1). Competent Medium Strength Sandstone outcrops through the N side of the slope that drops away from the ROW (Photo 2). A concrete driveway diverts off the ROW to a parking area near the road frontage (Photo 3). A stable steel and timber framed and clad granny flat has been constructed beside the parking area (Photo 4). The slope between the granny flat and the main house has been terraced with three stable sandstone block retaining walls and a series of stable garden slopes (Photos 5, 6, & 7). The old single-storey split level sandstone block house is supported on brick and sandstone block walls (Photo 8). Some stepped cracking was observed through the mortar of the sandstone blocks on the lower E side of the house (Photo 9). This type of cracking is typical in houses of this age and construction. No

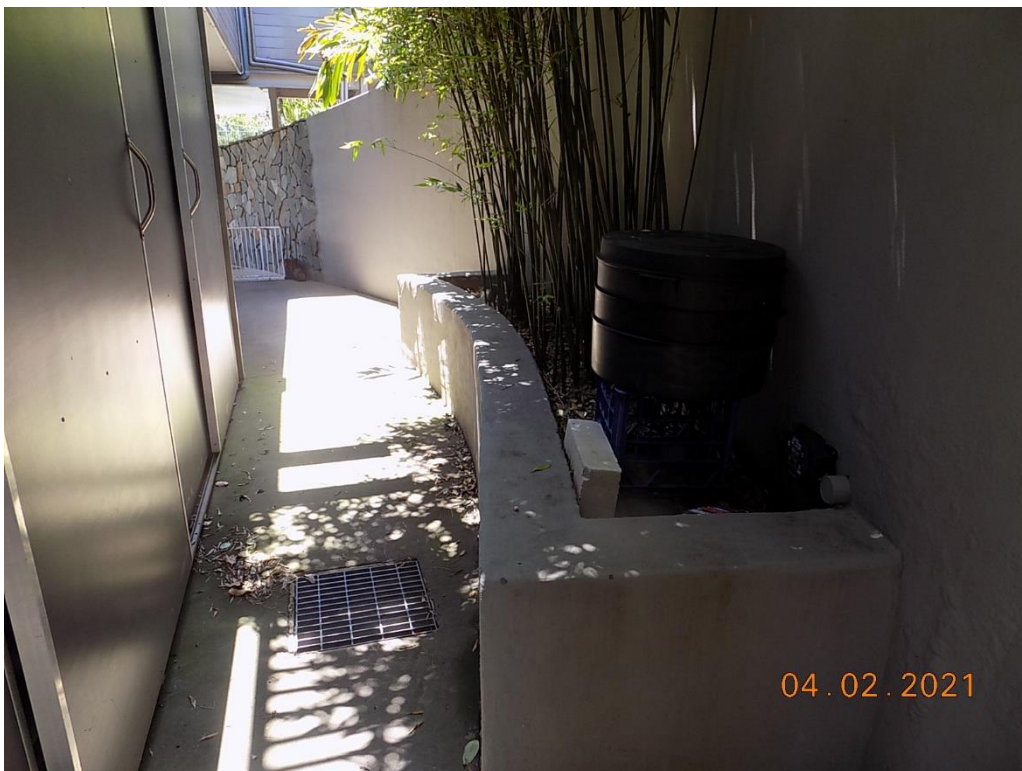
Photo 19

2.5 81 Myola Road – At the road frontage, a concrete ROW runs up the slope along the ridgeline to a garage on the ground floor of the house and to a carport with studio above on the S side of the property (Photos 18 & 19). An excavation has been made in the slope to level the slope surface for the driveway and house. The cut is supported by a stable retaining wall reaching ~2.3m high that has been mostly dressed in stone (Photos 20 & 21). The two-storey clad house is in good condition (Photo 22). A gently sloping lawn and garden area extends off the N and W sides of the house (Photo 23). An above-ground pool has been constructed in the NE corner of the property (Photo 24). The water level of the pool indicates no ground movement has occurred in the shell of the pool since its construction.
