GEOTECHNICAL INVESTIGATION:

New Pool and Landscaping at 292 Hudson Parade, Clareville

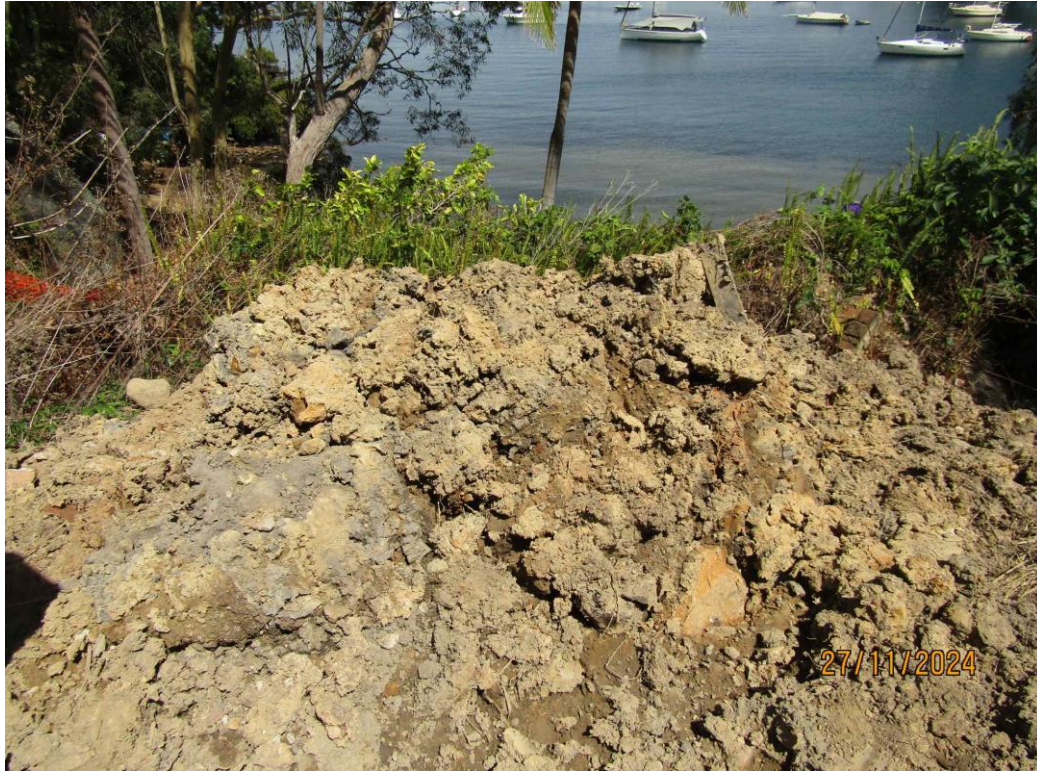
Photo 7

Construction/demolition works are ongoing at the downhill side of the house (Photos 5 & 6). An extreme heavy and prolonged rainfall event occurred during March, 2022. This resulted in movement of the deep fill that had been placed across the downhill side of the property during its development. The posts supporting a timber deck at the downhill side of the existing pool tilted and settled. Severe cracking and deflection occurred in a mortared stack rock retaining wall up to ~3.5m, that supported a fill immediately downslope of the pool. The base of the existing pool is undercut at the downhill side, although piers support this side of the pool (Photo 7). The deck, retaining wall and pool have been demolished or partially demolished (Photos 5 & 6). Structural landscaping retaining walls with counterfort returns will be constructed across the downhill side of the property as part of the proposed works to stabilise the slope.

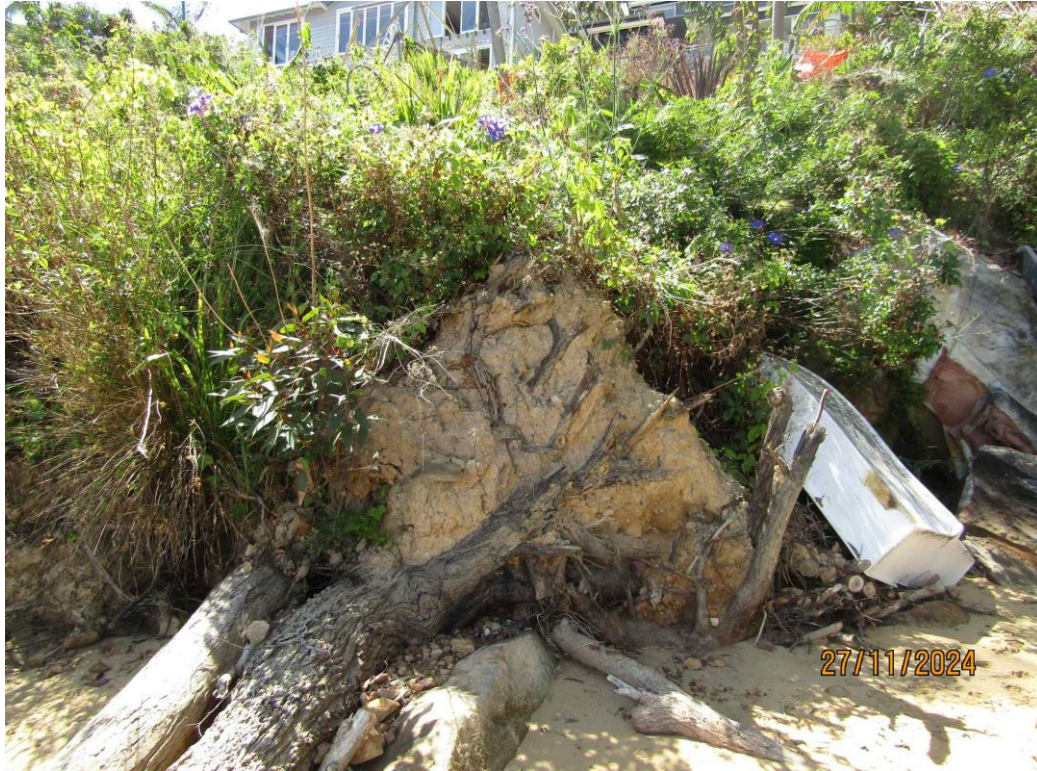
Photo 11

The steep slope below the property is densely vegetated with some rubble from the slope movement (Photos 8 to 10). Detached sandstone joint blocks are scattered across the toe of the slope (Photo 10). A tree has toppled and fallen down the slope in this location (Photo 11). Landslide material is also present at the toe of the slope (Photo 12). It is interpreted that the toppled tree and landslide rubble are the result of the slope movement initiated by the extreme rainfall event in March, 2022, and that was ongoing for some 6 months after.
