# Accessibility Assessment and Recommendation Report

**Pilu Restaurant, 80 Undercliff Road, Freshwater NSW**

Report Number: RE220643 Access

JUNE 2023

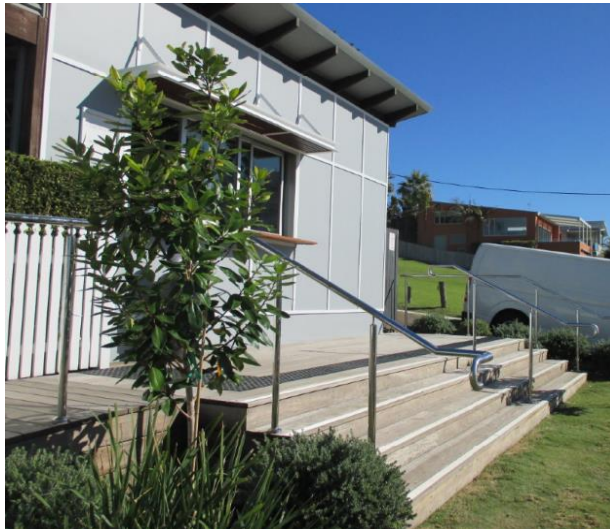
- (i) The deck of the kiosk can be accessed via the external walkway or from the arcade connected with Moore Road parking via the stairs.

*Figure 2- The kiosk*

It is not required to upgrade the accessible path of travel to the kiosk immediately as the reasonably accessible path of travel is provided. If any major building works are proposed within the complex, it is recommended to analyse the path of travel and provide the features based on AS1428 standards to comply with the Clause D3.3 of BCA.

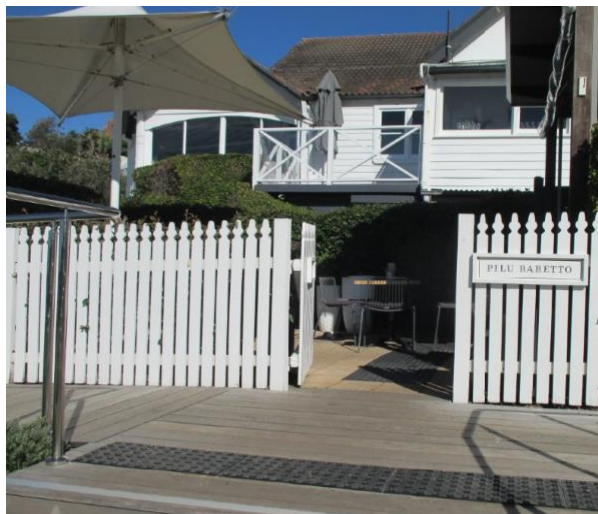
- (ii) The open seating area of the coffee shop can also be accessed via the external walkway or the stairs from the arcade.

*Figure 3- The Cafeteria*
