ARBORICULTURAL IMPACT ASSESSMENT REPORT

44 Lovett Street Manly Vale

Watermark Construction Group

3rd February 2020

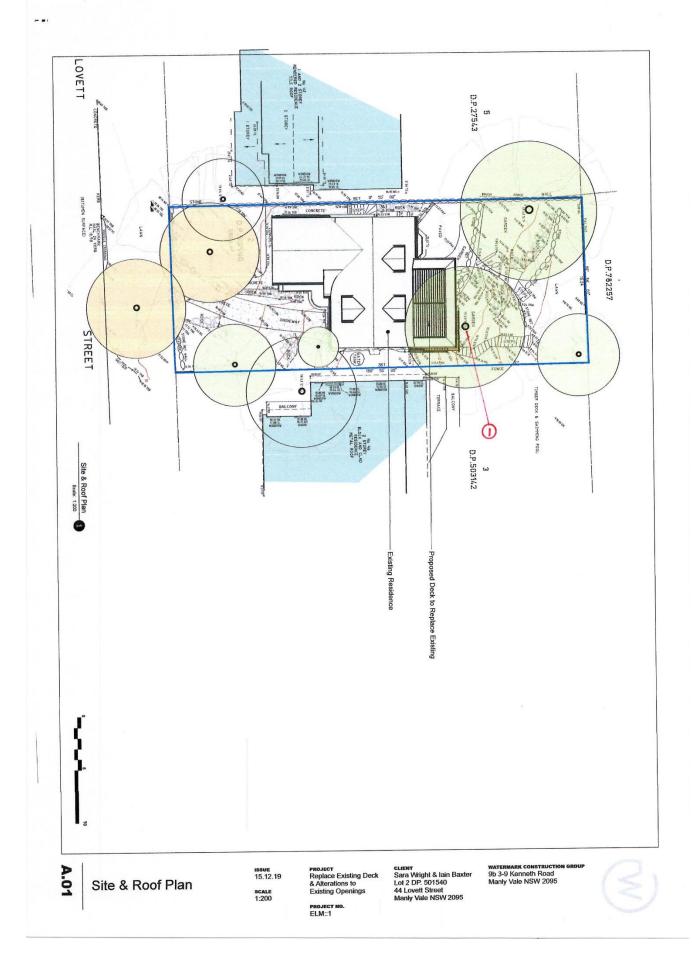
Annexure C: Tree impact plan

1. Tree 1 *Ficus rubiginosa* shows good vitality with an elevated form – refer plate 1. The proposed deck will be constructed on posts anchored to the existing rock which will not impact the root system of this tree, then constructed the deck with care. It is noted, no branch pruning is required to build the deck. All work is within the TPZ & SRZ of this tree, but by locating the posts on existing rock, the encroachment is considered acceptable as defined by AS 4970 – 2009. The new posts installation shall be supervised by the Project Arborist to ensure no damage occurs to this tree. Otherwise the work can proceed with care.

- d) An AQF Level 5 Project Arborist shall be engaged to supervise the building works and certify compliance with all Tree Protection Measures.
- e) The tree location plan can be found on Annexure B; &

f) The tree impact plan can be found on Annexure C.
