## **Geotechnical Assessment**

**Project:** Low Density Residential Development  
60 Binalong Avenue, Allambie Heights.

**REF: AG 18011**

2<sup>nd</sup> February, 2018

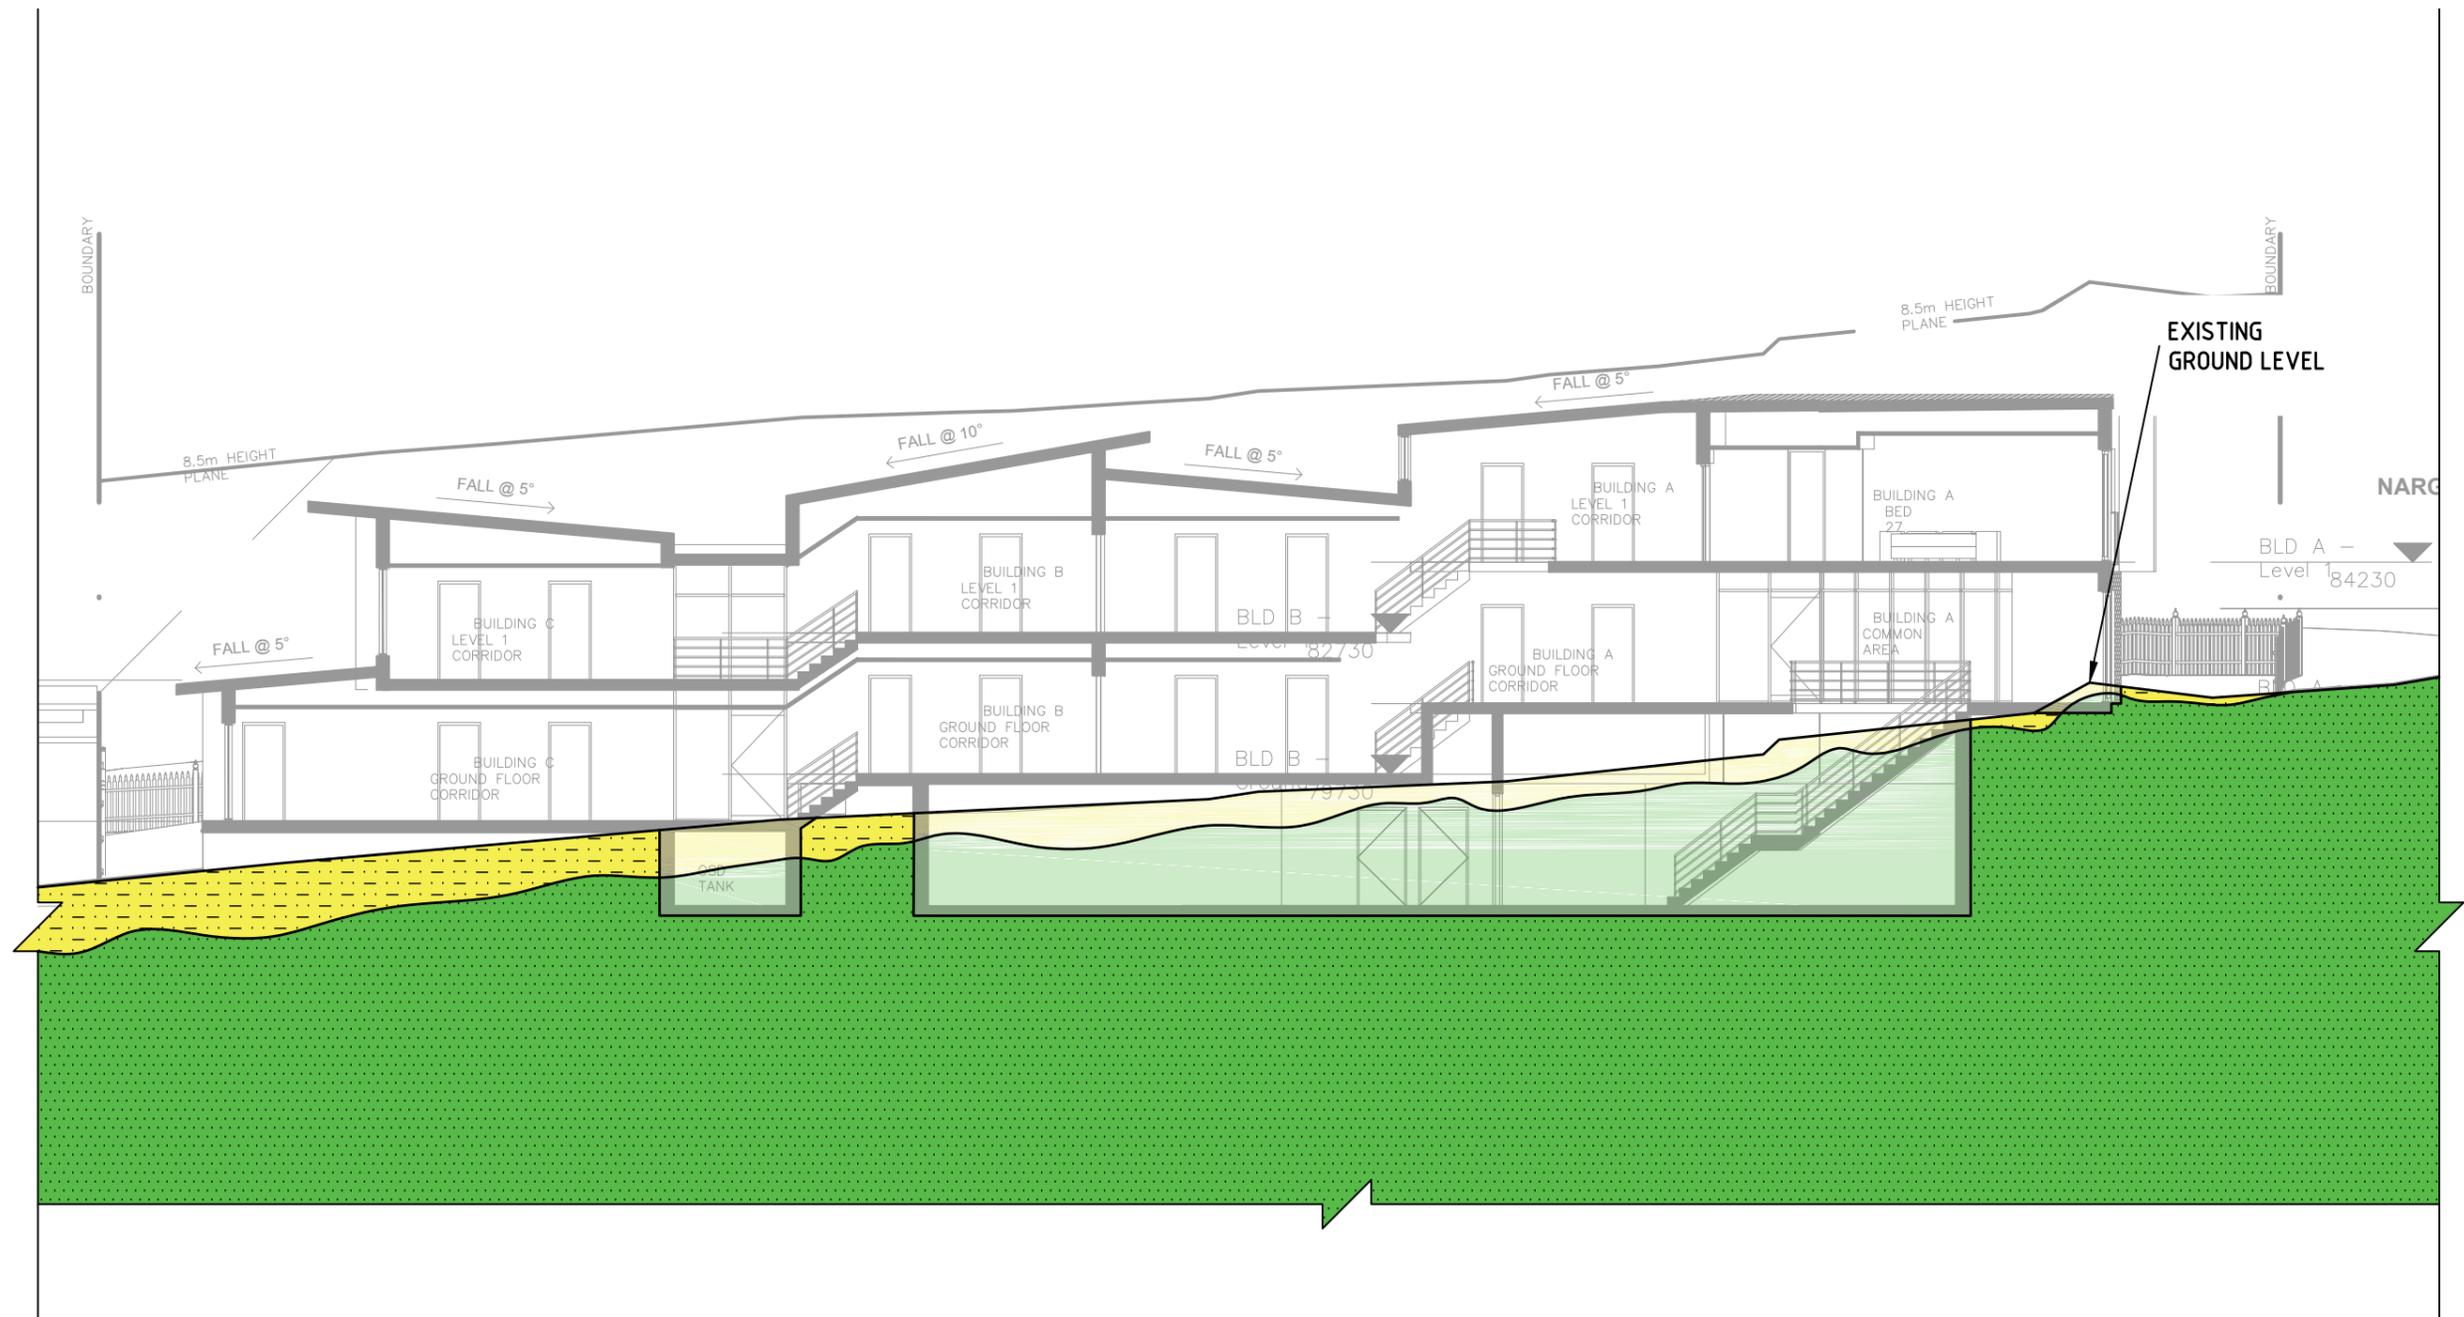
**INTERPRETED GEOLOGICAL SECTION**  
SCALE: NTS

INTERPRETED SUBSURFACE SECTION ONLY.  
ACTUAL GROUND CONDITIONS MAY VARY.
