74 Grandview Drive, Newport

Geotechnical Comments for Section 4.55

GEOTECHNICAL INVESTIGATION:

New Pool at 74 Grandview Drive, Newport

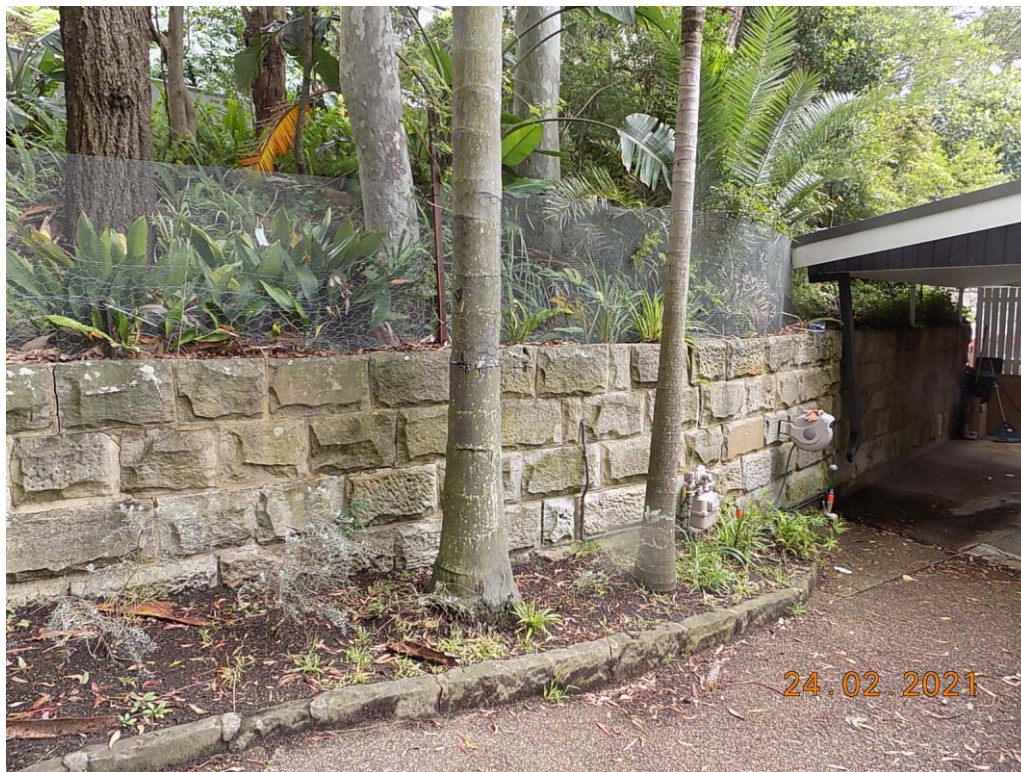
Photo 2

- 2.3** At the road frontage, a concrete driveway runs to a stable carport attached to the uphill side of the house (Photo 2). The cut for the driveway is supported by a mortared sandstone block retaining wall reaching ~1.2m high (Photo 3). The wall displays some cacking through the mortar but no signs of deflection and is considered stable. The part two-storey brick house is supported on brick walls (Photo 4). The supporting walls display no significant signs of movement. A large cut and fill encompasses the entire NE side of the property to create a level platform for the house and surrounding lawns and gardens. The cut is supported by a stable mortared
