GEOTECHNICAL INVESTIGATION:

New Pool at 129 Upper Clontarf Street, Seaforth

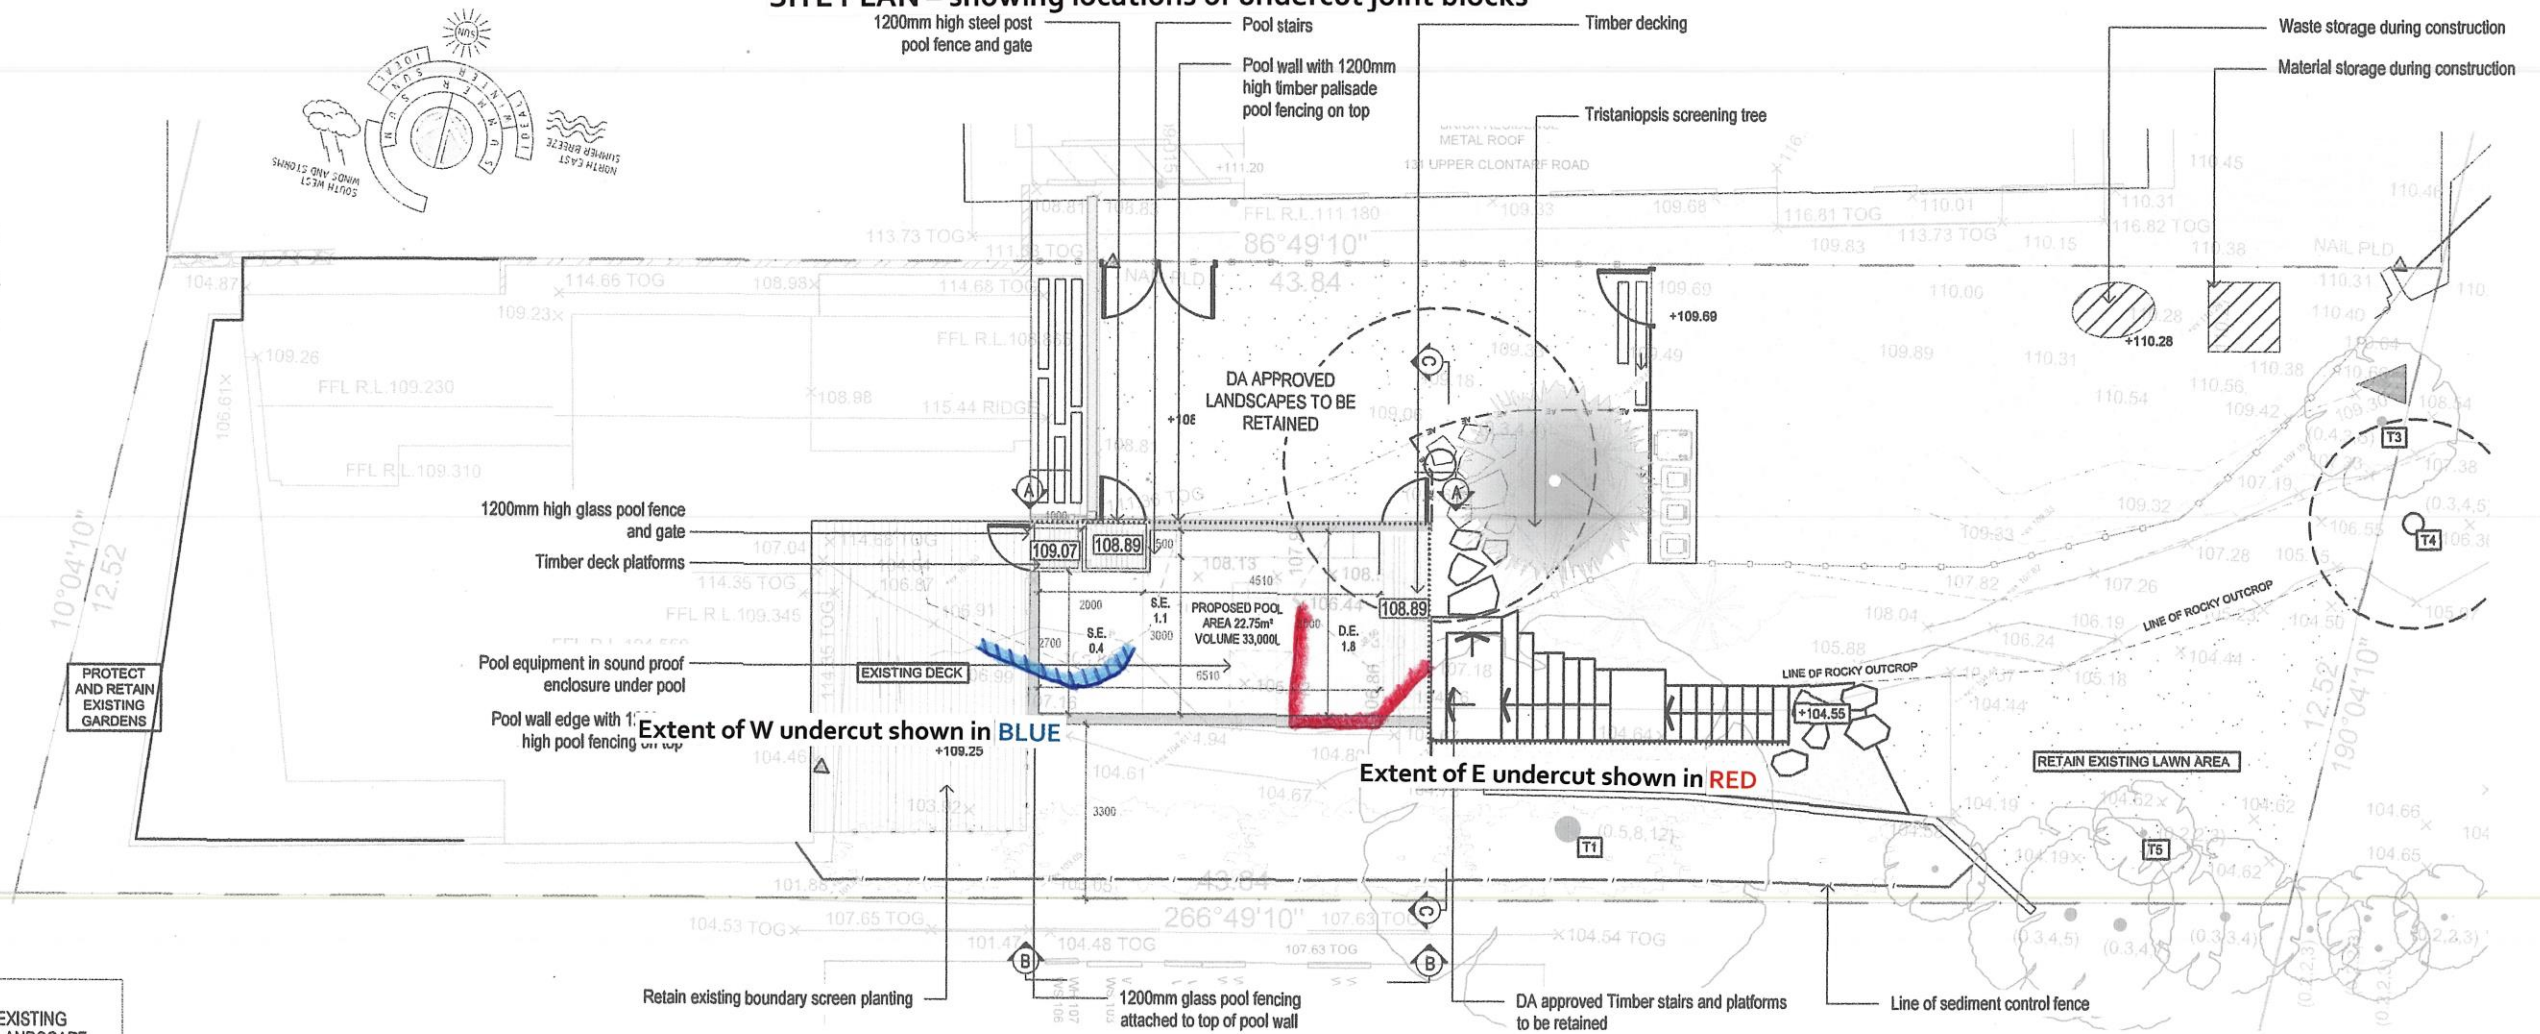
SITE PLAN – showing locations of undercut joint blocks

HAZARDS	Hazard One
TYPE	The construction of the proposed pool impacting on the undercut cliff face causing failure (Photos 5 & 6).
LIKELIHOOD	'Unlikely' (10^{-4})
CONSEQUENCES TO PROPERTY	'Medium' (35%)
RISK TO PROPERTY	'Low' (2×10^{-5})
RISK TO LIFE	4.2×10^{-6} /annum
COMMENTS	This level of risk is 'ACCEPTABLE' provided the recommendations in Sections 11 & 12 are followed.

The proposed pool will require partial excavation through Medium Strength Sandstone. The portion of the rock to be cut sits above the E undercut rock (Photo 5). To ensure the stability of the rock face into the future, we recommend all significant undercut portions of this rock face be cut back to form a sheer rock face.

The excavations through the undercut rock are to be carried out first. To reduce risk, they are to be undertaken using rock saws and are to be picked out without the use of pneumatic hammers. This is to ensure any vibrations generated during the excavation are below the threshold to impact on the rock face stability or to cause building damage. Following these recommendations, vibration monitoring will not be required.

We envisage most, if not all of the undercut rock will be removed by the pool excavation. If any significant undercut portions of the rock remain, these are to be supported with spaced blade walls. The requirement for this work will be assessed by the geotechnical consultant and is to be carried out before the construction of the pool commences. The blade walls are to be a minimum of 0.4m wide and are to be supported on foundations taken to rock. The tops of the walls are to be in full contact with the undersides of the undercut rocks so non-shrink grout will be required to achieve this. The blade walls are to be designed by the Structural Engineer in consultation with Geotechnical Consultant.
