41 Wallumatta Road, Newport

GEOTECHNICAL INVESTIGATION:

Alterations and Additions at 41 Wallumatta Road, Newport

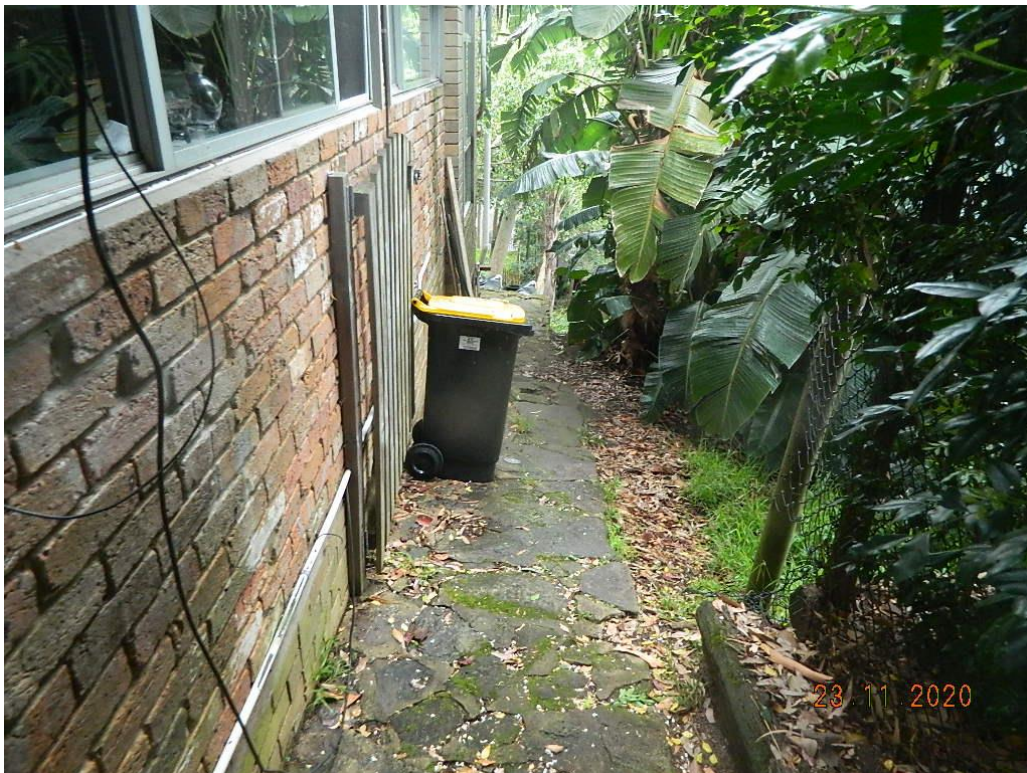
Photo 3

2.3 At the road frontage a concrete driveway runs down the slope to the house (Photos 1 & 2). Fill provides a level platform for a pavement next to the driveway (Photo 3). A stable rendered brick retaining wall up to ~2.1m high supports the fill. The two storey brick and timber clad house is supported by brick walls (Photos 2, 4 & 5). The external supporting walls show no significant signs of movement. A suspended deck supported by steel posts in good condition extends off the downhill side of the house (Photo 5). Fill provides a level lawn and pavement on the downhill side of the house (Photo 6). The fill is supported by stable sandstone flagging and rendered retaining walls up to ~1.3m high. A stable suspended timber deck supported by timber posts is located on the downhill side of the filled lawn (Photo 7). Medium Strength Hawkesbury Sandstone bedrock outcrops on the downhill side of the property (Photos 7 & 8). Stable sandstone joint blocks are embedded in the moderate slope on the downhill side of the property (Photos 9 & 10). No signs of slope instability that could have occurred since the site was developed were observed on the property. The adjoining neighbouring properties were observed to be in good order as seen from the street and subject property.
