GEOTECHNICAL INVESTIGATION:

Alterations and Additions at 10 Kookaburra Close, Bayview

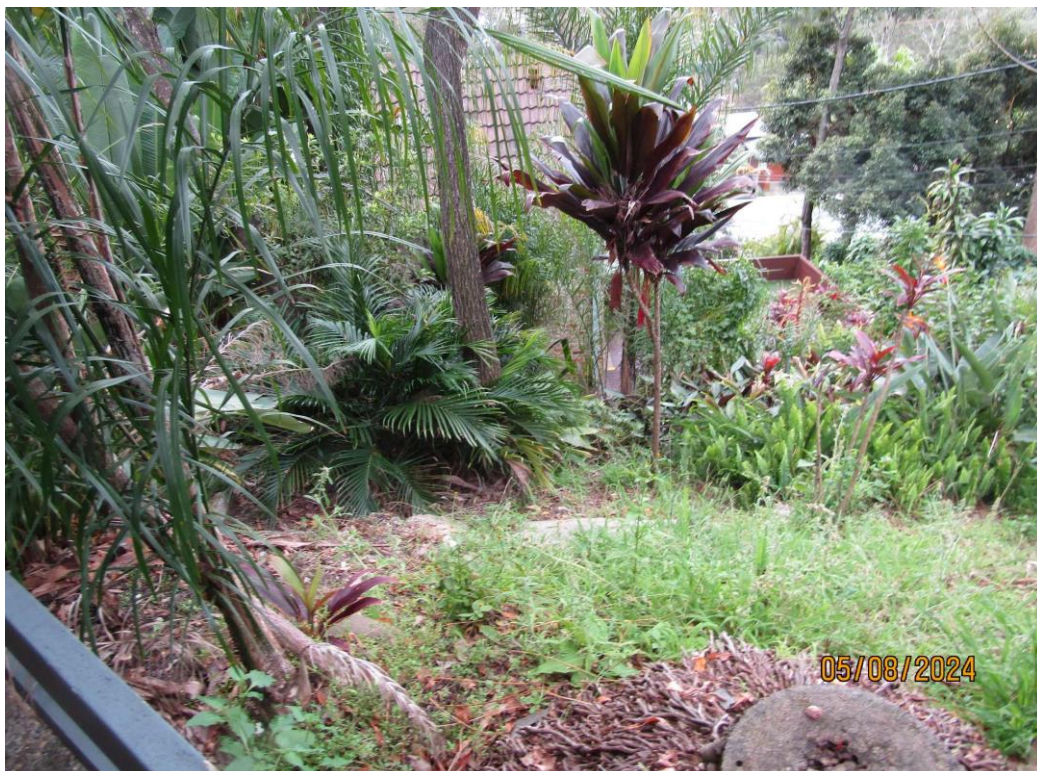
Photo 1

2.3 At the road frontage, a concrete driveway runs to a carport on the uphill side of the property (Photo 1). Fill to an unknown depth provides a level platform for the downhill side for the carport, entry pathway, and road reserve. The fill batter merges into the natural steep moderately-vegetated slope at the uphill side of the house (Photo 2). The SE side of the house has been terraced with a series of treated timber retaining walls. The uppermost wall is ~1.0m high and is tilting downslope significantly (Photo 3). See ‘**Section 16** Ongoing Maintenance’. The part two storey house is supported on brick walls (Photos 4 & 5). The external supporting walls show no significant signs of movement. A timber balcony with deck below extends off the downhill side of the house (Photo 5). The posts that support the balcony and deck stand vertical. The slope underneath and beside the deck has been terraced with a series of timber retaining walls up to ~1.5m high (Photos 6 to 8). One of the timber retaining walls is tilting downslope significantly (Photos 7 & 8). See ‘**Section 16** Ongoing Maintenance’.
