Geotechnical Assessment

Project: Alterations & Additions
1 Suncrest Avenue, Newport NSW

Ref: AG 25173
5 May 2025

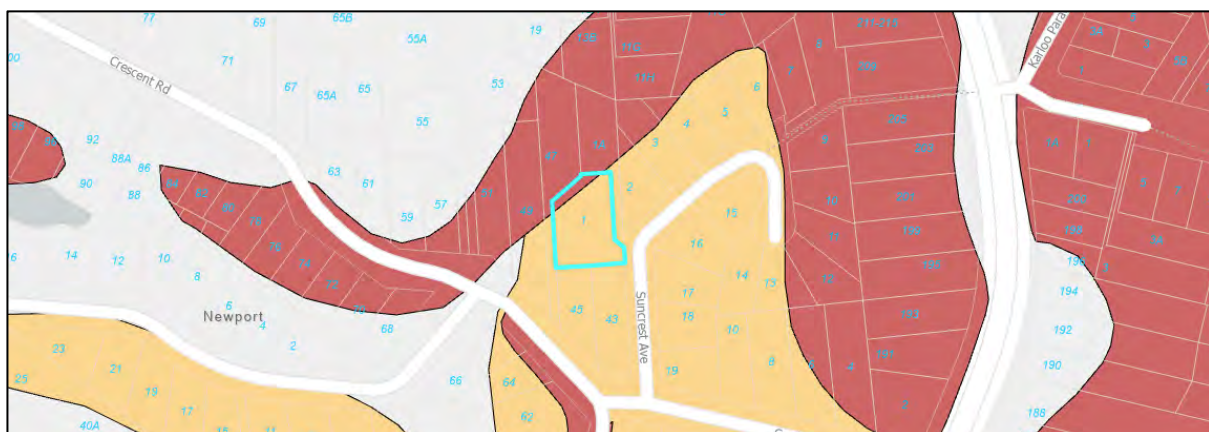
Image 2. PLEP Geotechnical Hazard Map
– 1 Suncrest Avenue, Newport NSW © NBC Maps

- No evidence of significant soil creep, tension cracks or landslip instability were identified across the site or on adjacent properties as viewed from the subject site at the time of our inspection.
- Based on reference to the plan entitled "Geotechnical Hazard Mapping" (Ref. P21DCP-BC-MDCP2002, dated 2007) prepared by GHD LONGMAC on behalf of Northern Beaches Council (Pittwater), the site is mapped in **Geotechnical Hazard H1 & H2** zones.

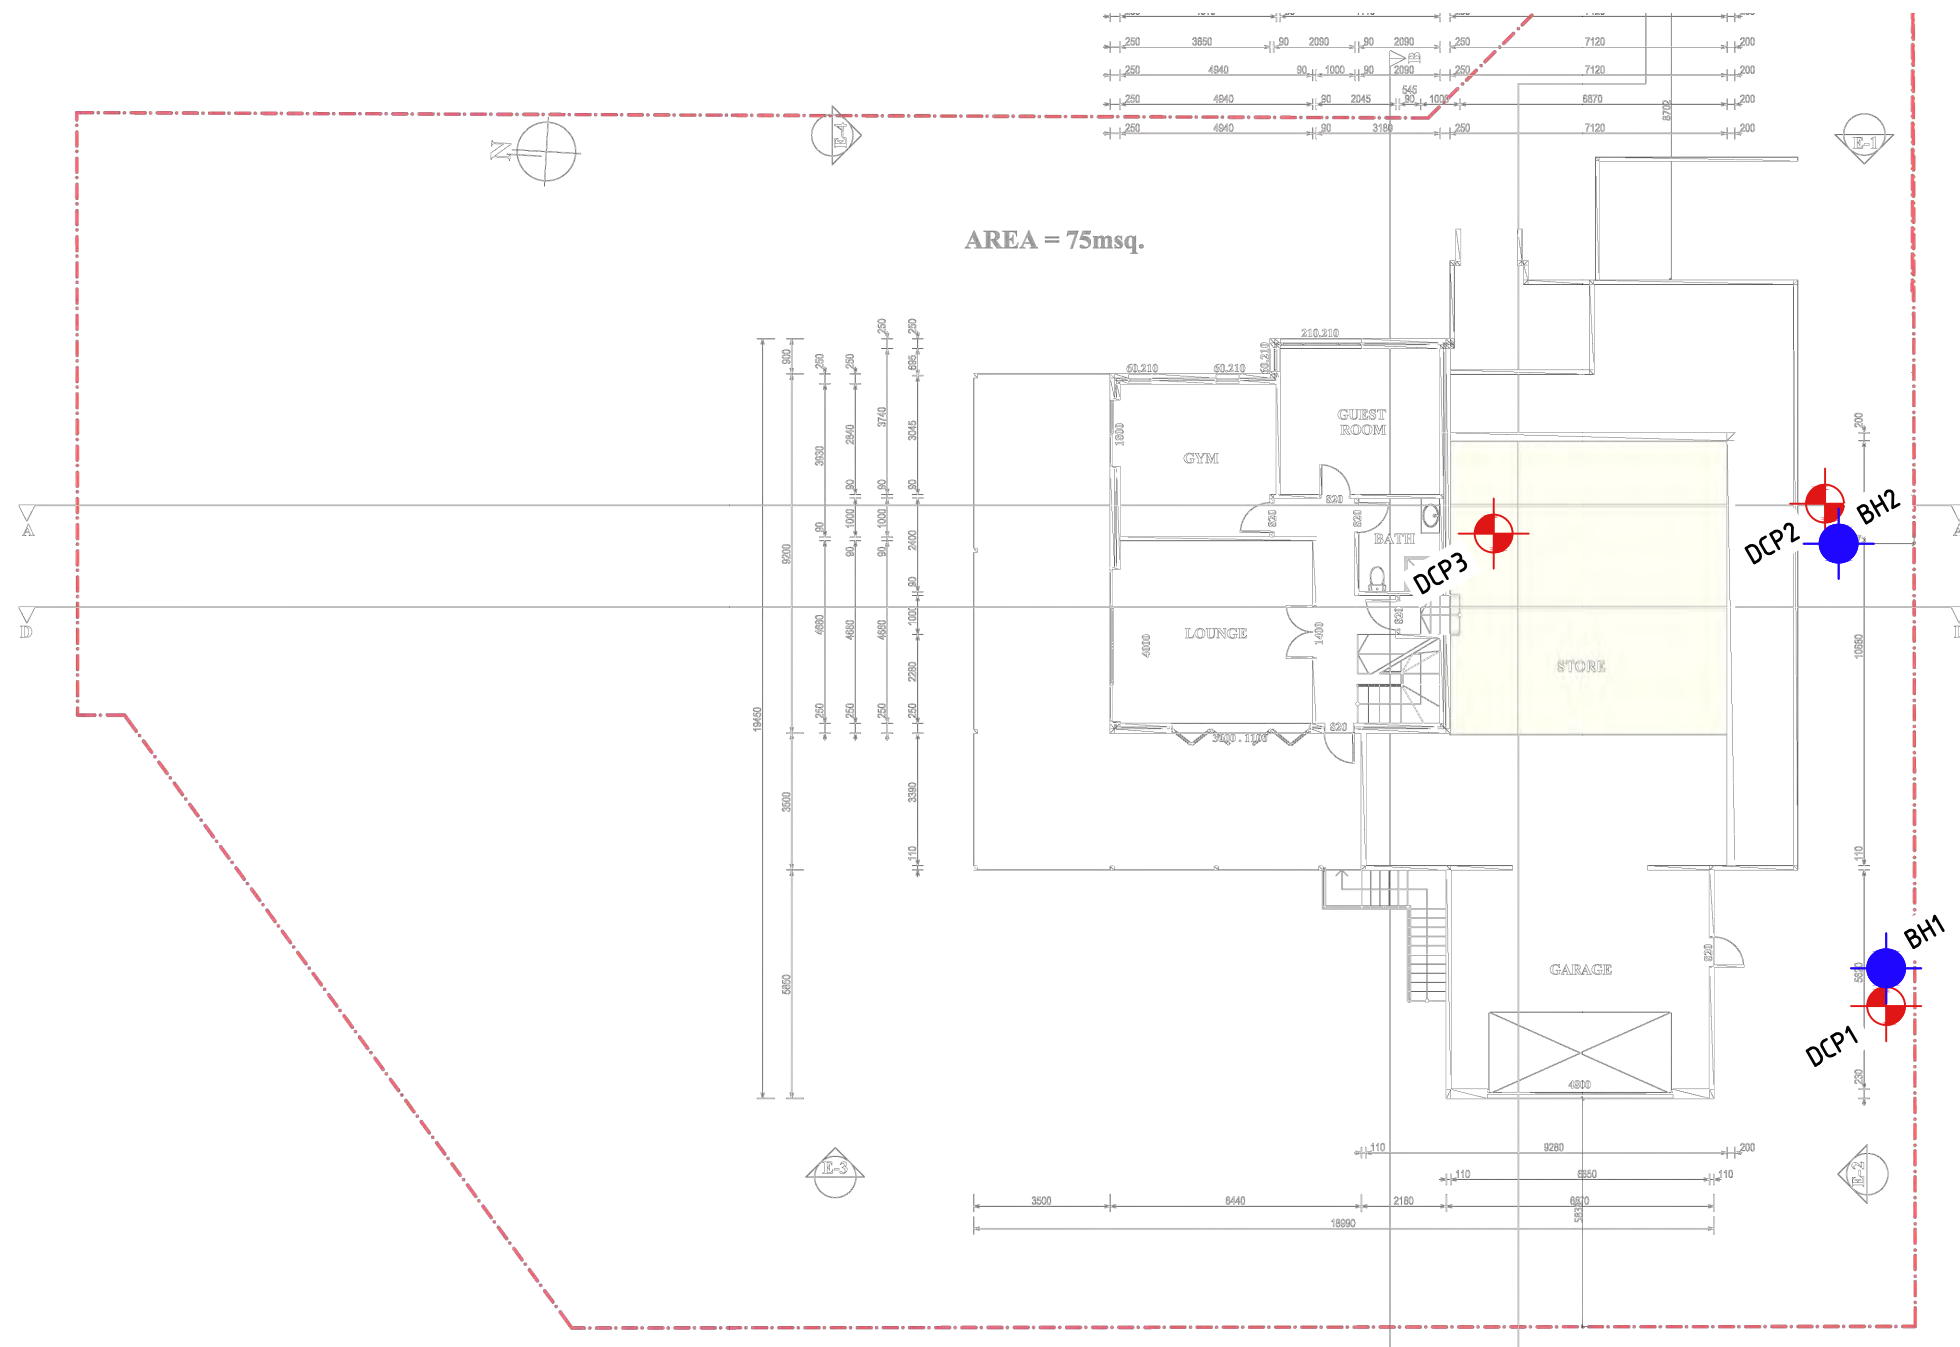
SITE PLAN/GROUND TEST LOCATIONS
SCALE NTS

BOREHOLE LOCATIONS
