Report Title: Geotechnical Assessment 44 Nareen Parade, North Narrabeen
Report Date: 11/03/21
Author : BEN WHITE
Author's Company/Organisation : WHITE GEOTECHNICAL GROUP PTY LTD

GEOTECHNICAL INVESTIGATION:

New Granny Flat at 44 Nareen Parade, North Narrabeen

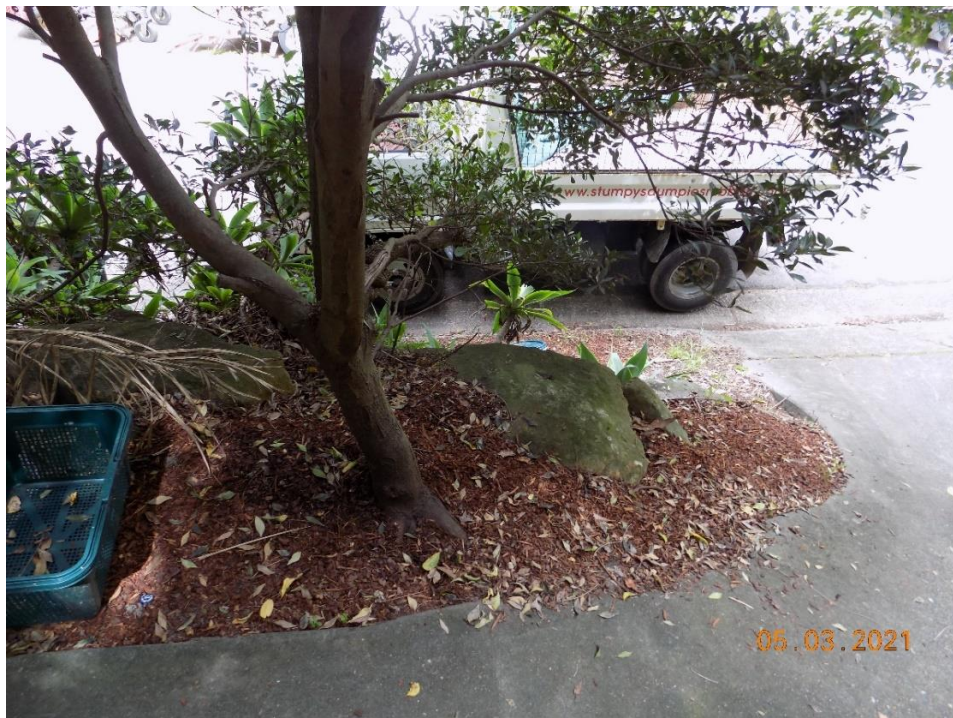
Photo 1

- 2.3** At the road frontage a concrete driveway runs up the slope to a parking area (Photo 1). The driveway has been partially cut into the slope. The cut is supported by a stable timber retaining wall ~1.5m high. A narrow timber pathway runs across the slope above this wall, and is supported by a stable keystone block retaining wall, ~1.2m high (Photo 3). The slope between the car space and the house is terraced with a series of timber retaining walls between ~1.0 and ~1.5m high. One of these retaining walls is tilting at a maximum angle of 18° downslope from vertical and will require remediation works (**see section 13**) (Photo 6). The two-storey timber framed and clad house is supported on steel posts and brick piers which appear to stand vertical. An excavation has been made through fill under the downhill side of the house for a storage area. The ~1.3m high cut face is unsupported. See **section 13** for
