Arboricultural Impact Assessment

15 Dress Circle Avalon

Prepared by Alex Austin

David Tory July 2020

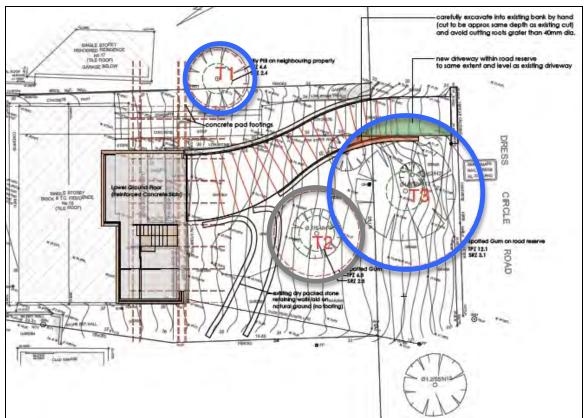
8.1 Tree Plan

Figure 6: The site plan indicating the location of the 3 trees, The Blue circles indicates Moderate retention value and Grey Circles indicate C (Low) Retention values. (Source: Site plan, Titled 'PROPOSED NEW WORKS IN RELATION TO EXISTING TREES', by David Tory Architect, dated 13/07/20, modified by Austin 15/07/20)
