Address of site 23-25 Bassett Street, Mona Vale

GEOTECHNICAL INVESTIGATION:

Proposed Aged Care Centre at 23-25 Bassett Street, Mona Vale

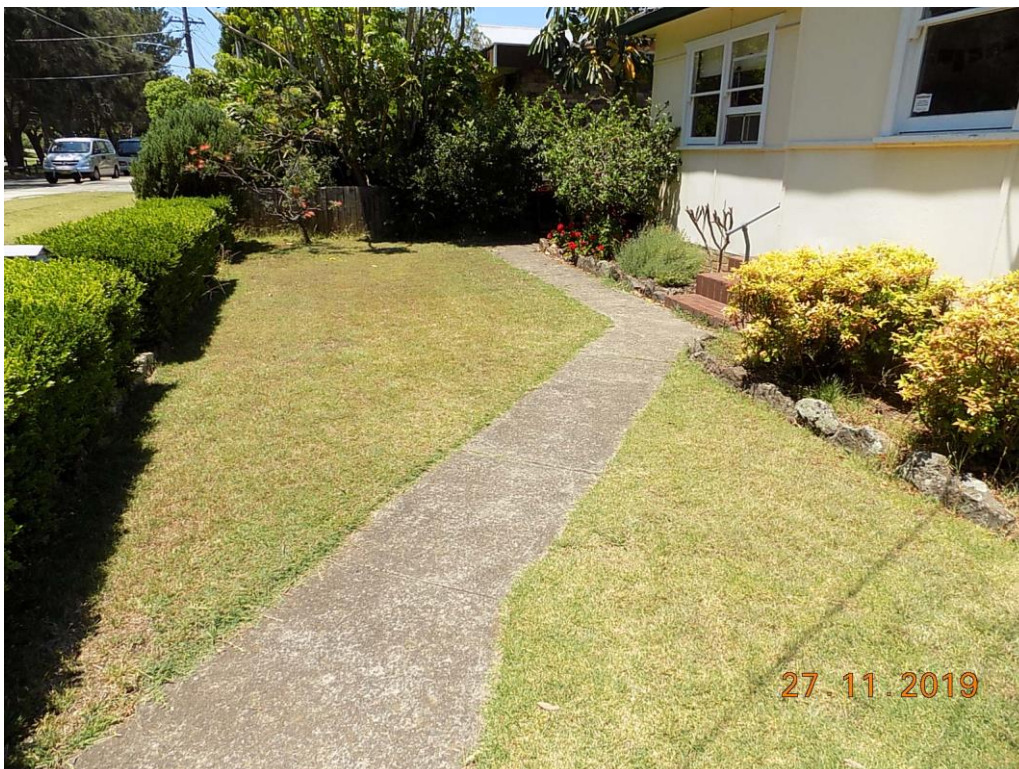
Photo 1

- 2.3** **23 Bassett Street** - At the road frontage, a concrete and gravel driveway runs to a parking area on the W side of the house (Photo 1). Between the road frontage and the house is a near-level lawn (Photo 2). Another near-level lawn extends off the S side of the house, past two garages, to the S common boundary (Photos 3, 4, and 5). The house and both garages will be demolished and the site will be cleared as part of the proposed works.

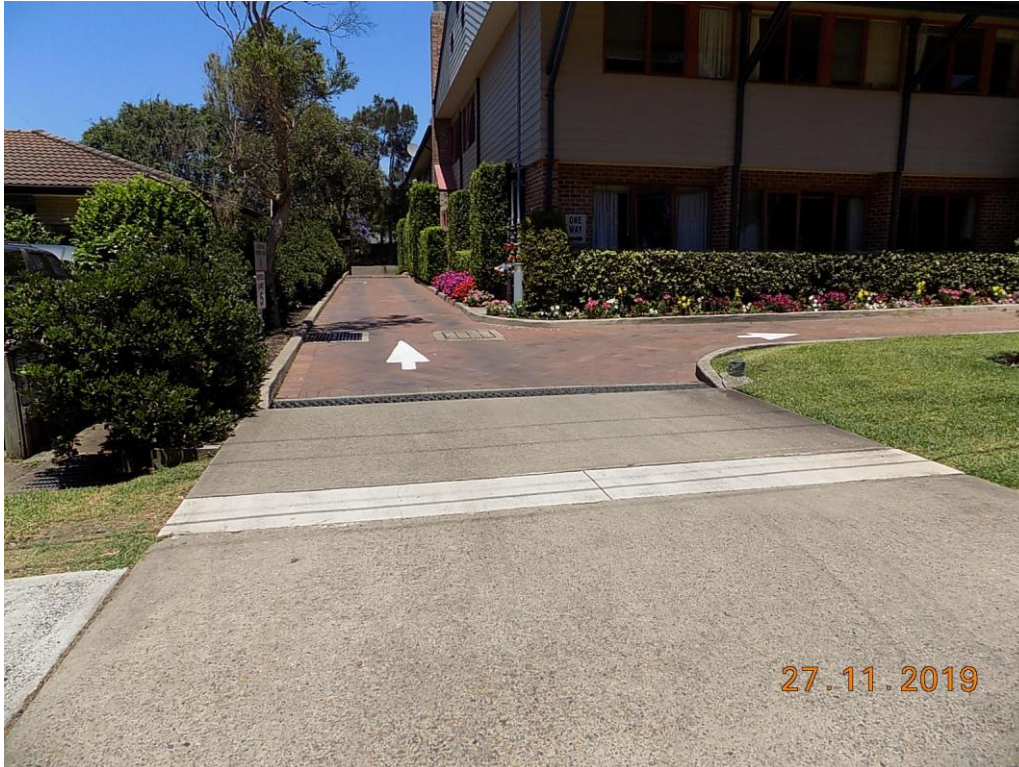
Photo 8

- 2.5** **25 Bassett Street (Residential)** – At the road frontage, a concrete driveway runs to a garage attached to the W side of the house (Photo 6). Between the road frontage and the house is a near-level lawn and garden area (Photo 7). Another near-level lawn extends off the S side of the house to the S common boundary (Photo 8).

AUGER HOLE 2 (~RL3.9) – AH2 (Photo 8)

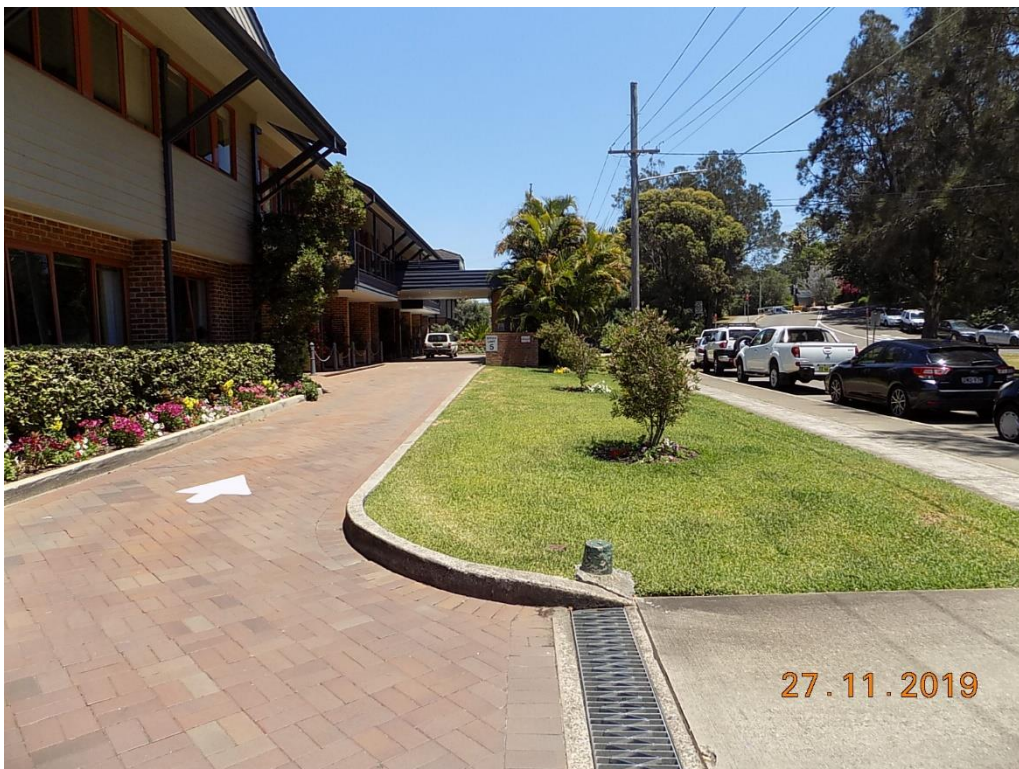
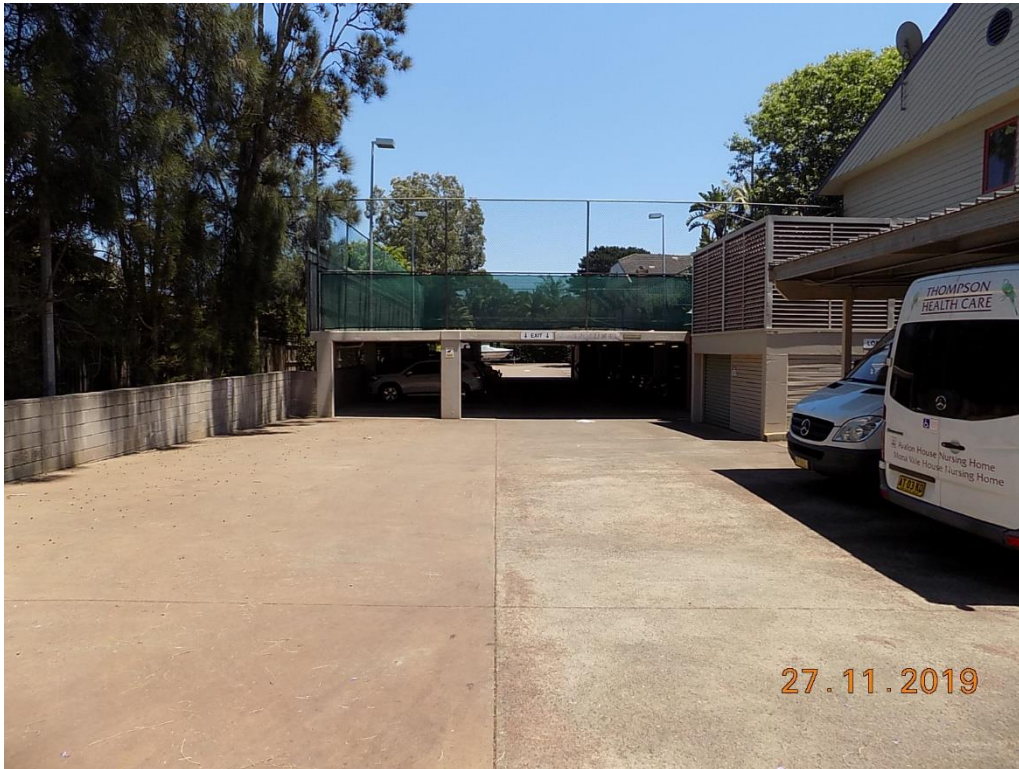
2.6 25 Bassett Street (Aged Care Centre) – At the E end of the road frontage, a concrete and brick driveway runs along the N side of the building to a drop-off and pick-up area before running back to the road frontage (Photos 9 & 10). Between the road frontage and the driveway is a gently sloping lawn and garden area. The E end of the driveway also diverts down the E side of the building to a large concrete parking area on the S side of the property (Photo 11). The parking area is cut into the slope. The cut is supported by a concrete block retaining wall. A portion of the parking area has a suspended tennis court over. The driveway runs back along the W side of the building to the road frontage (Photo 12). The building and tennis court will be demolished and the site will be cleared as part of the proposed works.
