60-62 Chisholm Avenue, Avalon Beach

Comments on Updates to Plans

GEOTECHNICAL INVESTIGATION:

New Driveway and Garage at **60-62 Chisholm Avenue, Avalon Beach**

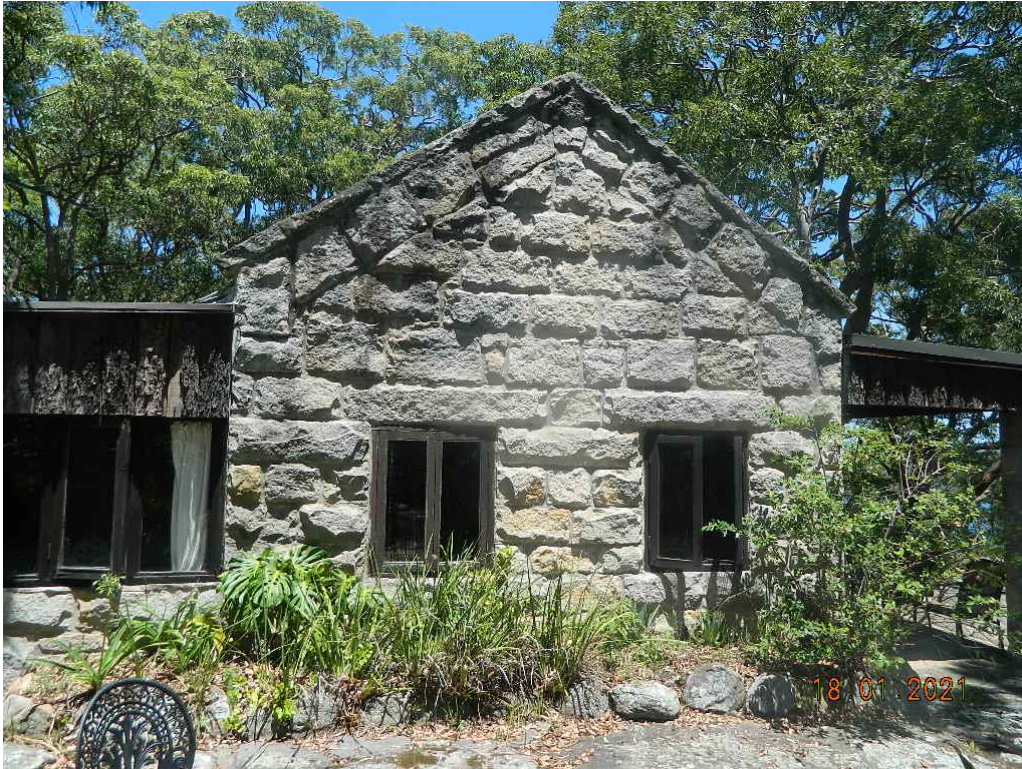
Photo 10

The house at 62 Chisholm Ave is accessed by a bitumen right of carriageway (ROW) and sandstone driveway (Photos 8 & 9). A sandstone dressed concrete block garage in good condition is located on the W side of the house (Photo 10). The old single storey sandstone block house is supported by sandstone block walls and sandstone piers (Photo 11). The supporting walls and piers stand vertical and display no significant signs of movement (Photo 12). The house is supported on exposed sandstone bedrock on the crest of the slope. A moderately sloping lawn on the NW side of the house is terraced by stable sandstone block retaining walls up to ~1.5m high. Sandstone bedrock is outcropping on the steep slope on the NW side of the property. A portion of the rock is undercut by up to ~3.5m (Photos 13 & 14). The undercut has a relatively thin cantilever arm in relation to its overhang length however has stood in its present state for at least hundreds of years. In the unlikely event that the undercut fails, it will fall onto the area immediately below. Given the location of the undercut and provided no one spends time under it, it is not considered a significant threat to life or property.

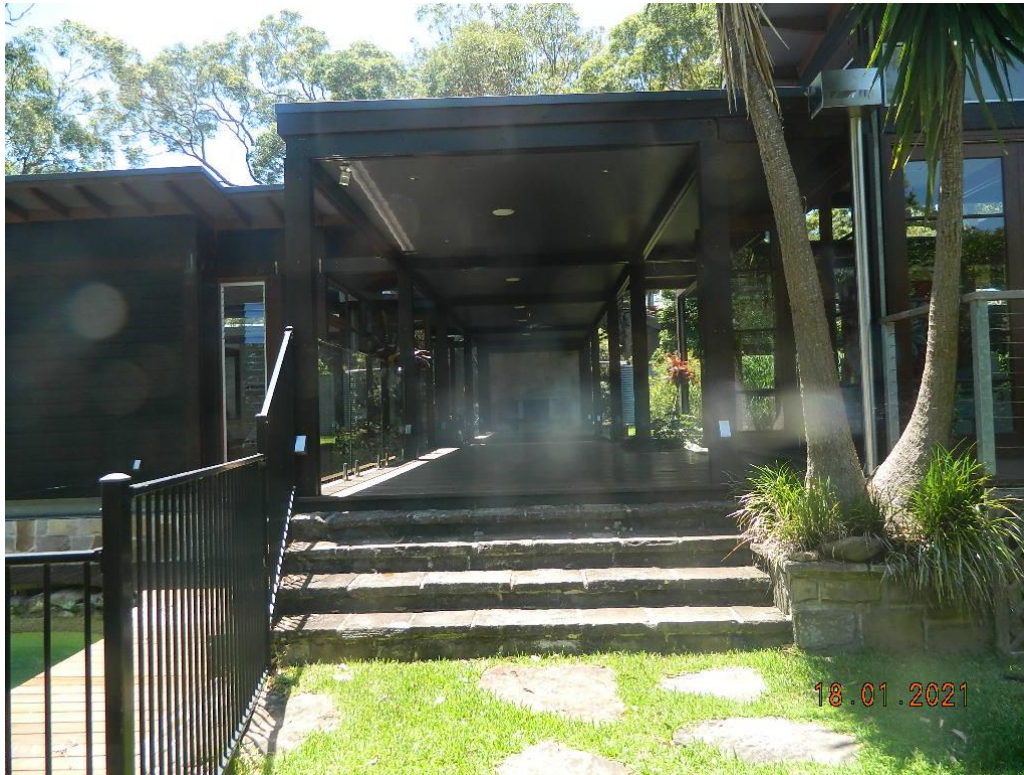
Photo 16

The ROW extends to the house at 60 Chisholm Ave (Photo 15). A pool in good condition is located on the W side of the house (Photo 16). A stable sandstone block retaining wall up to ~2.2m high supports fill on the downhill side of the pool. The part two storey timber clad house is supported by steel posts and concrete block walls (Photos 17 & 18). The supporting posts and walls stand vertical and show no significant signs of movement.
