Geotechnical Assessment

Project: Alterations & Additions
2/1 Lister Avenue, Seaforth NSW

Prepared for:
Mr & Mrs Vescio

Ref: AG 25134
9 April 2025

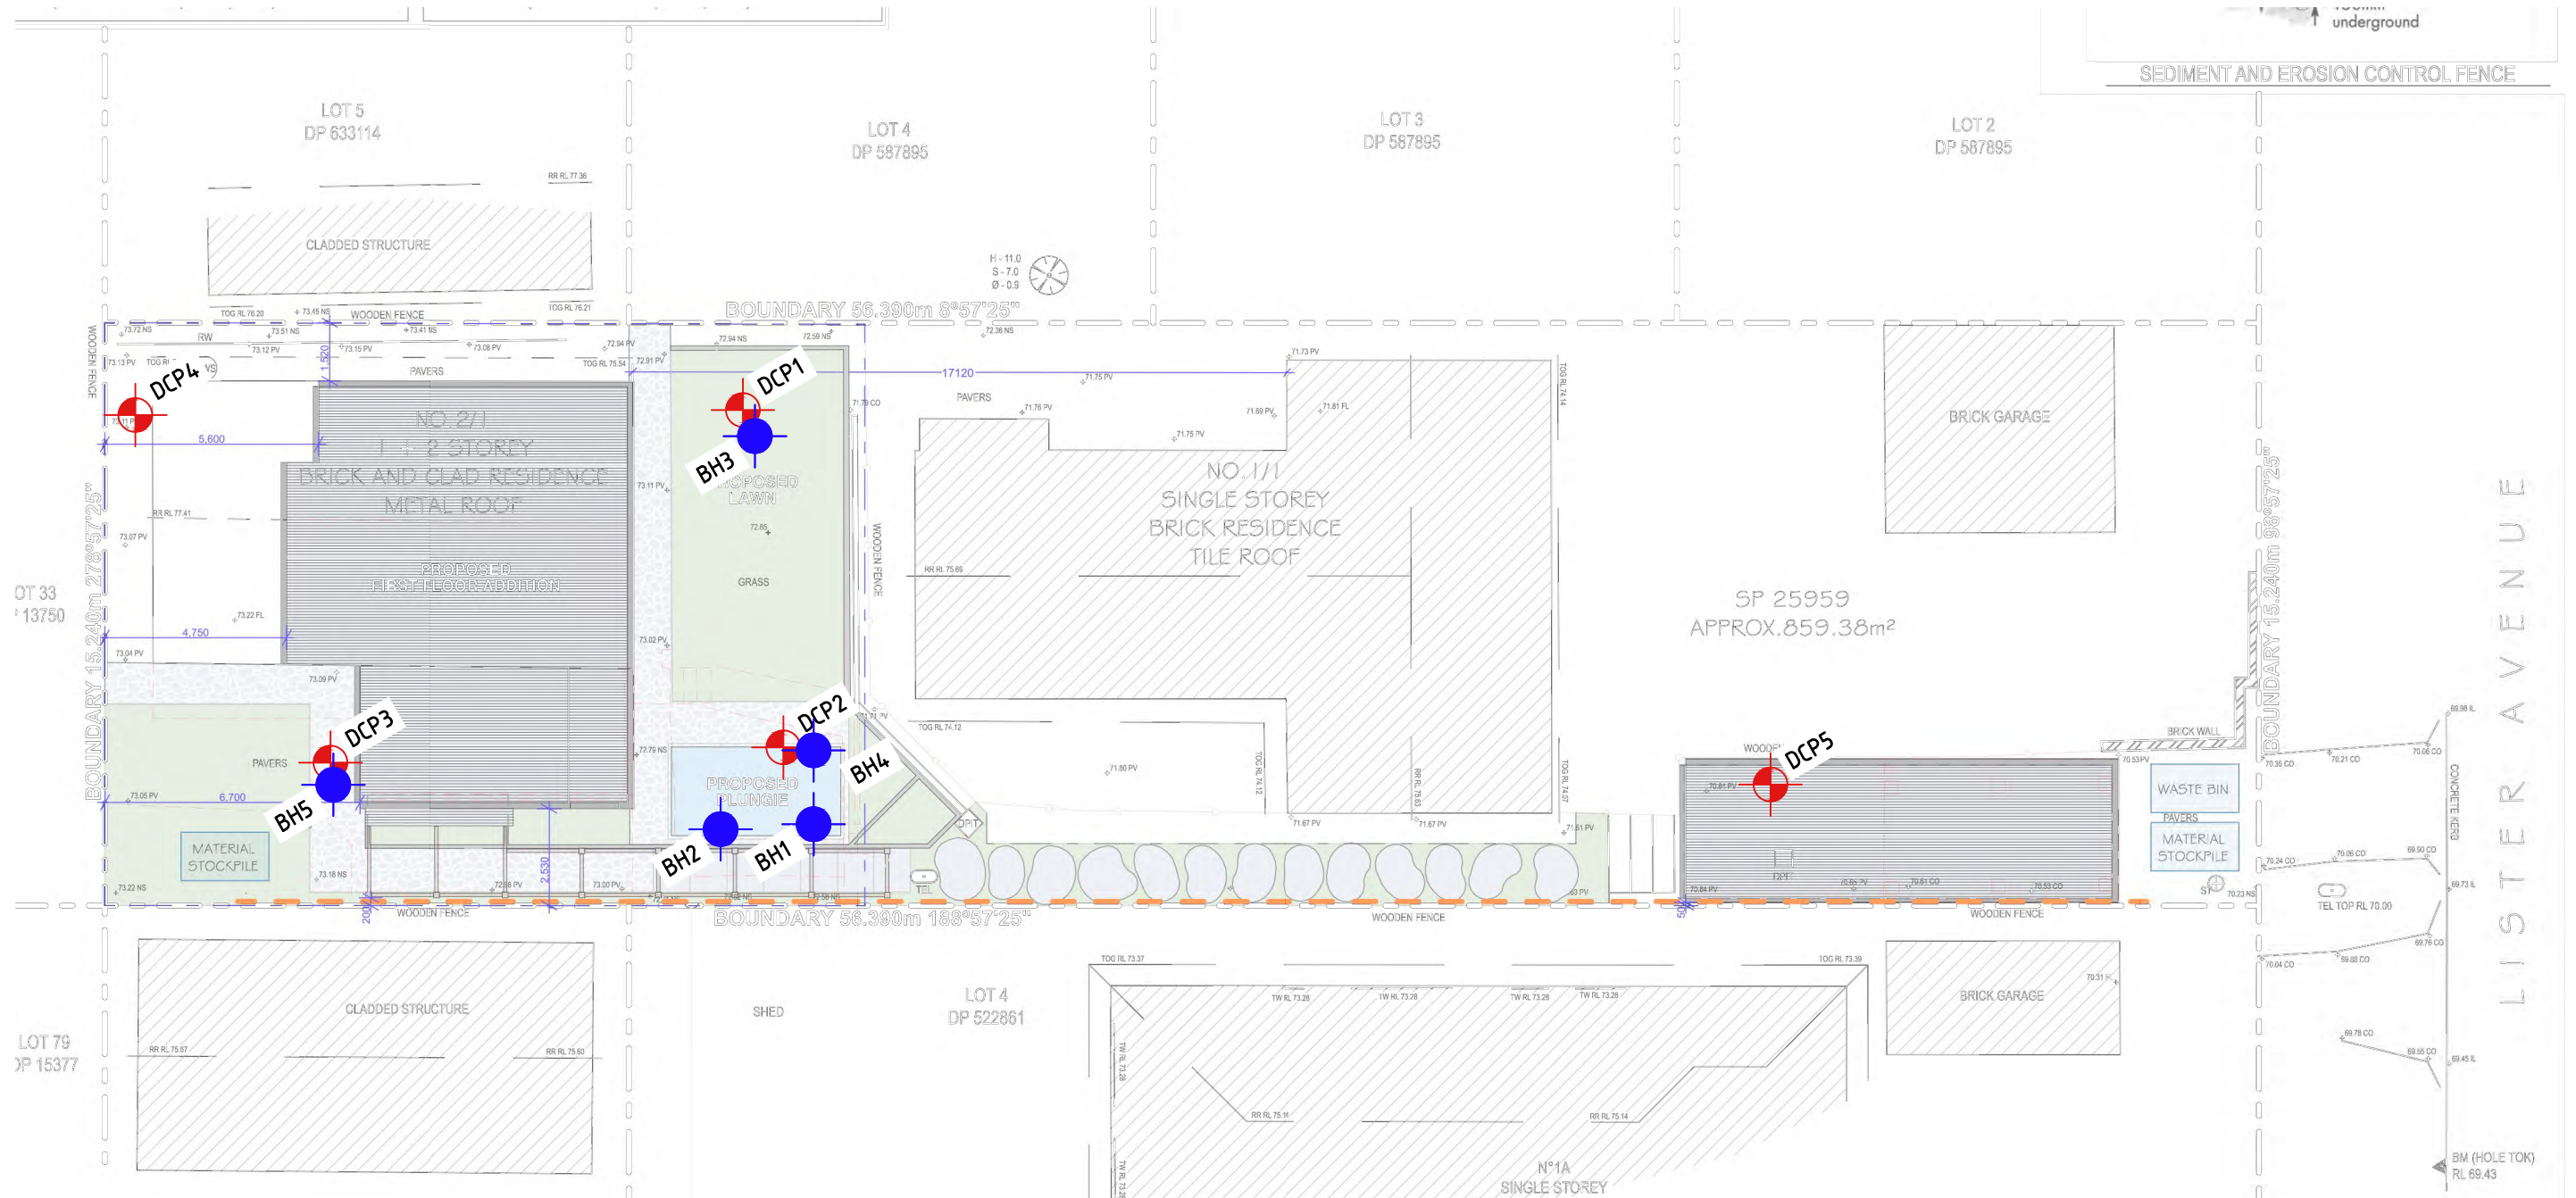
SITE PLAN/GROUND TEST LOCATIONS
SCALE NTS

Test	Summary
DCP 1	Refusal @ 0.75m. Bouncing on assumed sandstone bedrock. Brownish grey sand on moist tip.
DCP 2	Refusal @ 1.30m. Bouncing on assumed sandstone bedrock. Orangish brown sand on wet tip.
DCP 3	Refusal @ 0.55m. Bouncing on assumed sandstone bedrock. Orangish brown sand on wet tip.
DCP 4	Refusal @ 0.60m. Bouncing on assumed sandstone bedrock. Greyish brown sand on wet tip.
DCP 5	Refusal @ 1.10m. Bouncing on assumed sandstone bedrock. Grey sand on wet tip.
