Geotechnical Assessment

Project: Alterations & Additions
5 Roosevelt Avenue, Allambie Heights NSW

Prepared for:
Aaron Hawkins

Ref: AG 24350
6 September 2024

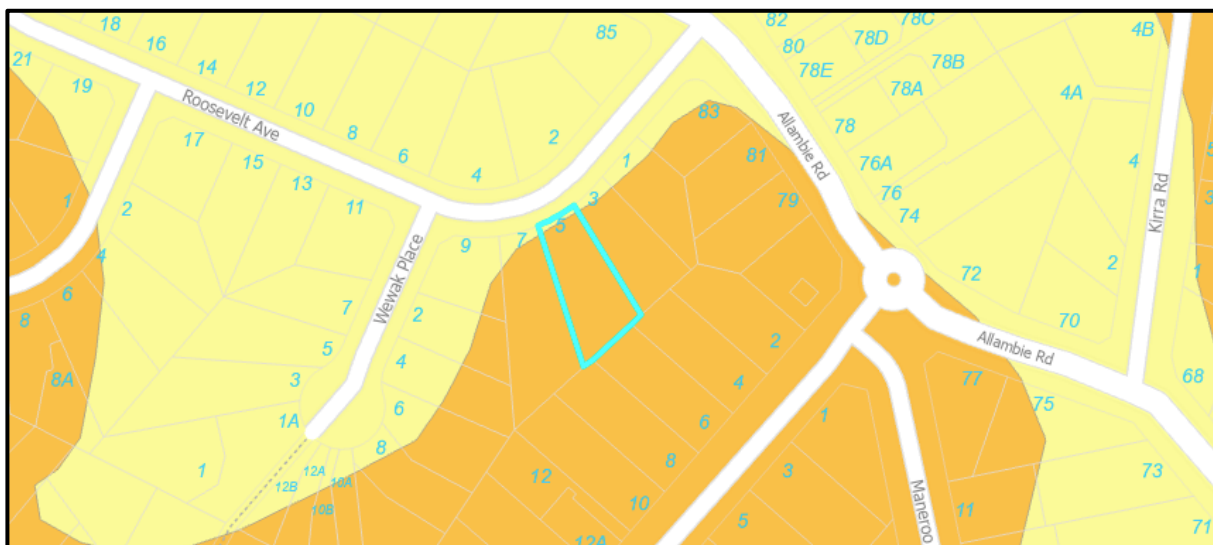
Image 2. Warringah Landslip Risk Map:
5 Roosevelt Avenue, Allambie Heights NSW (© NBC Maps)

- No evidence of significant soil creep, tension cracks or landslip instability were identified across the site or on adjacent properties as viewed from the subject site at the time of our inspection.
- The property is classified as **Area B** with reference to Northern Beaches Council WLEP – Warringah Landslip Risk Map (**Image 2**).
