# *Arboriculture Assessment & Management Statement*

April 2020

**Site:** Lot 1 in DP 588372  
9 Bate Avenue  
ALLAMBIE HEIGHTS, NSW|

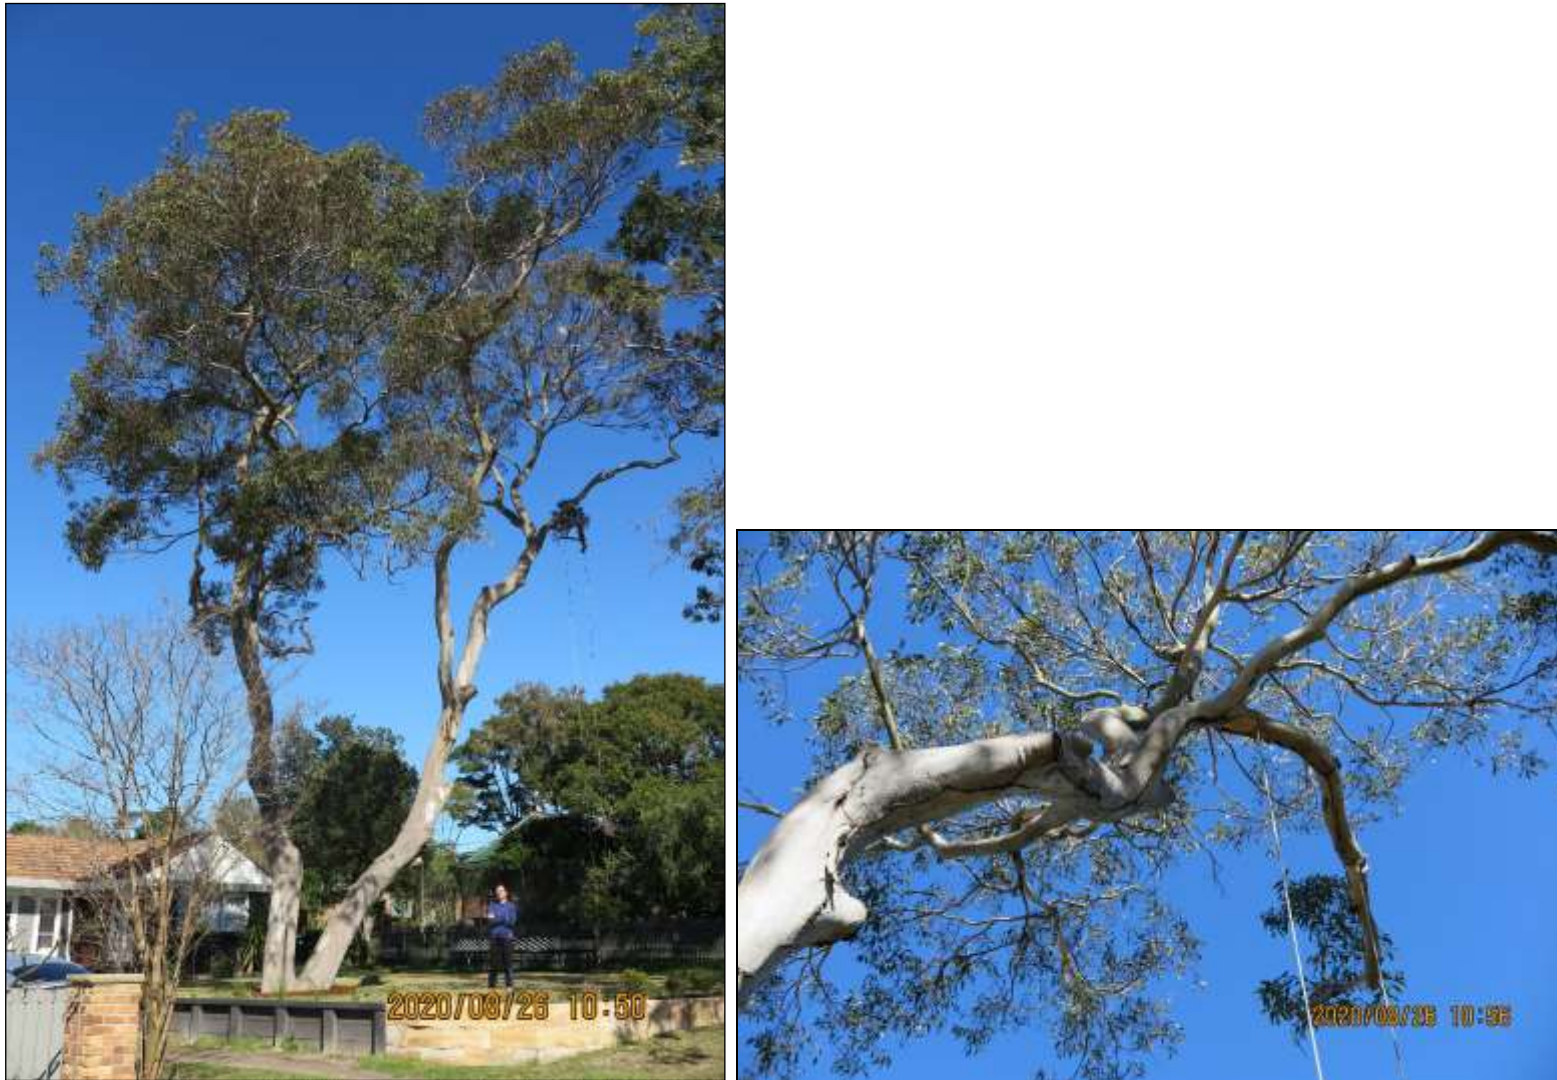
This document will specify the tree be monitored for any signs of active termite activity & change in appearance of its canopy. Multiple 'trunk/stem open wound sites display previous termite damage plus the likely presence of decay pathogen (fungal) organism damage. Monitor these wound sites for the appearance of 'fruiting bodies', commonly referred to as 'Bracket Fungi'. Should these appear the tree would likely require more in-depth assessment, i.e. Resistograph® of Sonic Tomograph (e.g. Picus® or Arbortom®) to quantify the presence of functional verses dysfunctional supporting wood tissues. (This is an expensive process & would not be undertaken unless council or consultant arborist specification to do so.)

Figure 3: Left illustrates the location of the tree, note changed soil levels/retaining wall. Right illustrates one of multiple old termite transport galleries.

- *Document in writing with supporting photographic evidence any excavation process required.*
- *Reassess the tree relative to its Health & Vigour at least every 3 years, more often if still day 'live branch failures' occur or the tree can be visibly seen to be in a state of accelerated decline.*
