Arboricultural Impact Assessment

31-33 Sturdee Lane, Elvina Bay

Ref: 250027

13/03/2025

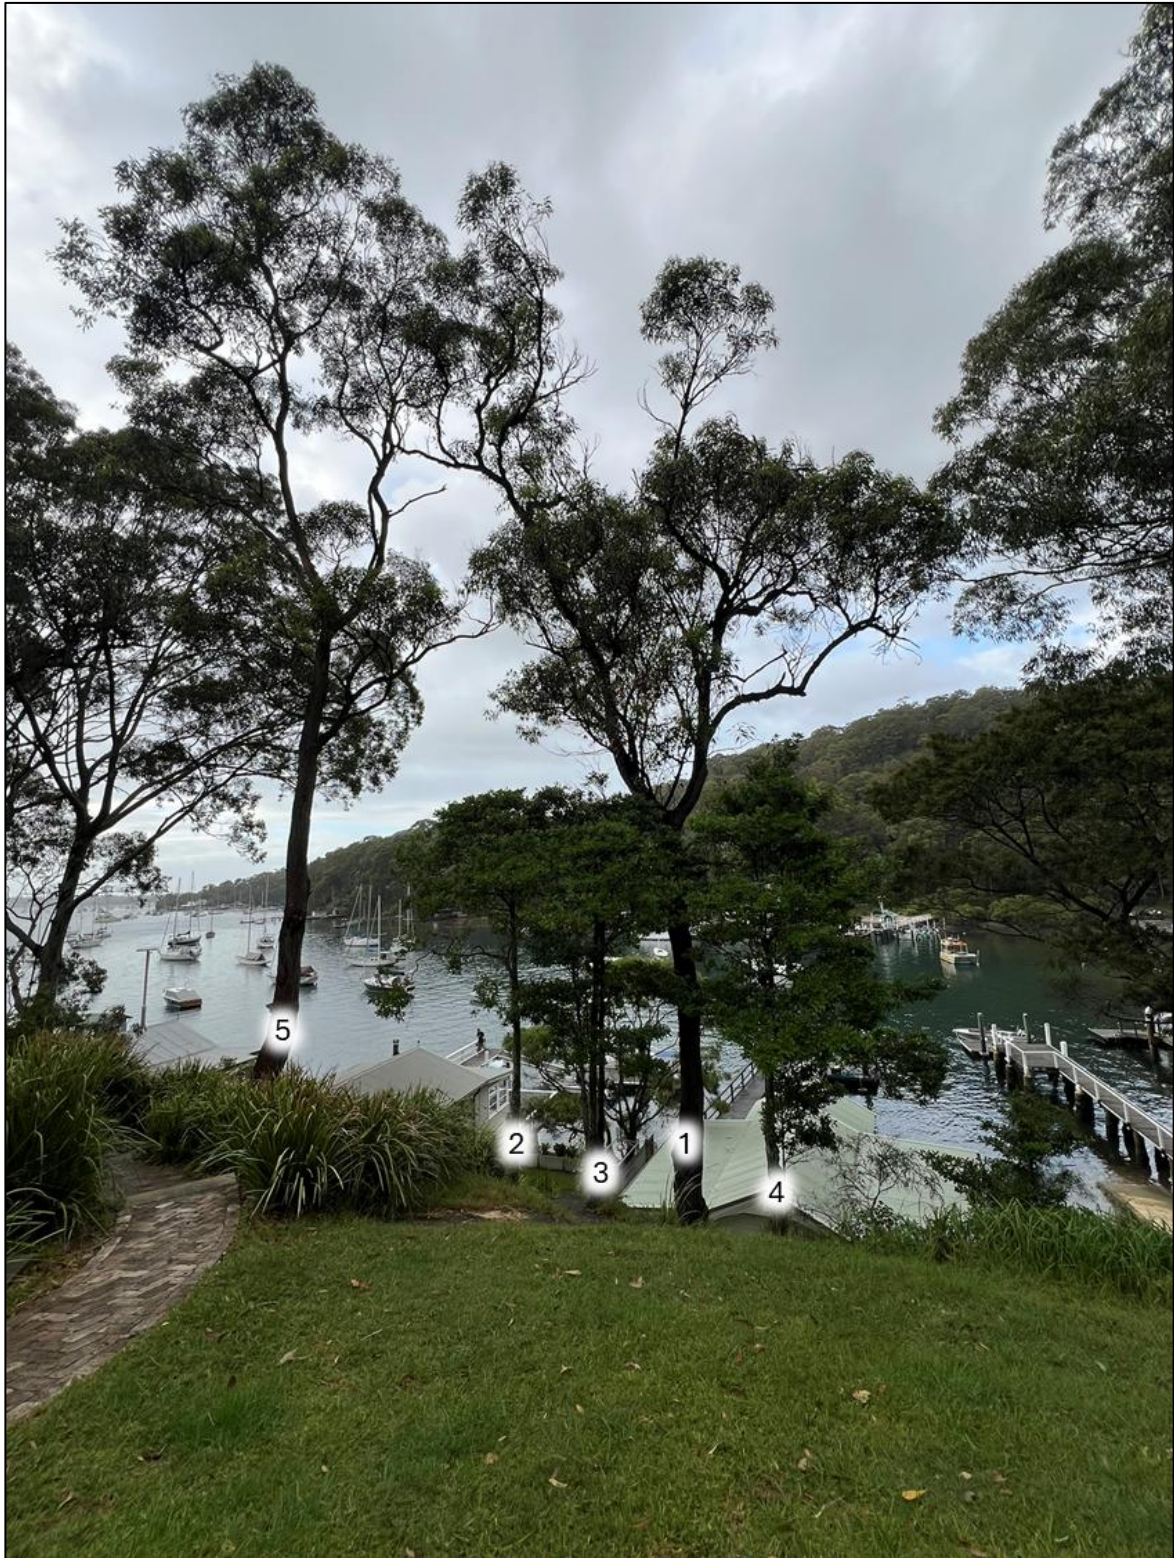
Figure 3. Position of Trees 1-5 adjacent to the shared boundary between 31 and 33 Sturdee Lane, Elvina Bay. Photograph from northern view.

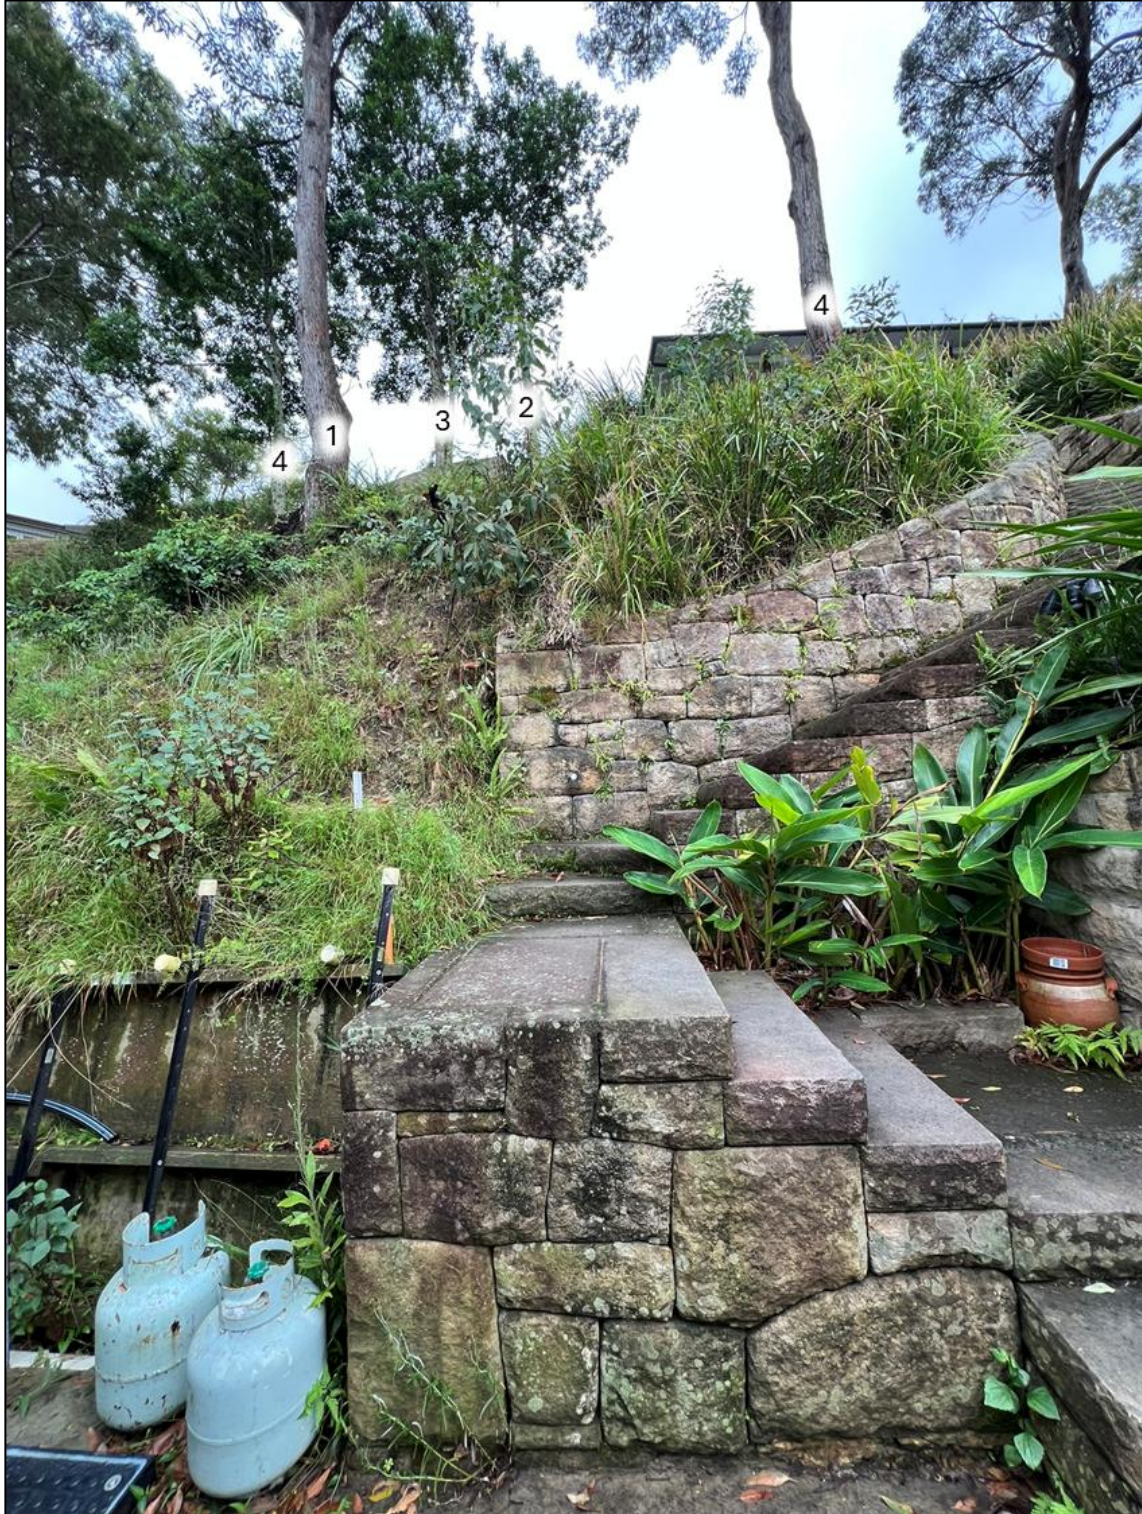
Figure 4. Position of Trees 1-5 adjacent to the shared boundary between 31 and 33 Sturdee Lane, Elvine Bay. Photograph from southern view.
