Report Title: Geotechnical Report 130 Irrubel Road, Newport  
Report Date: 24/12/21

## **GEOTECHNICAL INVESTIGATION:**

New Pool at **130 Irrubel Road, Newport**

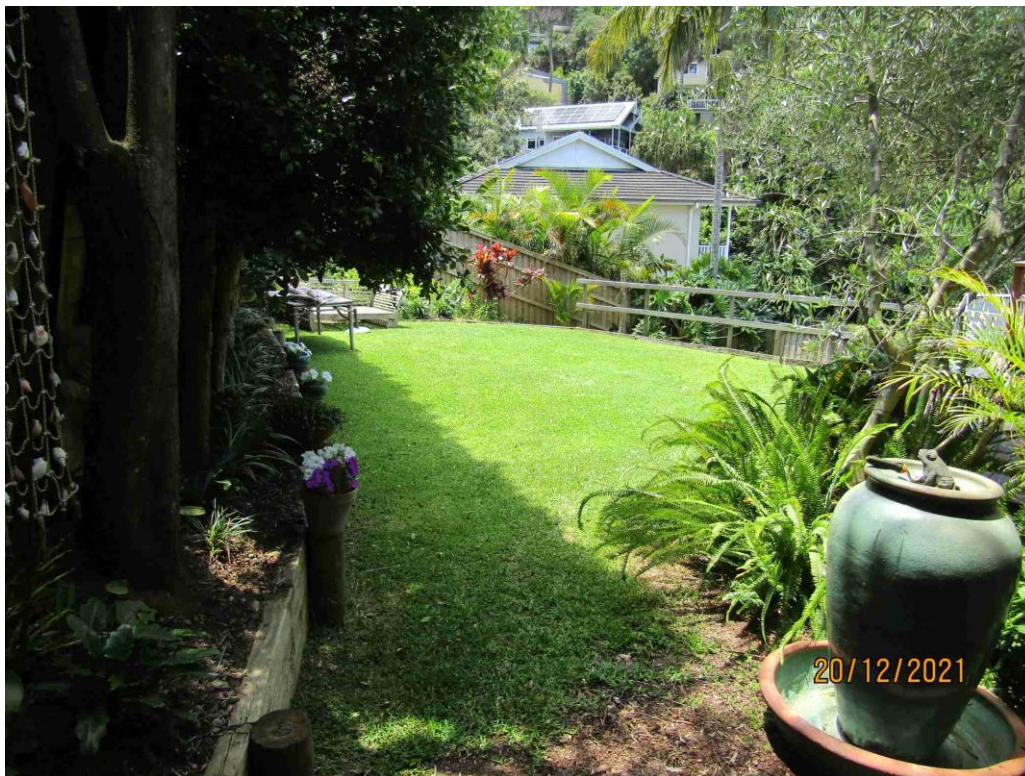
Photo 2

An excavation to a maximum depth of ~1.8m is required to install the proposed pool. The excavation is set back ~0.8m from the existing timber deck (Photo 2).
