ARBORICULTURAL IMPACT STATEMENT

On: Tree Specimens at tree inspection at
552 Pittwater Road North Manly NSW
2100

For.Mr. & Mrs. Davey
On. 21/8/2021

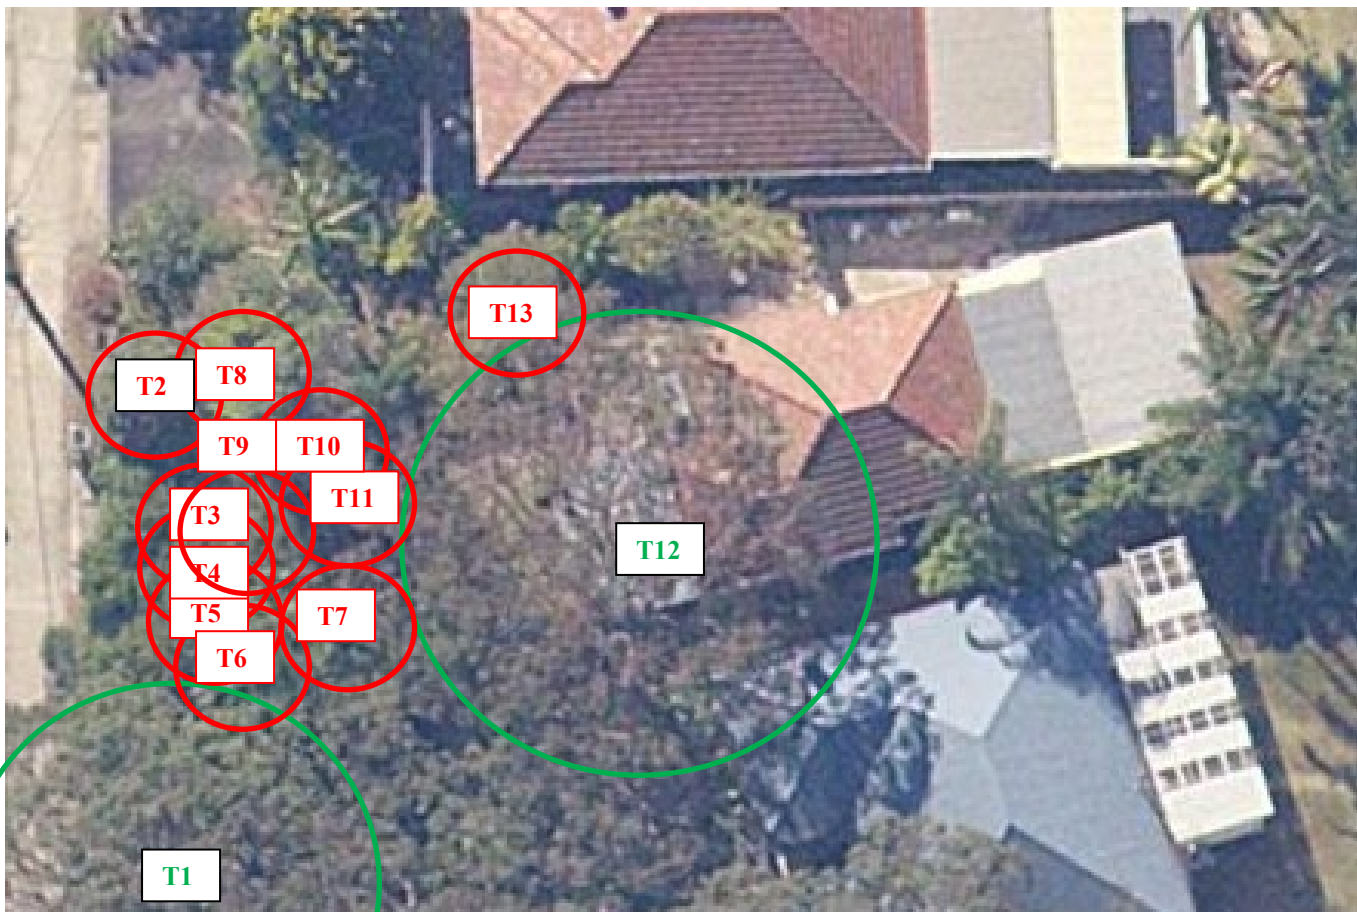
Fig 1. Aerial view of Site with proposed for removal in Red circles and those to be protected and retained in green.

2.3 The 13 trees are designated **T1** to **T13**. Of these 12 of the specimens are located in the front yard to the West of the dwelling while T1 is located on the neighbouring property to the South- west of the Site. (See Fig. 1 below). **T1** is included in this tree schedule as it within 5 m of the boundary may be subject to injury during deliveries or crane activity

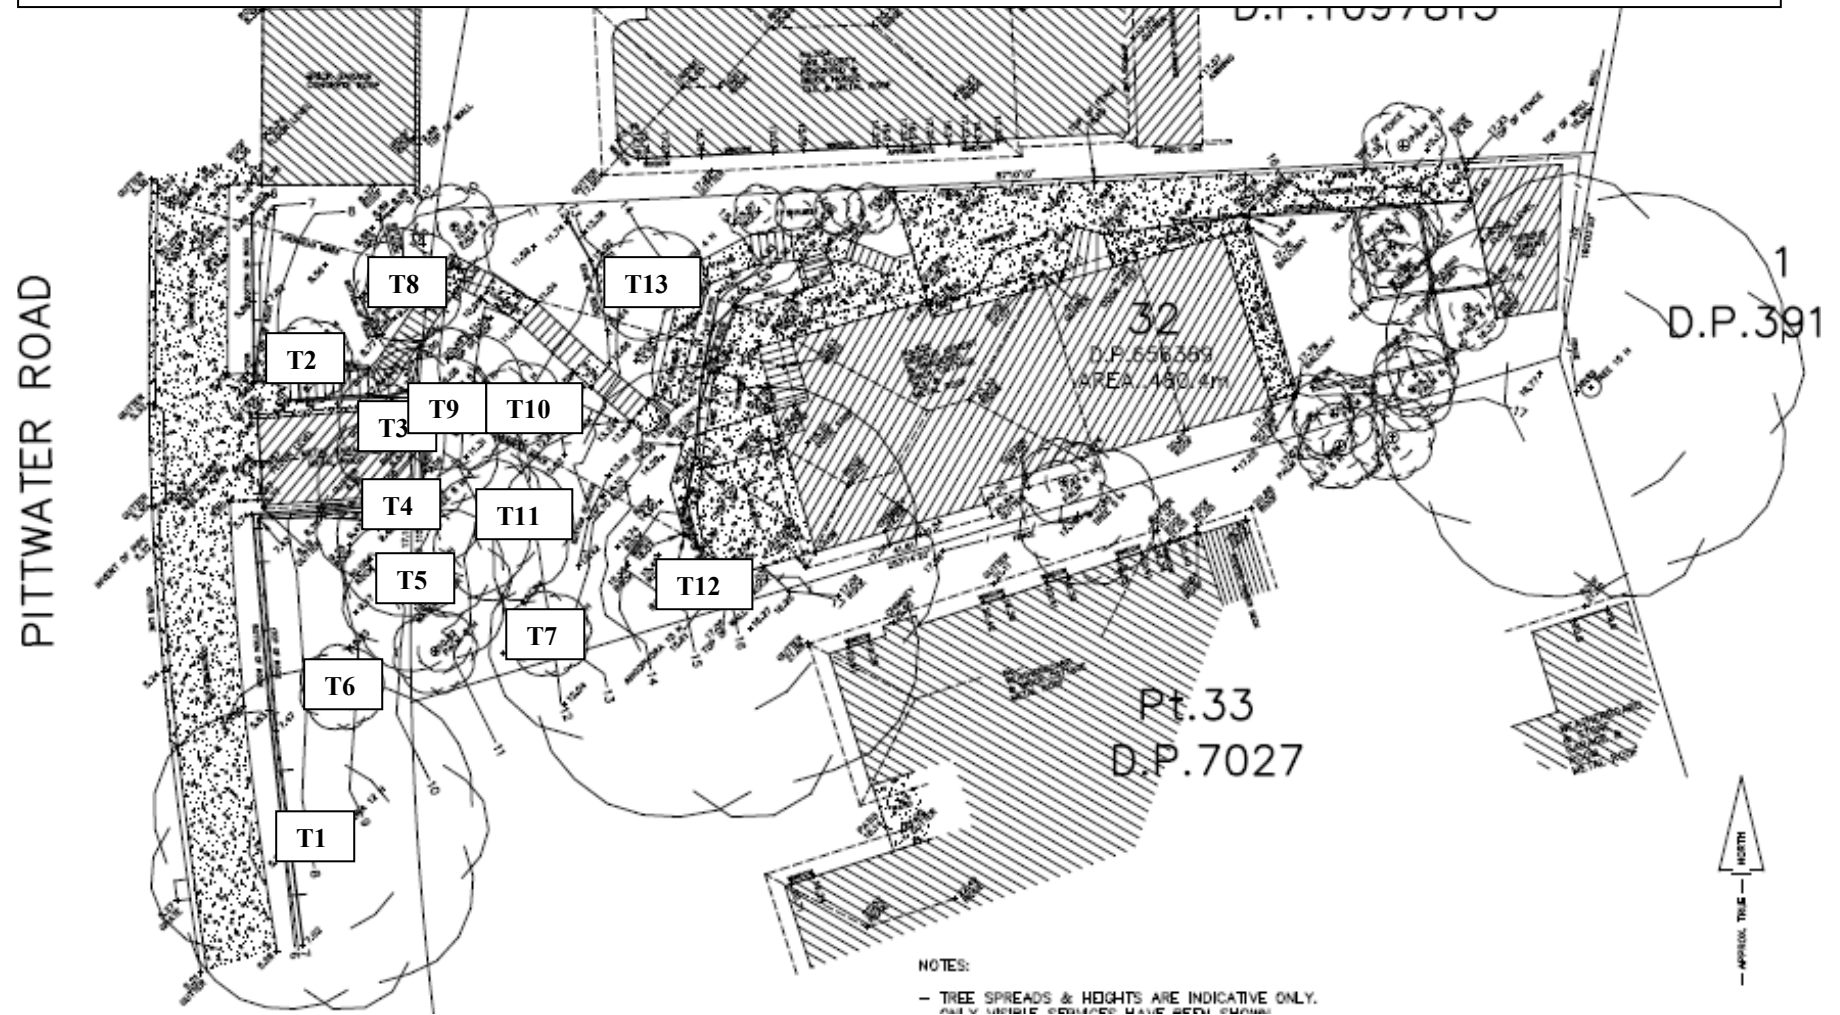
APPENDIX 2a. Excerpt from Site Survey showing position of trees examined in this report.

2.2 At the time of my inspection there was an existing fibro clad dwelling on the Site with an annex to the East of the existing dwelling (See Appendix 2a).

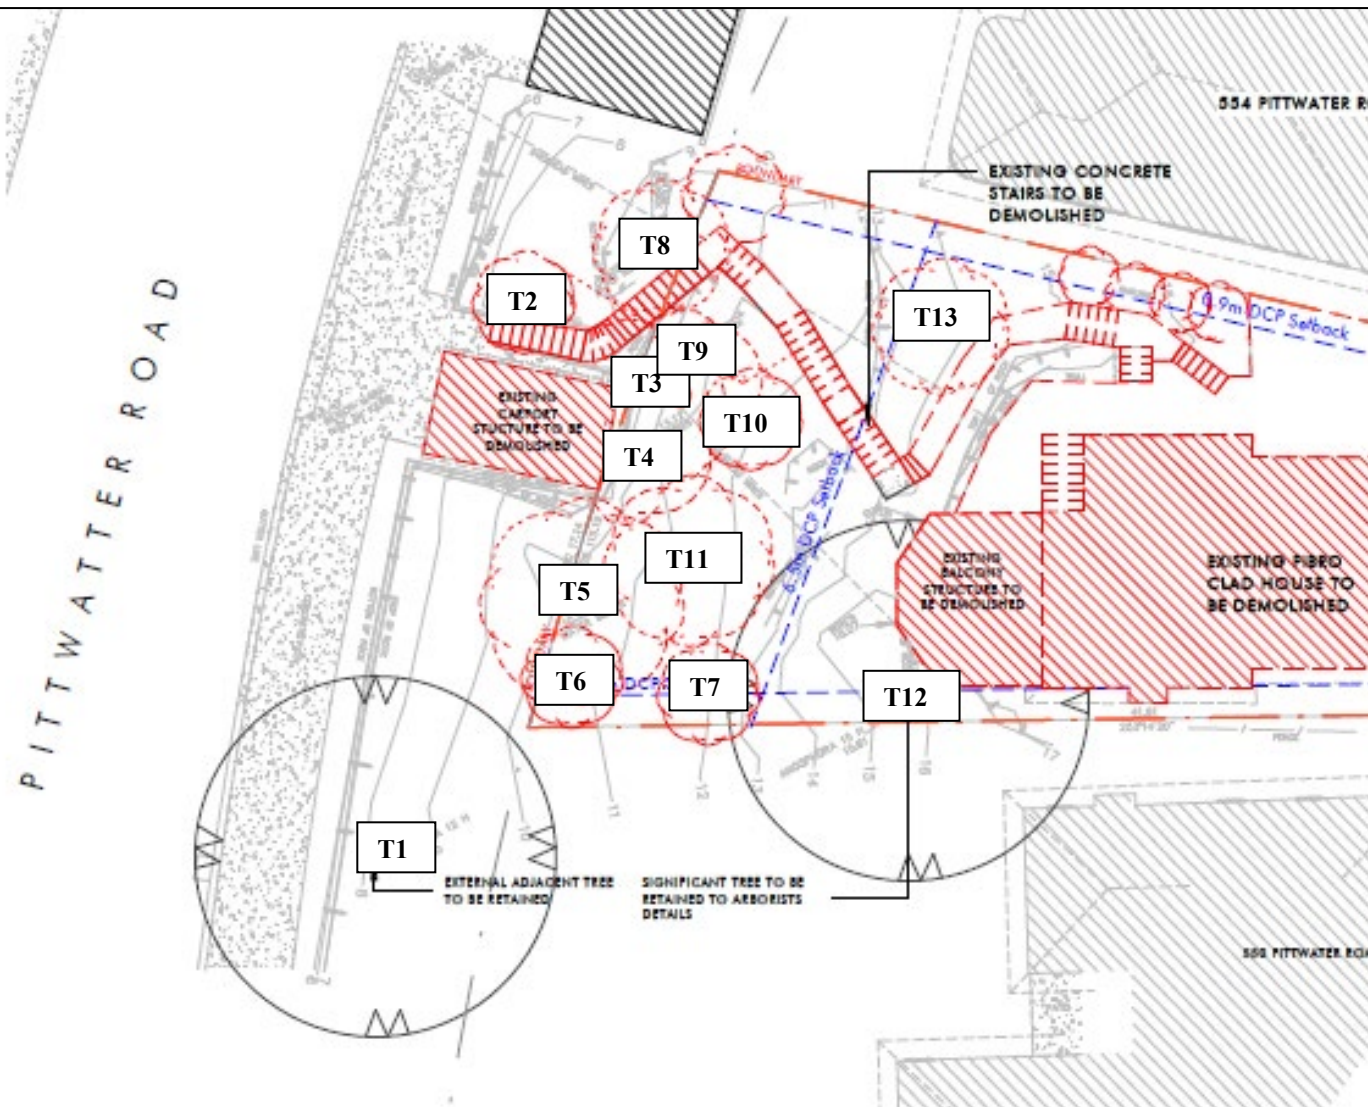
APPENDIX 2b. Excerpt from Site Plans showing tree removal and demolition plan for the site

- Tree **T1** is located well away from the proposed development area and is unlikely to suffer from any adverse affects from the site works (See Appendix 2b).
- Tree **T2** will be subjected to a Major Encroachment into its TPZ and SRZ from the extension in the form of a deck which will replace and extend the existing deck (See Appendix 2b)
