## **GEOTECHNICAL INVESTIGATION:**

Subdivision and New Houses at **10 Beverley Place, Curl Curl**

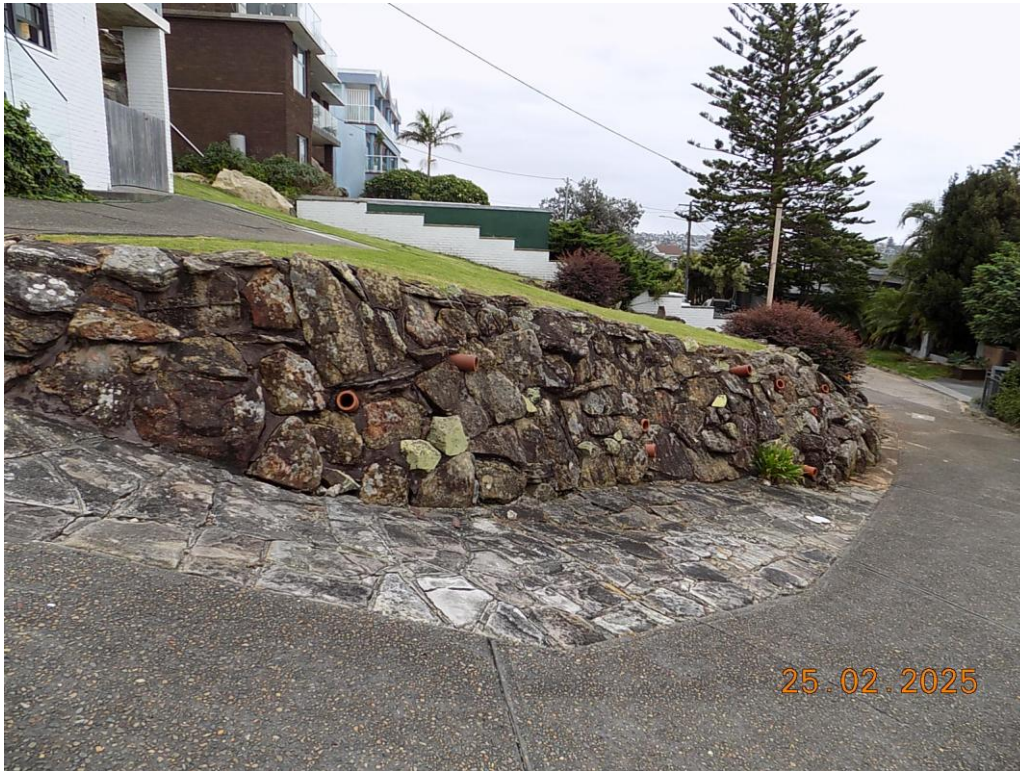
Photo 3

The excavation requires the removal of the two ~1.0m brick retaining walls which support fill for landscaping above the house and below driveway (Photos 2 & 5), as well as the ~2.0m mortared sandstone retaining wall below the house (Photo 3). The walls are to be demolished from the top down in an orderly manner with the fill behind the walls being systematically lowered at the same time. The soil batter slope is not to exceed 1.0 Vertical to 1.7 Horizontal (30°) as the walls are demolished.
