Geotechnical Assessment

Project: Alterations & Additions
1 Phyllis Street, North Curl Curl NSW

Prepared for:
Shane & Ceinwen Lawrence

Ref: AG 25058
19 February 2025

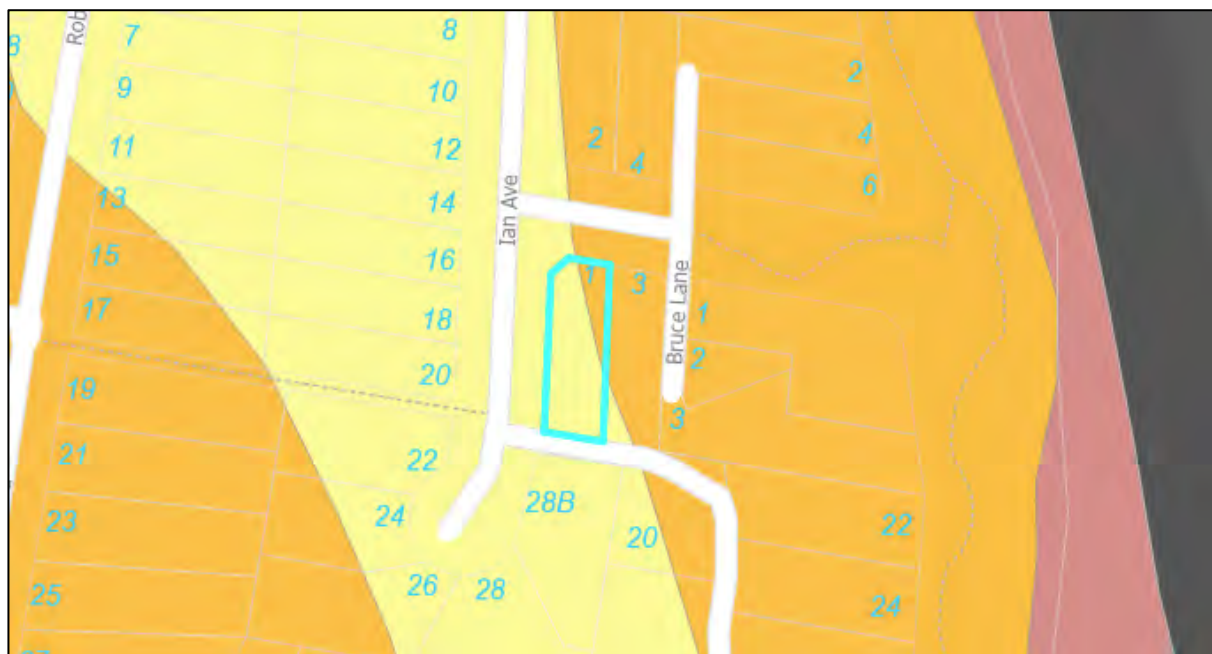
Image 2. Warringah Landslip Risk Map:
1 Phyllis Street, North Curl Curl NSW (© NBC Maps)

- No evidence of significant soil creep, tension cracks or landslip instability were identified across the site or on adjacent properties as viewed from the subject site at the time of our inspection.
- The property is classified as **Area A & B** with reference to Northern Beaches Council WLEP – Warringah Landslip Risk Map (**Image 2**).
