Report Title: Geotechnical Report 197 McCarrs Creek Road, Church Point
Report Date: 15/9/22

GEOTECHNICAL INVESTIGATION:

New Extension, Deck, Swim Spa & Spa at **197 McCarrs Creek Road, Church Point**

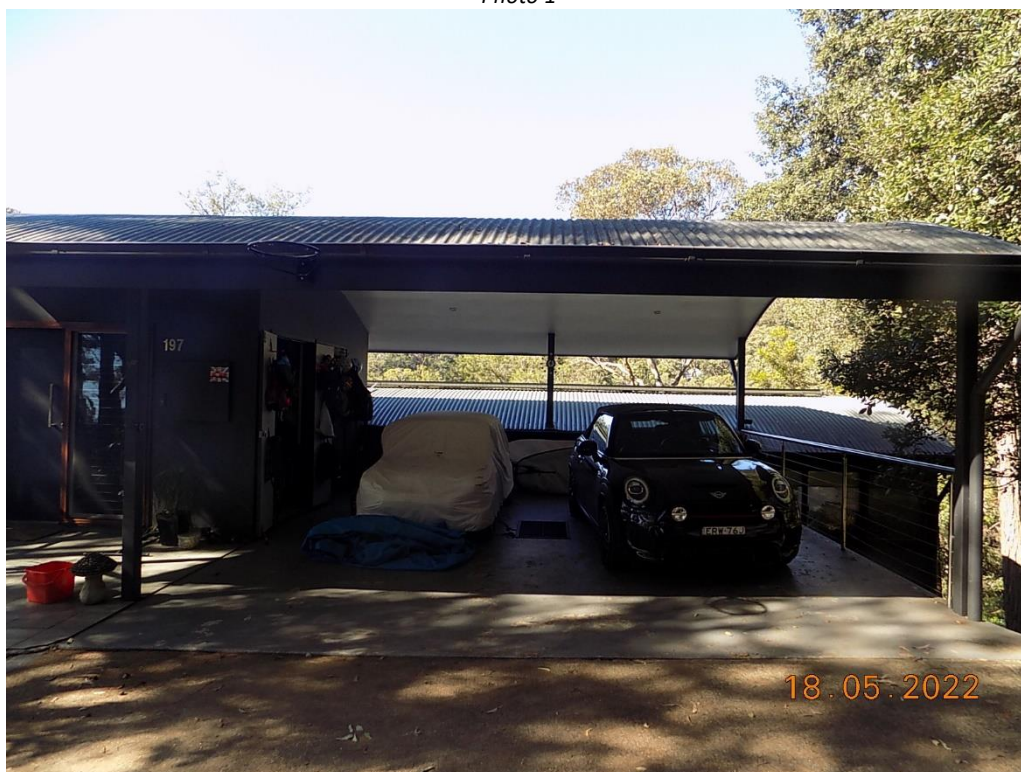
Photo 1

- 2.3** The property is accessed by a ROW off the uphill side of the road. The cut for the ROW is supported by large dimensioned sandstone boulders (Photo 1). A concrete driveway diverts off the downhill side of the ROW to a suspended carport on the uphill side of the property (Photo 2). In between the ROW frontage and the house is a steeply sloping embankment (Photo 3). The toe of the slope has been cut vertically to heights of up to some ~0.8m. See **Section 16** for advice regarding this cut. The two-storey clad house is steel framed and supported on steel posts. The steel posts appear to stand

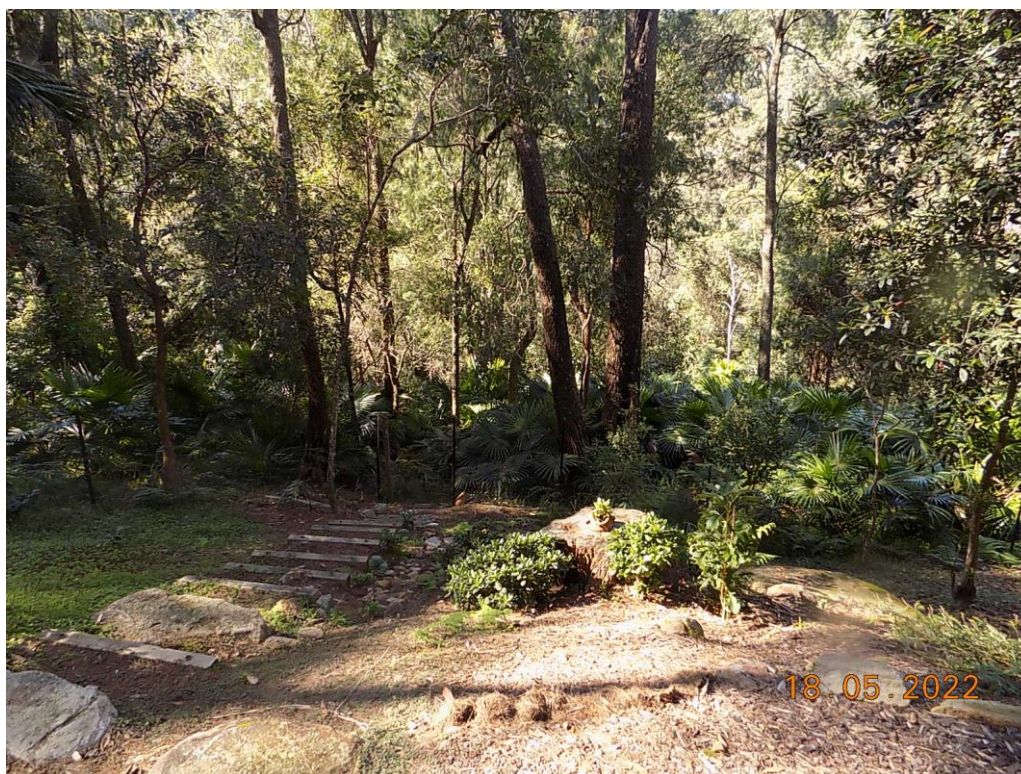
Photo 5

vertical. Several large boulders are embedded in the slope in stable positions (Photo 4). A level lawn area extends off the N side of the house to the N boundary. The fill for the level lawn area is supported by a stable ~1.2m high stack rock retaining wall and a stable ~1.2m high timber retaining wall (Photo 5). The retaining walls and lawn area are to be demolished as part of the proposed works. A steeply sloping lawn area extends from the downhill side of the house to the lower boundary (Photo 6). The lower two-thirds of the property is densely vegetated and was unable to be assessed in terms of stability (Photo 7 & 8).
