REPORT ON GEOTECHNICAL SITE INVESTIGATION

PROPOSED DEVELOPMENT

LOT 3, 1110 BARRENJOEY ROAD, PALM BEACH

Project No.: 2020-232

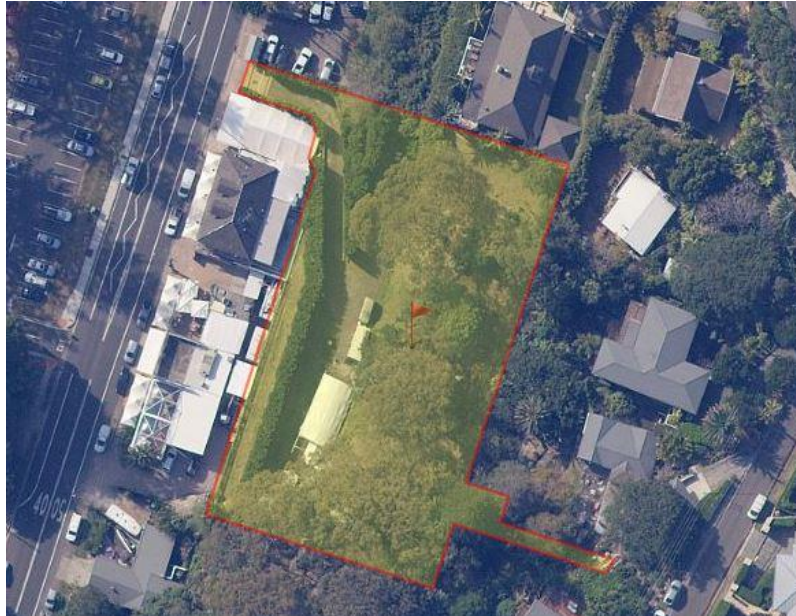
Photograph-1: Aerial photo of site and surrounds

An aerial photograph of the entire site including Lot 1 and Lot 2 and its surrounds is provided below (Photograph 1), as sourced from NSW Government Six Map spatial data system whilst the front of the site is shown in Photograph 2.
